RECORDS OF THE
GEOLOGICAL SURVEY
OF WESTERN AUSTRALIA

No. 1962 / 11.

TITLE: SOUTH CANNING DAM SITE -
A PRELIMINARY APPRAISAL.

DATE: 5th October, 1962.

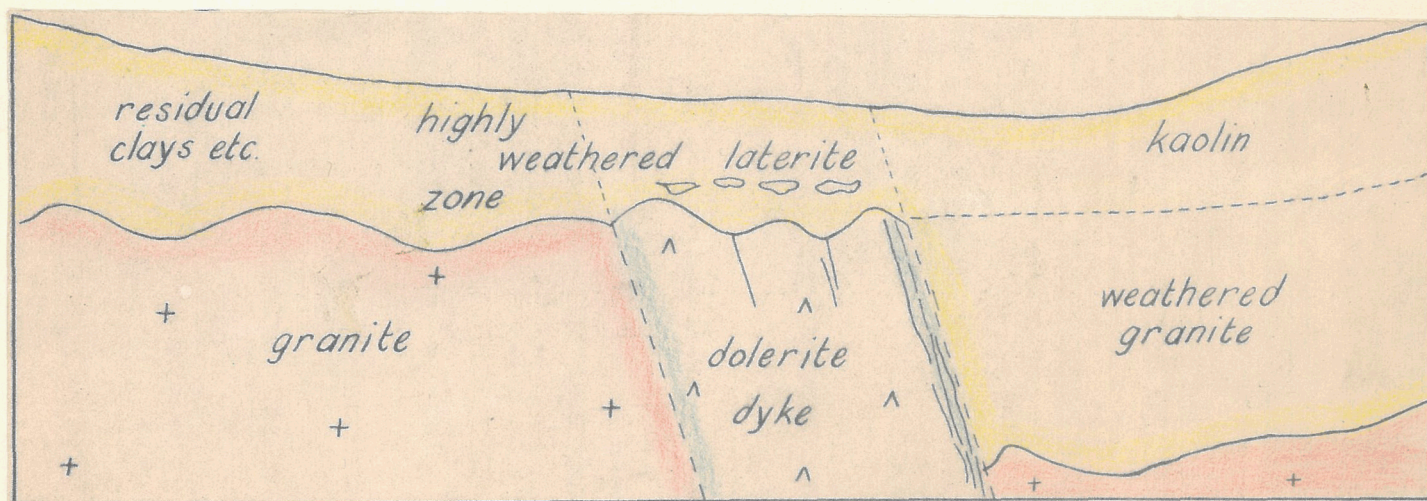
Fig. 1.

Of 12 bores situated round the bend in the river and a short distance from it, the three bores at the northern (upstream) end encountered weathered granitic material to a depth of 54-58 feet; there was weathered dolerite over dolerite at 50 feet in the next hole; the next three bores showed an undulating dolerite surface between 16 and 27 feet; and the remainder of the holes revealed high level (17 feet - 22 feet) granite. The picture thus presented indicates a dolerite dyke intruded into granite with strong displacement

on a fault cutting the northern contact. (Fig.1). There is

a further possibility of faulting down the contact, with shattering of the adjacent dolerite, and the granite down thrown vertically.

This means that the core wall would be founded on different materials along the centre line, and also that the downstream side of the core wall would be founded on high-level dolerite (20 feet) while the upstream side was on decomposed granite, as shown by the dotted line on Fig.1. This situation is most undesirable as differential settlement could lead to rupture of the core wall.

It is suggested that the core wall be placed entirely on the high level granite and dolerite on the southern, or left hand bank of the river. This would involve a downstream shift of the centre line of about 80 feet, and the sequence along the proposed centre line would be :-

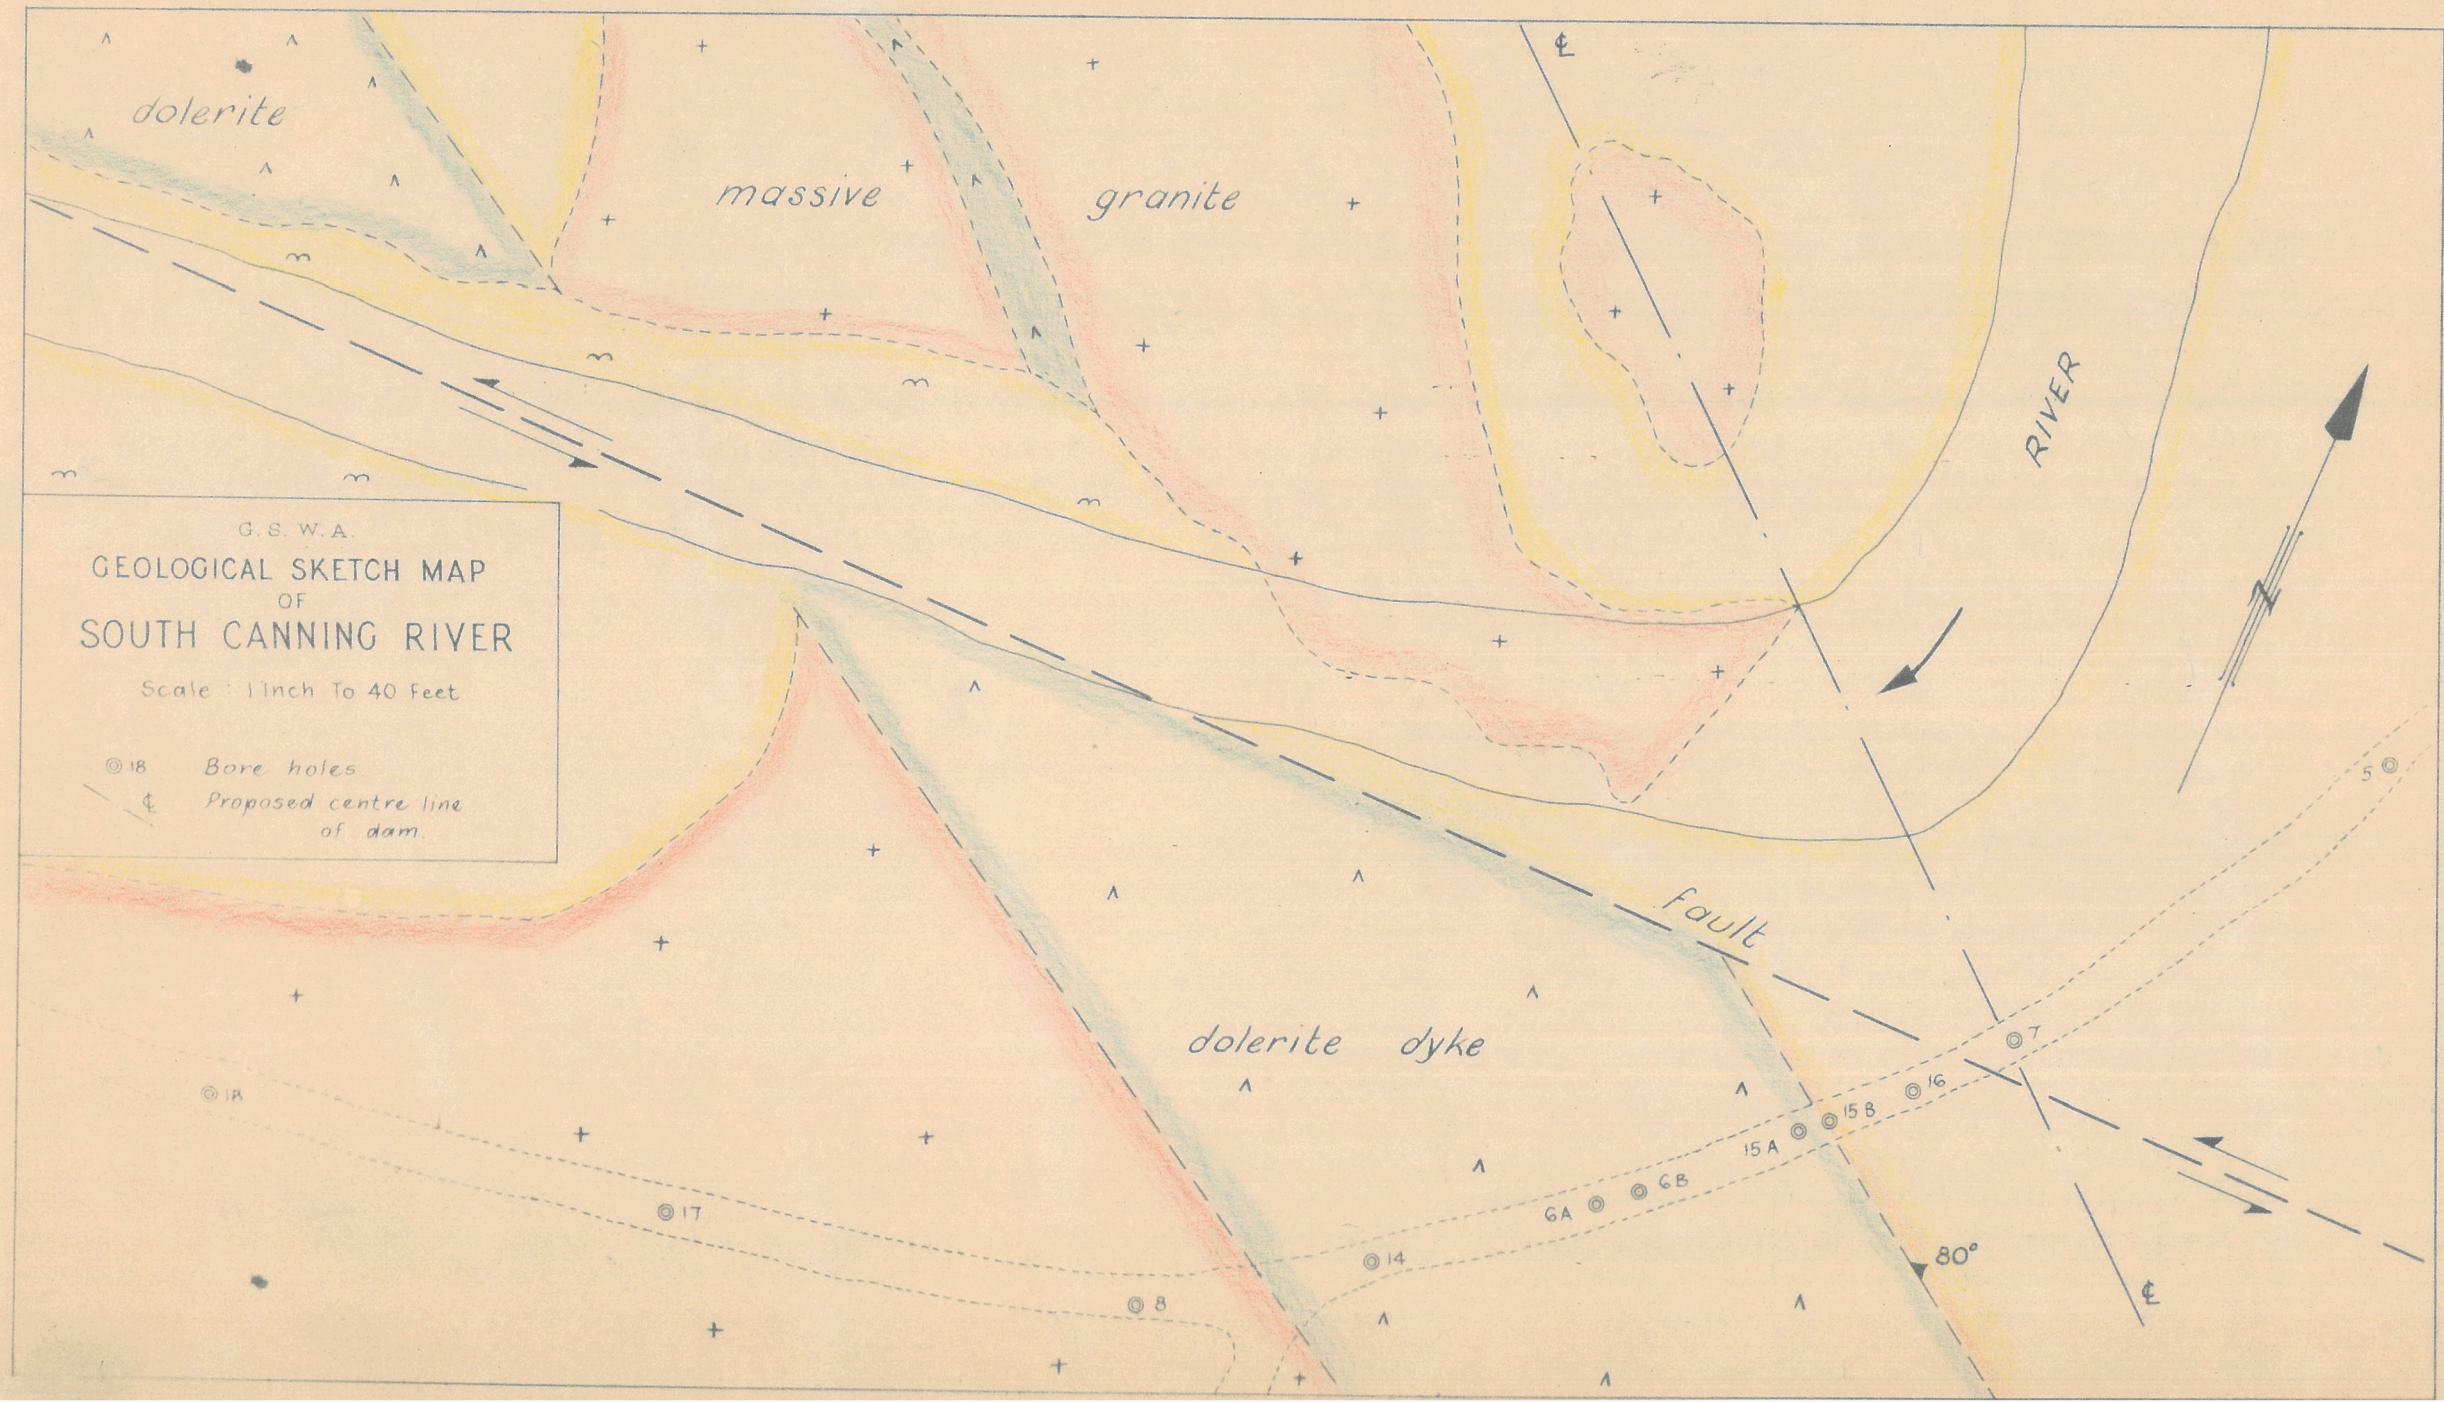
G. S. W. A.
GEOLOGICAL SKETCH MAP
OF
SOUTH CANNING RIVER

Brief surface examination has enabled the drawing of a geologic sketch plan (Fig.2). The dolerite dyke encountered in the drill holes strikes N.E. and appears to be displaced horizontally about 120 feet by a fault that trends roughly E.W. along the second straight of the right angled bend of the river.

- (i) exfoliating granite mass, tabular outcrops sloping to river;
- (ii) South Canning River - (fault) controlled, (joint) deep pool in granite;
- (iii) left hand bank - deep weathering, over 50 feet in granite;

- (iv) fault zone - no more than 2 feet wide deeply weathered granite;
- (v) fault zone at edge of dolerite - deep weathered dolerite;
- (vi) dolerite - high level beyond Bore Hole 9.

The fault offsetting the dolerite will be a possible leakage path, and will have to be grouted. It is not thought likely that the affected area would be more than 2 feet wide. However, a diamond drill hole from just below 6B, at right angles to the river, and extending across underneath it, would be valuable in assessing leakage conditions.

On the massive granite of the right hand bank and river bed, and on the dolerite dyke, a concrete cut-off wall will be desirable to fit in with the core wall. The jointing pattern thus far seen suggests that there is some strong

Future work of an investigational nature would involve accurate geological mapping and appraisal of the finally chosen site and the drilling of two diamond drill holes, each about 100 feet long at a depressed angle of 30° with full core recovery essential. It is suggested that the drilling precede the geologic appraisal to allow assessment of rock jointing and thus of remedial grouting.
