RECORDS OF THE
GEOLOGICAL SURVEY
OF WESTERN AUSTRALIA

No. 1962 / 7.

**TITLE: REPORT ON ROCK STABILITY.
MUNDARING WEIR PUMP HOUSE.**

DATE: 16th July, 1962.

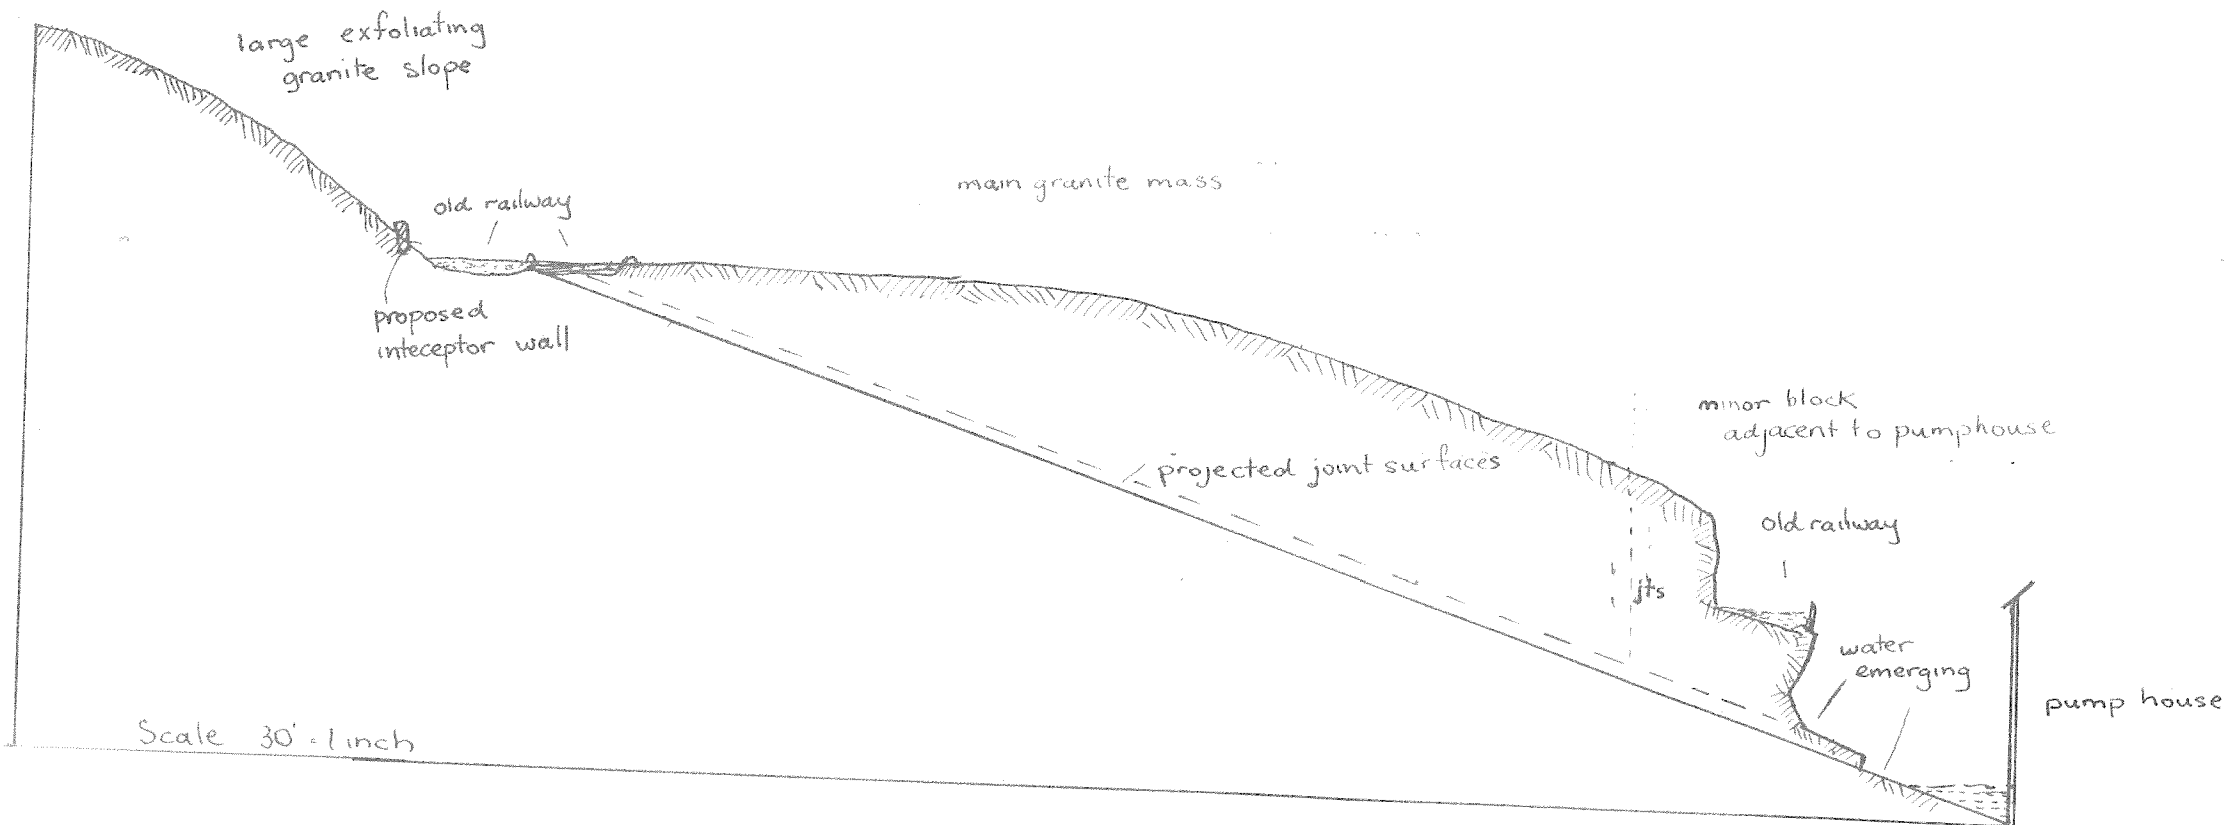
The overhanging face at the rear of the pump station is 15 feet high, and the face above the old railway line is a further 20 feet, most of the block being 35 feet thick. (See sketch). There are no apparent buttresses supporting the block between the pump house and the stream and thus the block is unsupported over a width at least equal to the width of the pump house. From head to toe the block is approximately 240 feet in length, and allowing for a $22\frac{1}{2}^{\circ}$ surface, the volume of the rock mass is 20,000 cubic yards, the weight involved being approximately 38,600 tons.

Examination of the two main parallel joint surfaces about 2 feet apart shows that on top of the lower joint plane there is a clay parting with slickensides inclined at 30° to the strike of the joint plane. This indicates former movement in a direction parallel with the small stream valley. Above the thin parting (an attrition product) there are two or three inches of broken granite, and another joint opening. The broken granite is in a condition akin to a lightly cemented sand, some of which is constantly being removed by water seeping along the joint surface. Moss covers the four inches or so of the affected joint surfaces. In places there is no sand or moss parting, but a gap indicates a place where water flow has concentrated. The upper joint does not have a clay layer, and the thickness of crushed and weathered granite is only two inches. Less water emerges from this joint, but again there are two areas where considerable flows emerge after prolonged rain.

Section showing potential block glides
at rear of Mundaring Pumphouse.

Water in the joints naturally reduces the factor of safety, and the accelerated weathering of the joint zone materials to sand and clay will lead to further lowering of the safety factor. Examination of the rock mass indicates that the major portion of the water must be derived from the upper exfoliation surface, and enters the joint system at about the westerly point of the old zig-zag railway (see plan). Diversion of this water will be necessary to preserve the long term stability of the rock mass, and the simplest method would be to build an interceptor wall across the foot of the upper rock mass, the water being then led by pipe to discharge downhill in the direction of the stream valley. In addition a properly designed drainage ditch (see sketch) should run along the upper side of the road proposed for the old railway track.

It has been established that the vertical angle of repose for rock masses resting on joint surfaces with saturated clay partings is 15° , and 25° for sand and other materials. It is thus apparent that as the joint surface here is at about $22\frac{1}{2}^{\circ}$ with the parting mainly sand, conditions are close to the equilibrium point. In addition to this small frictional restraint we have, however, a certain support from the materials at the foot of the rock slope, for only where the joint surfaces are exposed is there lack of material at the toe. The most effective method of increasing the factor of safety is the removal of water from the joint planes, but we could consider positive restraint by the use of bolts or anchors. In view of the size of the block involved it is obvious that an enormous number of rock bolts would

be needed to provide effective restraint if movement were initiated by some outside agency, (e.g. earthquake). However, a small additional restraint may prevent initial movement, but once a block of rock has started moving, restraint is most difficult. The longest effective bolts in use at present are 30 footers, which is less than the average thickness of the block, so rock dowelling would appear to be the only practical method, i.e. holes are drilled into the rock normal to the joint planes, and heavy steel dowels are grouted in the holes.

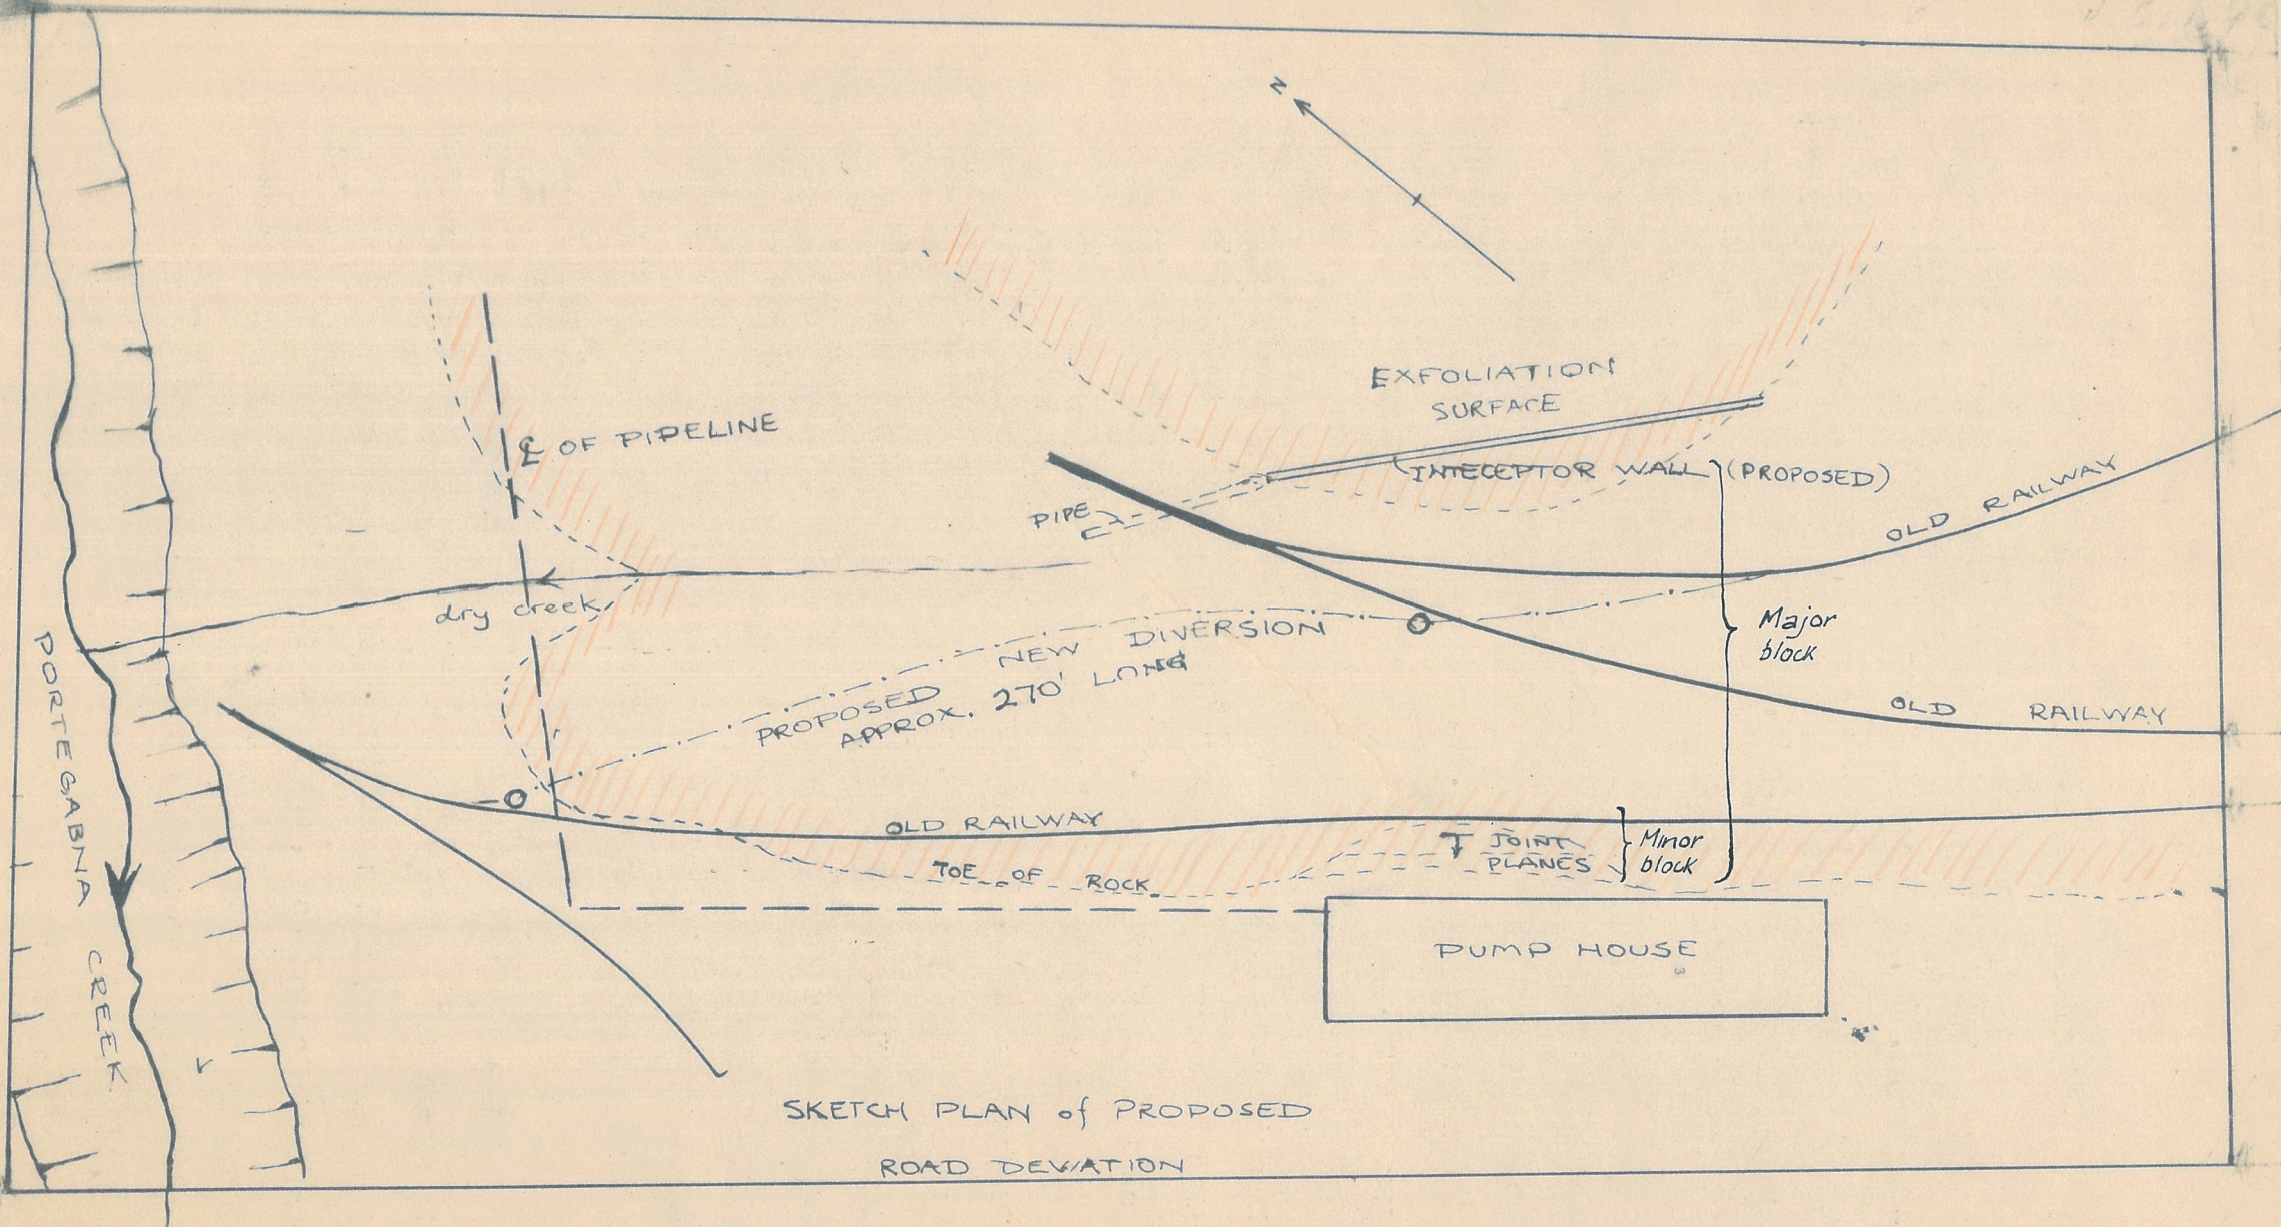
The safety of the mass of rock immediately behind the pump house is determined to a large extent by the positional relation of the major joints. On the diagram the main joints are shown, and geometrical considerations indicate that fracture or breakage down the 105° set is likely, and thus a block of 60 feet wide x 20 feet high x 20 feet deep is involved, i.e. 42,000 cubic feet or 3,100 tons. In its present position it shows no sign of movement but the cutting of a road, with

blasting and vibrations would probably be critical, and movement of a rock slide or block glide type would possibly be initiated. As the block is not large, and several surfaces are exposed parallel to the joint surface, it would appear that the rock bolting would offer effective restraint.

This would involve the use of bolts from 5 feet to 30 feet long (depending on the position above the joint surfaces) placed at 3 foot centres. With a tension of 10,000 lbs. each, the number of bolts N would have to be:

One inch nominal diameter, hollow, mild steel bolts loaded to 10,000 lbs. are suggested, with a Williams impact setting anchor, and the bolts should be grouted on taking up. Bolts of this type have been widely tested and used in the Snowy Mountains tunnels, and are supplied by G.K.N. - Lysaght Pty.Ltd., Alexandria, N.S.W. (An illustrated article on their use is in the Chemical Engineering and Mining Review of April 16, 1960, page 49).

The layout of the holes for the bolts will depend on the thickness of rock above the joint plane and the inclination of the rock surface. Bolts are most effective at right angles to the surface of potential movement, but in this case a few inclined bolts will be effective in pinning the whole rock mass together. There are a few refinements of technique now available such as the use of heavy grease between the bolt head and bearing plate, but these may be considered at a later date.

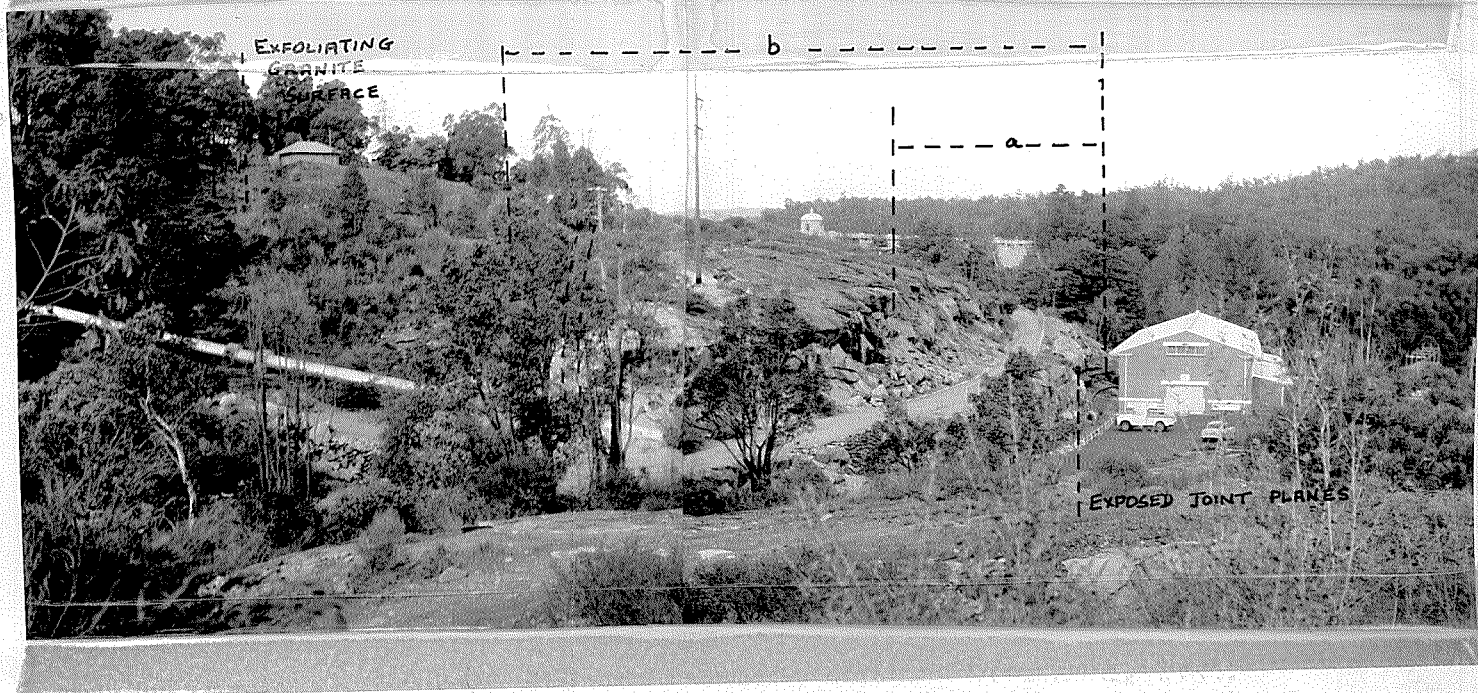
Photo 1: Panoramic view from Kalamunda road showing the relationship of the exposed joint forces behind the pump house to the minor block 'a' and the major block 'b'.

The proposed deviation follows down the centre of the photograph.

Some measures for the constraint of movement have already been discussed, however the whole problem could be avoided if the road were relocated clear of the pump house region. This is possible by locating the road down the inside slope of the hill from the point of the zig-zag to the end of the sealed road from the pump house (see photographs). The distance is 275 feet and the fall is 56 feet i.e. 1 in 5 or 20% (11°). A turning area could be provided in the bottom area but this will be also necessary with the zig-zag proposal. It is suggested that strong consideration be given to this proposal which would involve little excavation, the only additional item being a crossing of the main pipe line.

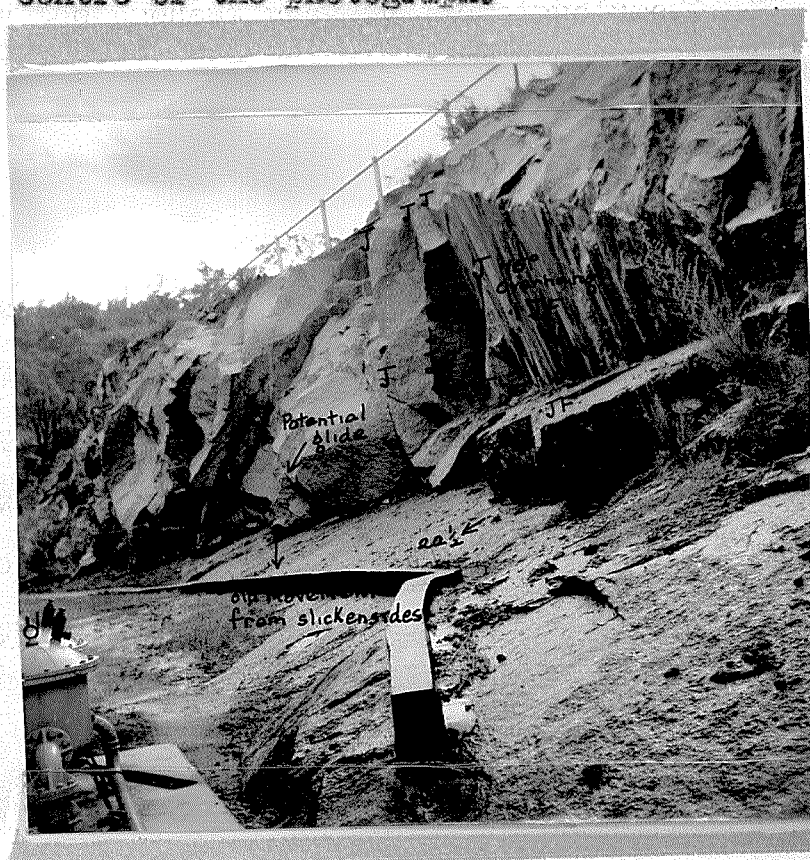
Photo 2: Taken at the rear of the pump house. The joint planes sloping at $22\frac{1}{2}^{\circ}$ are covered with water from the joint. The 75° overhang and a small block in a position of potential block glide are notable.
