BULLETIN 126

THE MECKERING AND
CALINGIRI EARTHQUAKES
OCTOBER 1968 AND
MARCH 1970

by
F. R. GORDON and J. D. LEWIS

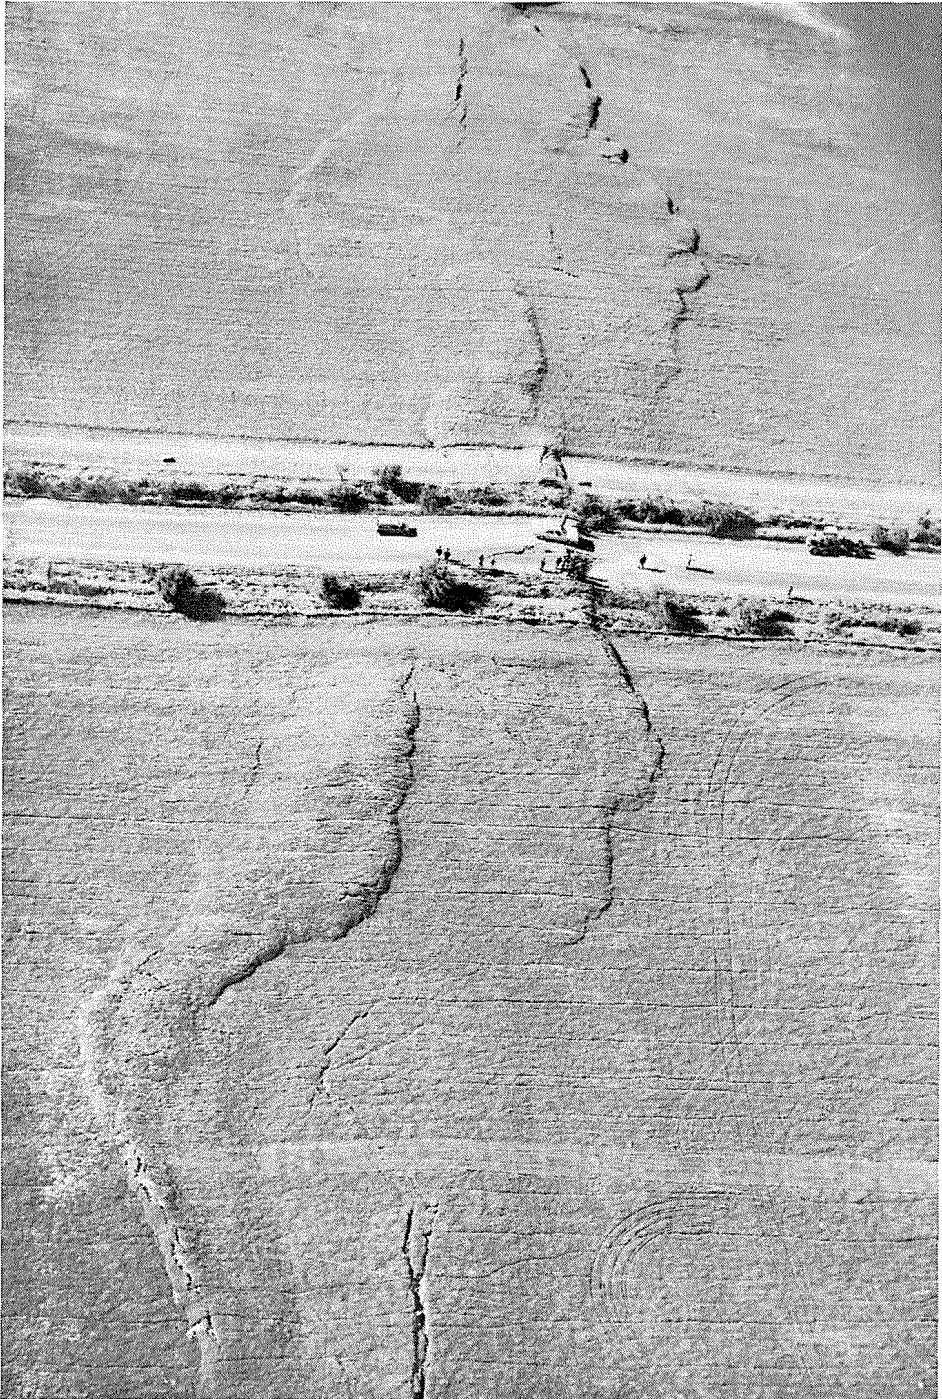
1. The Meckering Fault as it crosses the Great Eastern Highway southwest of the town (Photo: W.A. Newspapers).

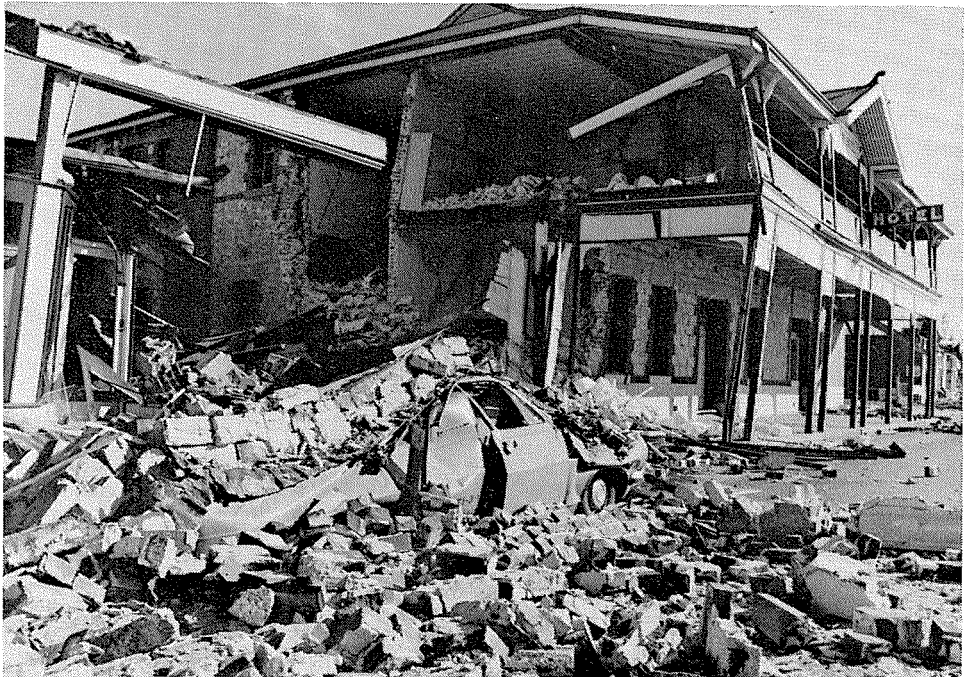
4. The Railway Hotel, Meckering (Photo: W.A. Newspapers).

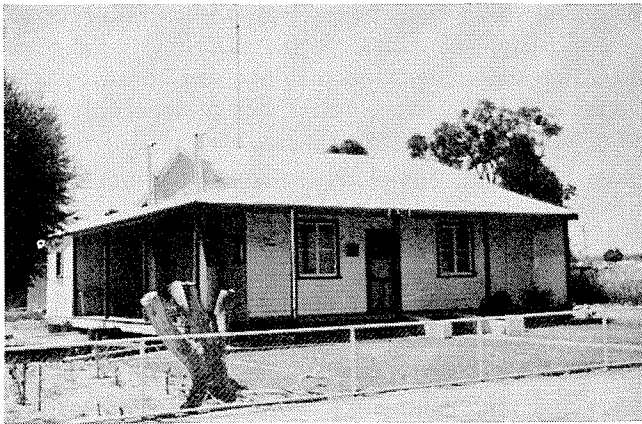
A

- (a) Wooden house in Johnson St, distorted but intact.
- (b) The baker's shop, of asbestos, on the east side of the Railway Hotel.
- (c) House in Dreyer St. The concrete walls are intact but the concrete-block gable, and the granite masonry at the rear, have collapsed.

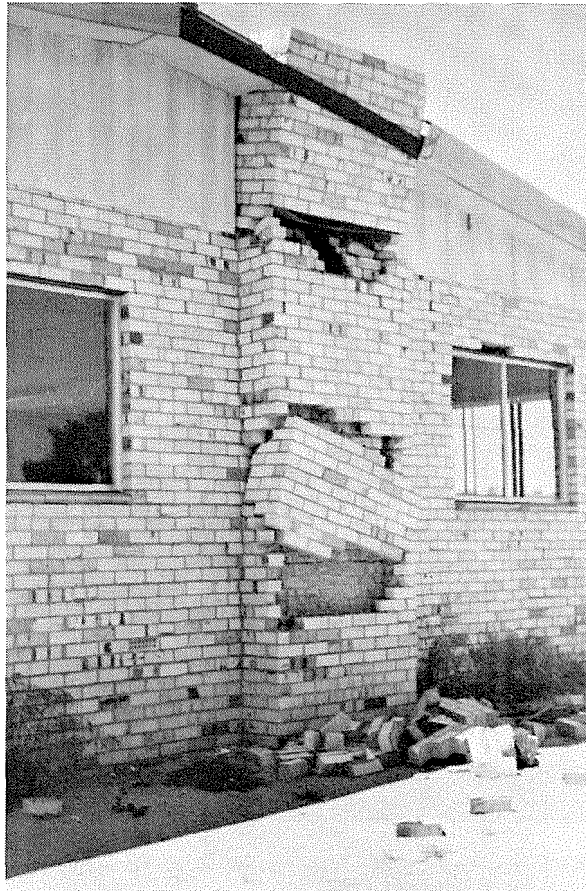
8. Chimney of the Meckering Golf Club house, damaged by the main earthquake and progressively wrecked by aftershocks.

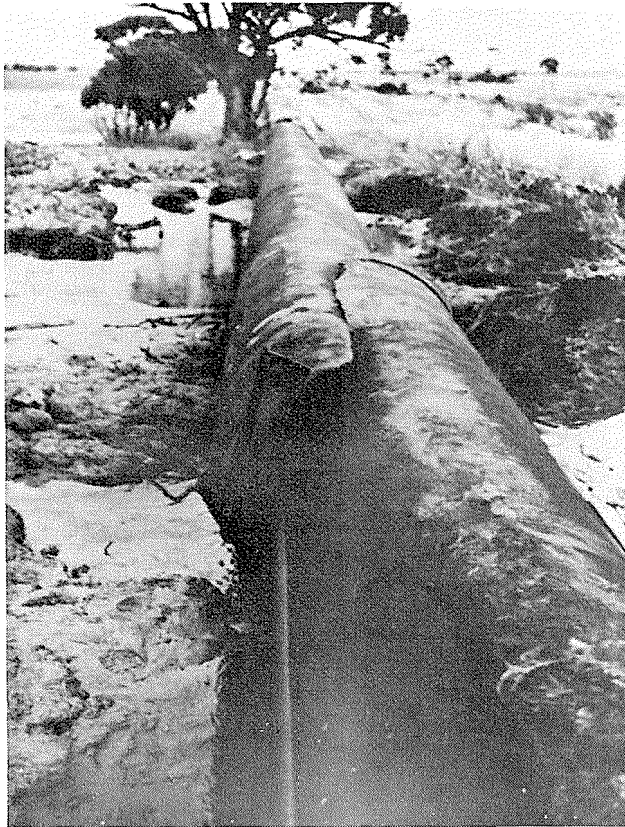
9. Impaction of the Goldfields Water Supply 76cm pipeline at the Meckering Fault, 4km southwest of the town. The compression at this point was 1.32m.

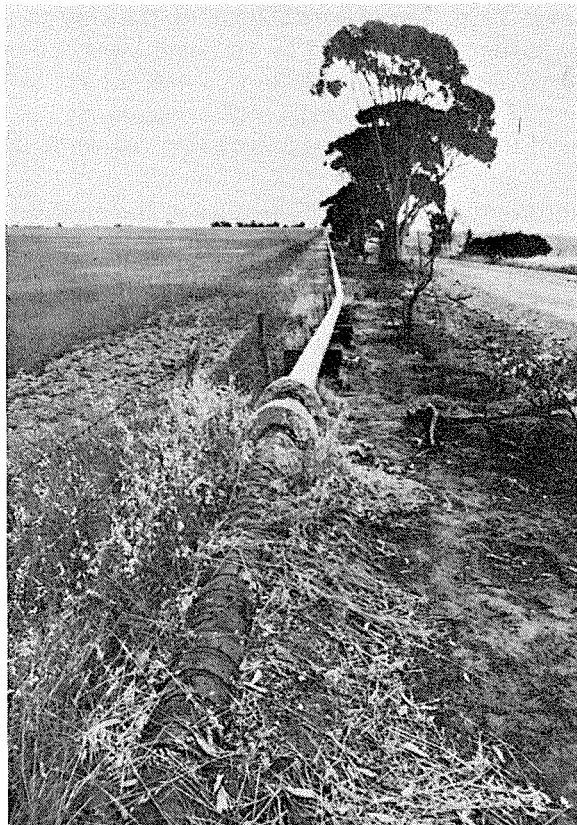
10. The Meckering-Goomalling pipeline at the Meckering Fault, 1.6 km northwest of the town. The original line of the pipe can be seen from the position of the abandoned pipe support.

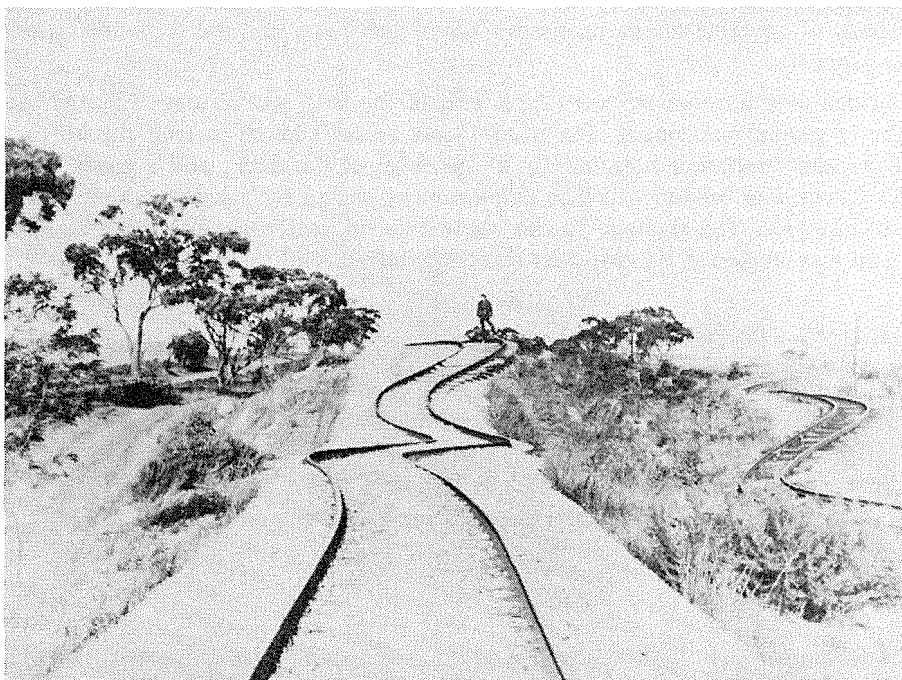
11. Distortion of the standard and narrow gauge railtracks at the Meckering Fault. The figure is standing on the 3 m-high fault scarp.

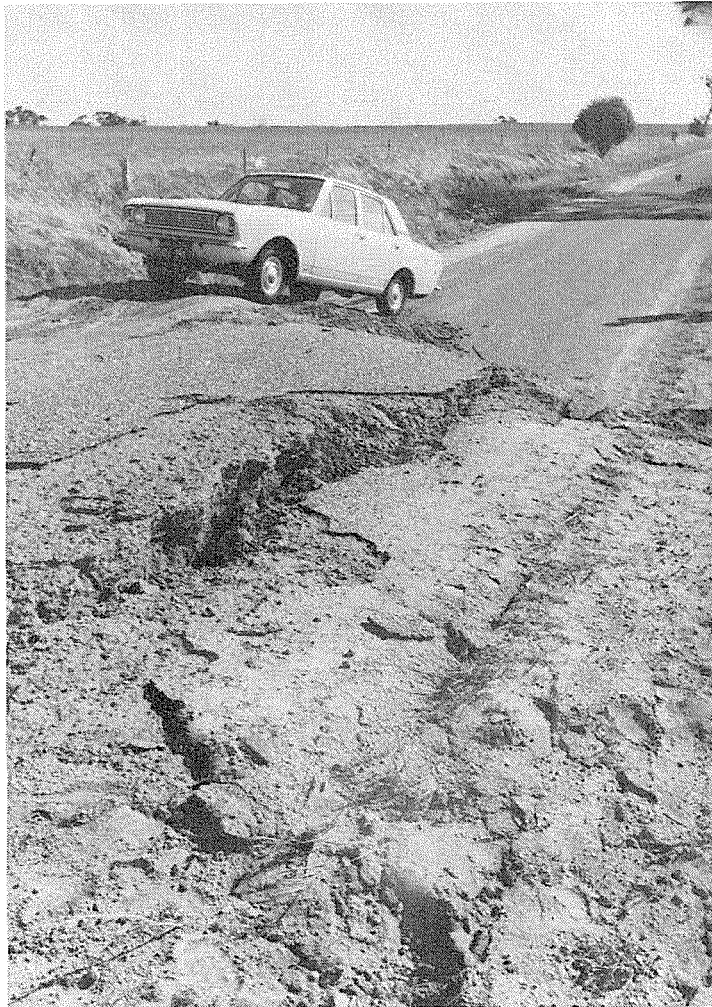
12. The Meckering Fault scarp on Koolbunine Road, 11 km south-southwest of Meckering. (Photo: W.A. Newspapers).

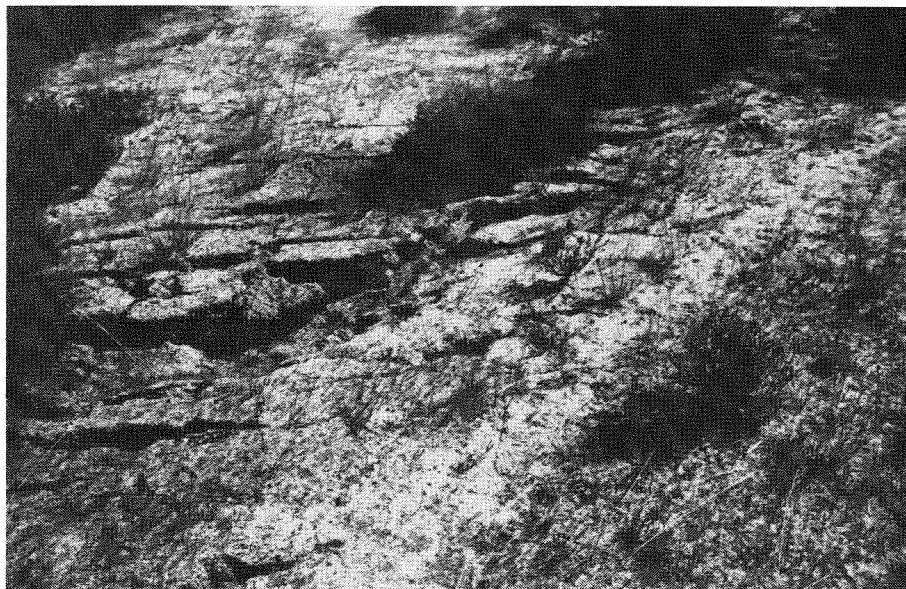
28. The northern end of the Meckering Fault. The *en echelon* fracture pattern indicates dextral displacement, but without appreciable vertical movement.

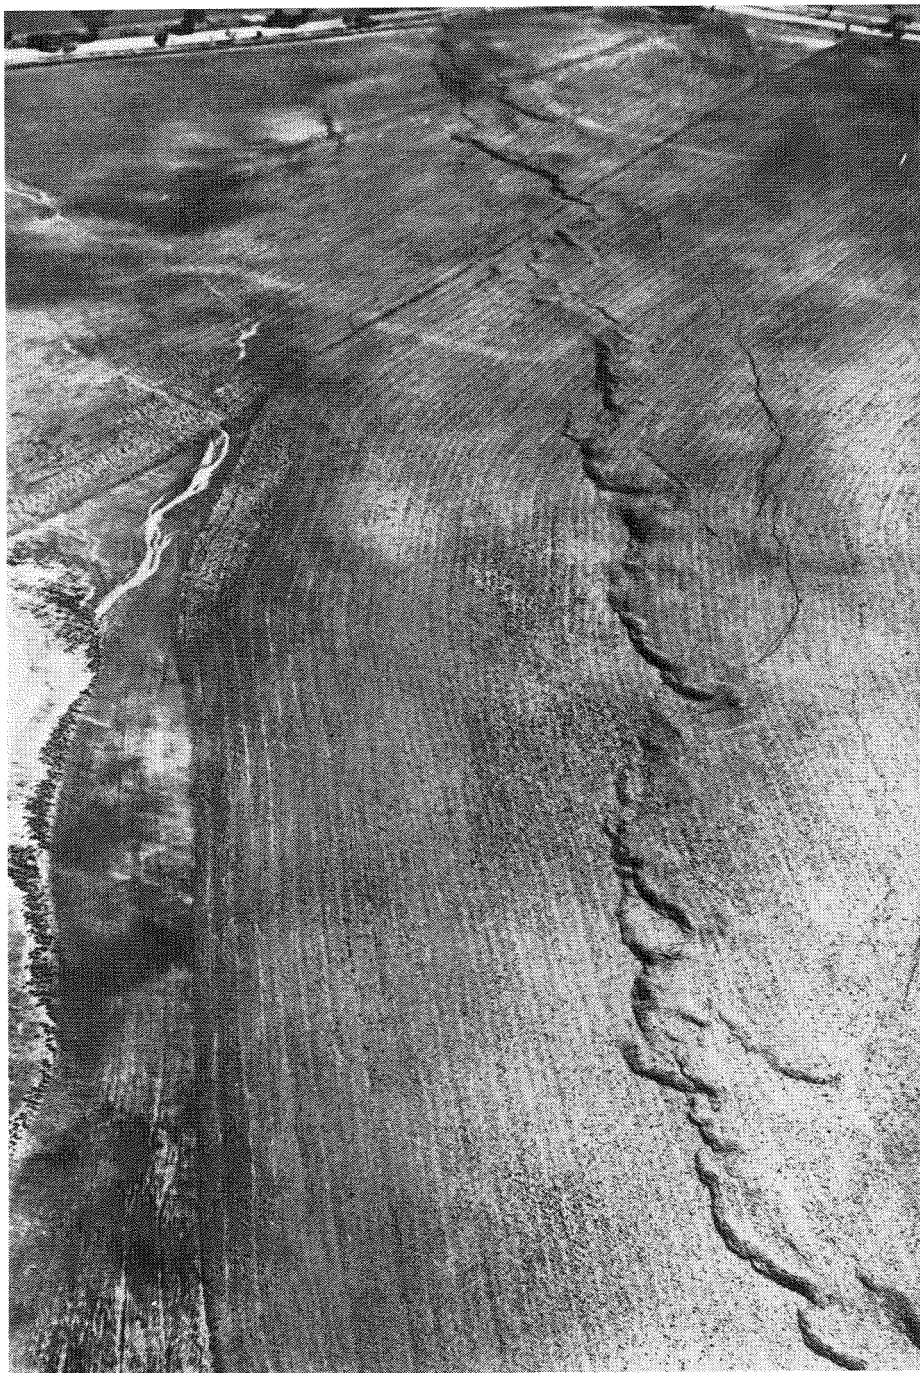
31. The Meckering Fault, looking north to the junction of Stewart Road and Moore Road, 2.4 km west of Meckering. The fault scarp is lobate and there are large tension fractures to the rear. (Photo: B.M.R.)

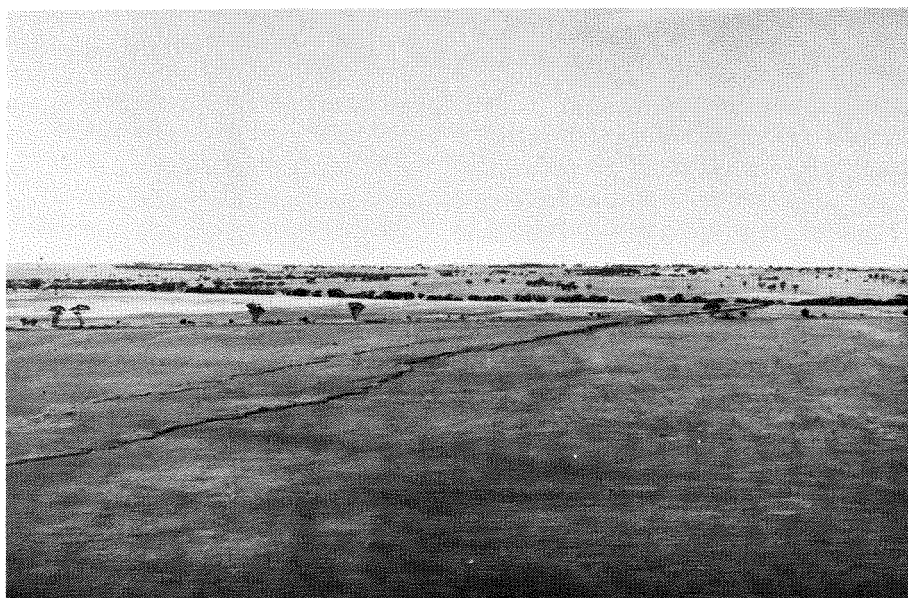
34. Meckering Fault north of Koolbunine Road. Two parallel thrust scarps, approximately 40 m apart. The small easterly (left) scarp dies out southward and the fault continues as a simple thrust (Photo: B.M.R.).

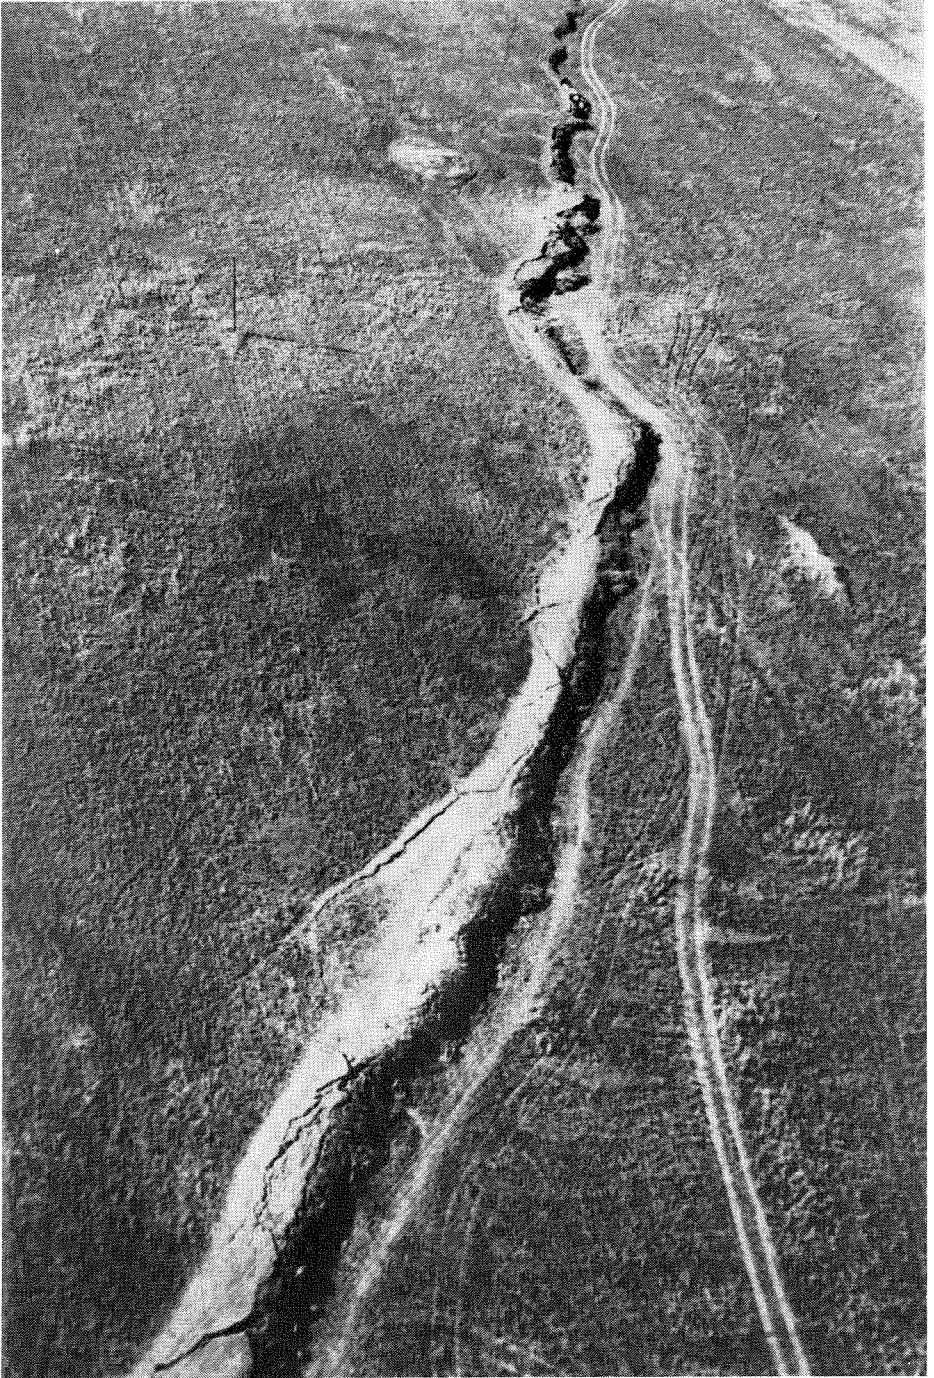
35. The Meckering Fault south of Koolbunine Road (Photo: B.M.R.).

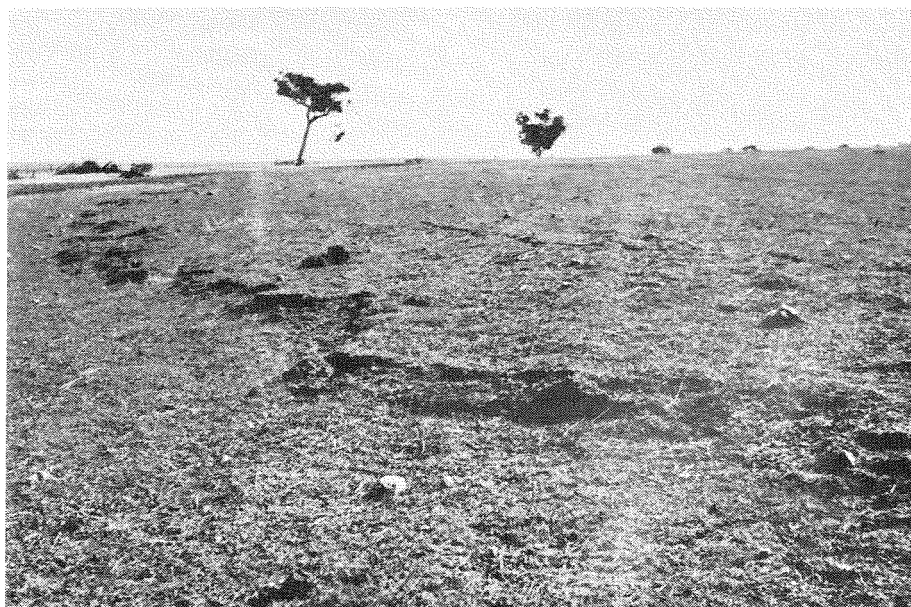
36. Southern end of the Meckering Fault. The well defined blocky scarp has a throw of 15 cm, dextral strike slip of 23 cm and a heave of 18 cm.

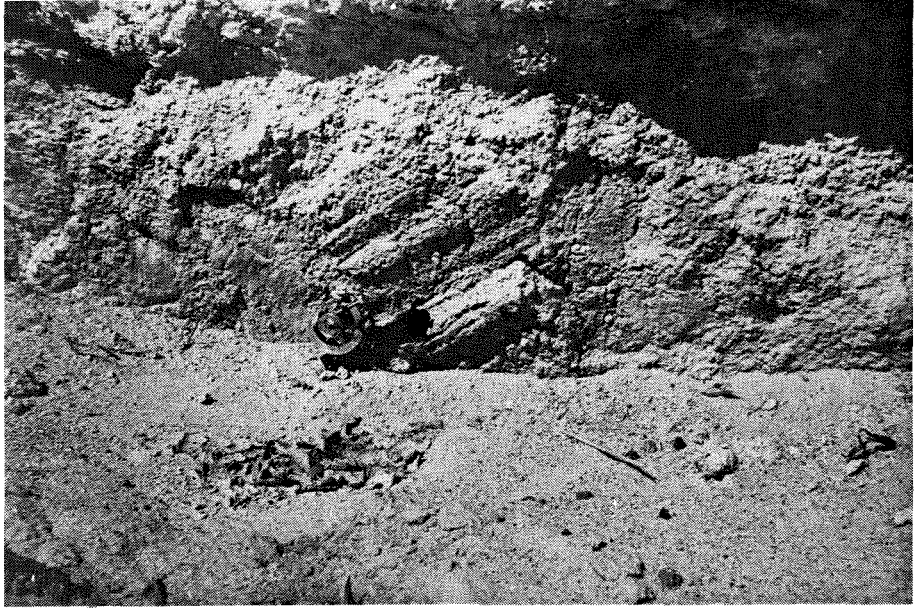
40. Slickensides on the plane of the Burges Fault. The fault plane dips at 80 degrees to the southeast, and the slickensides plunge at 32 degrees to the northeast.

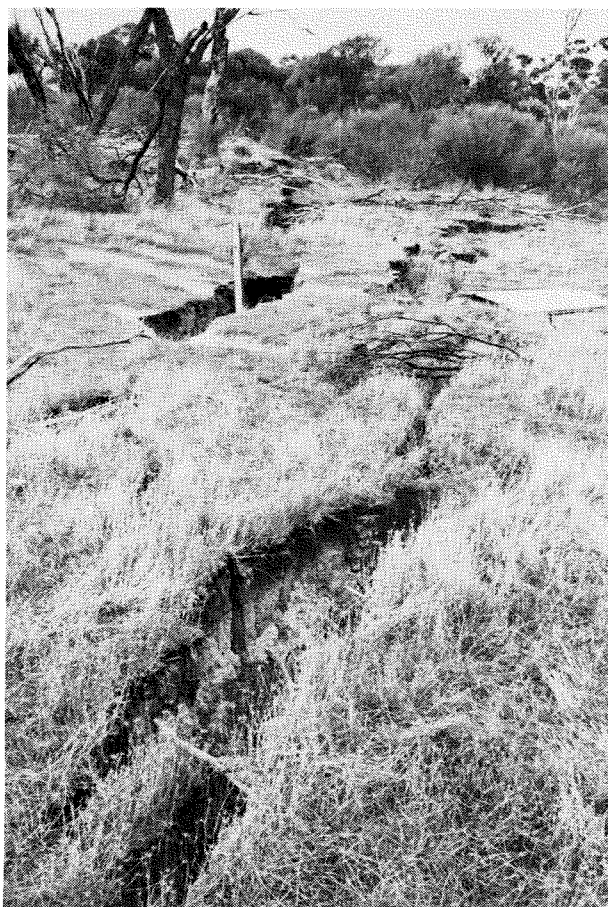
44. Open wrench fractures 880m south of Koolbunine Road. The blocks between the fractures were tilted, with the north side up 30 cm at the eastern end and south side up 45 cm at the western end. Dextral movement along the fractures was about 50 cm.

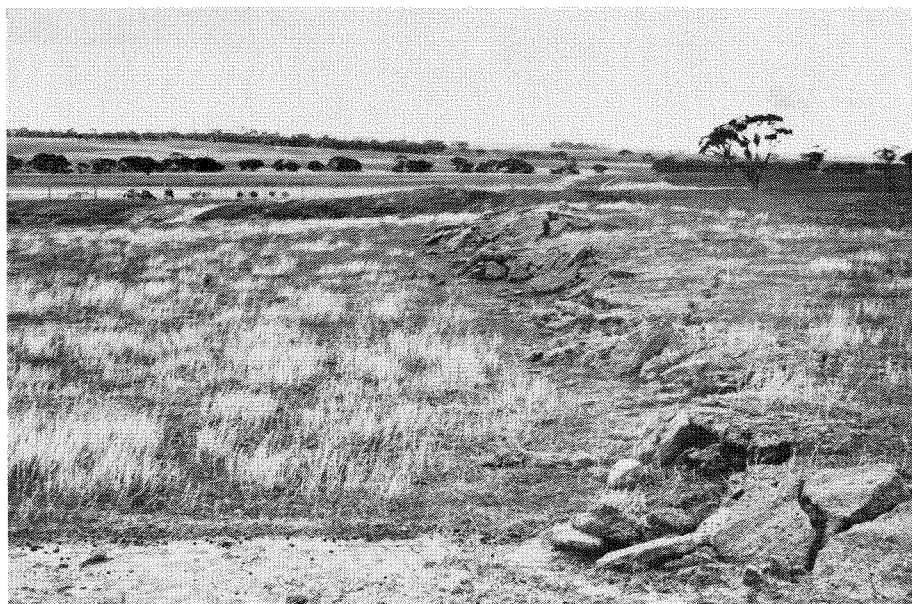
45. The Meckering and Burges Faults. The smooth scarp of the Meckering Fault in the left centre of the photograph is terminated by the normal Dextral shear of the Burges Fault which shows a broken scarp.

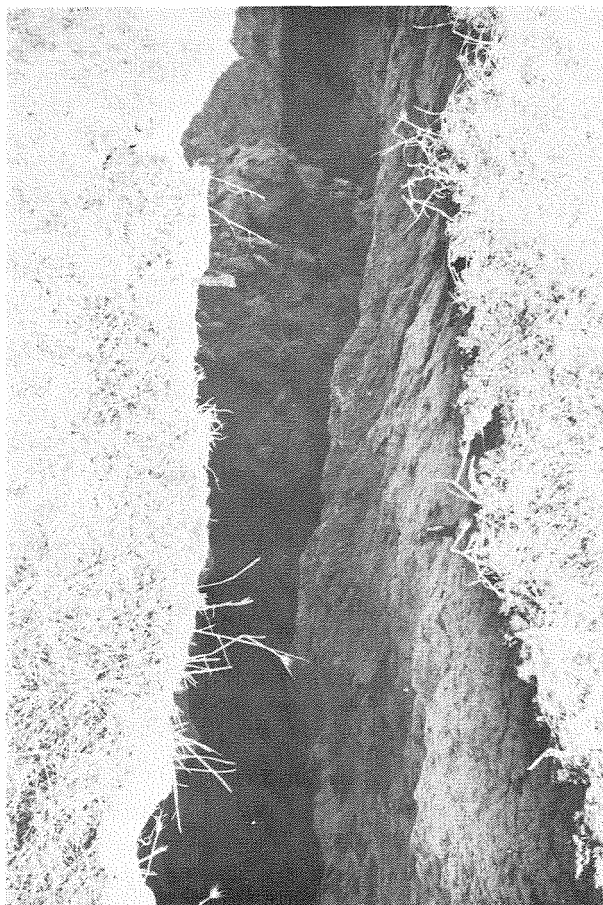
46. The Burges Fault plane, showing a opening of 45 cm to a depth of about 3 m and a dextral strike slip 90 cm on the broken tree root.

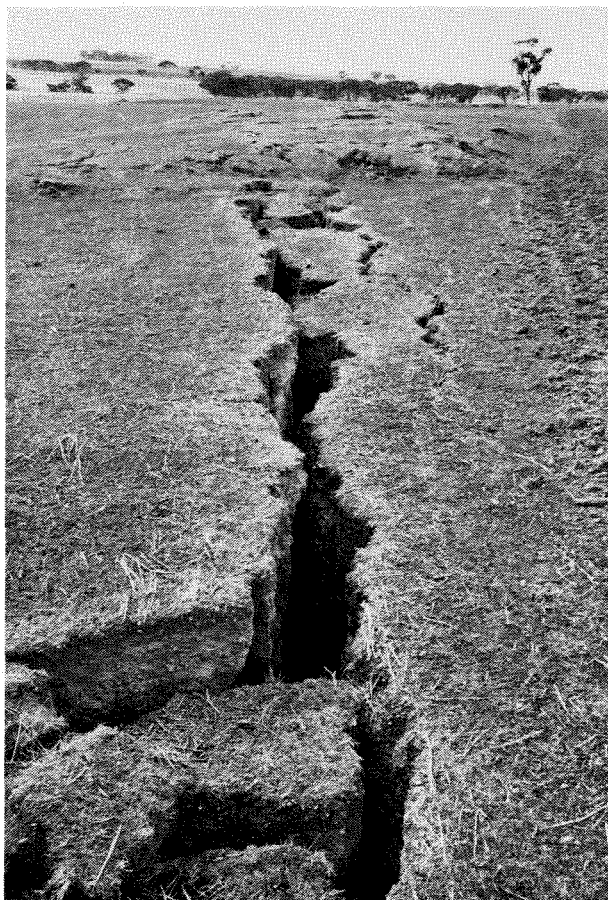
50. Posterior Fault: The main thrust scarp is in the background, the large fractures to the rear of the scarp were at least 4 m deep, open 30 cm and showed dextral movement of 40 cm and downthrow to the south of 25 cm.

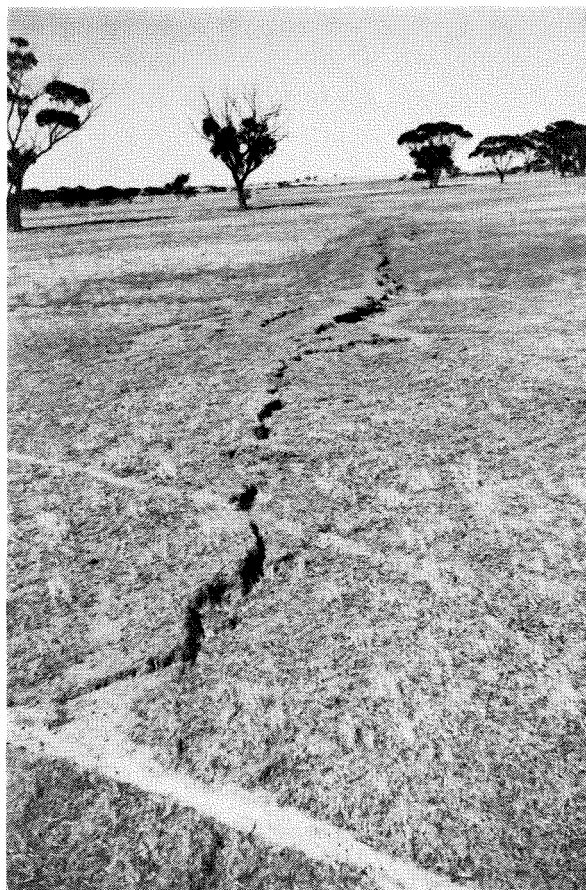
51. Posterior Fault: The most southerly offshoot, showing dextral movement of 7.5 cm, downthrow of 10 cm to the north and a fault opening of 15 cm.

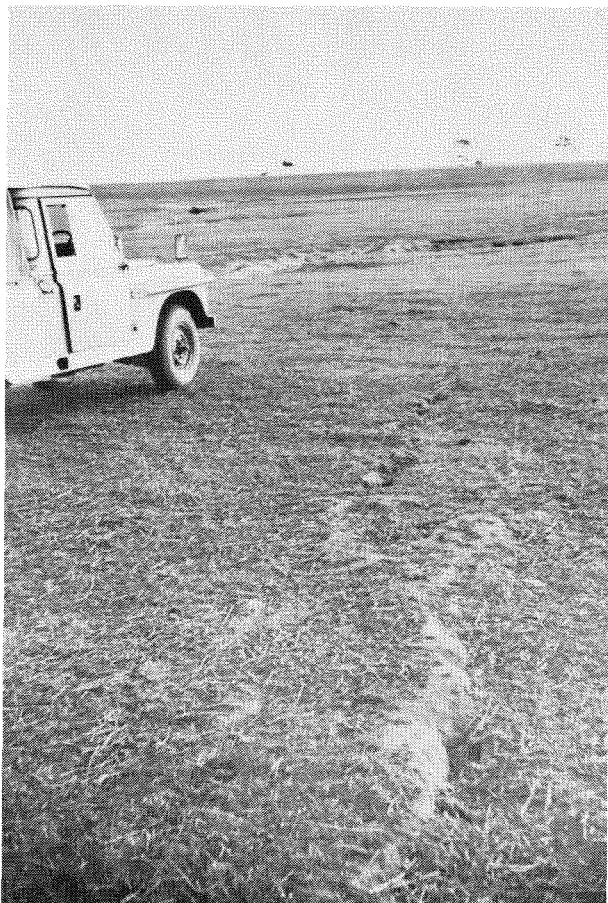
52. The Robinson Fault 400 m west of the Meckering Fault. *En echelon* fractures at 20° to the fault trend and showing minor dextral strike slip.

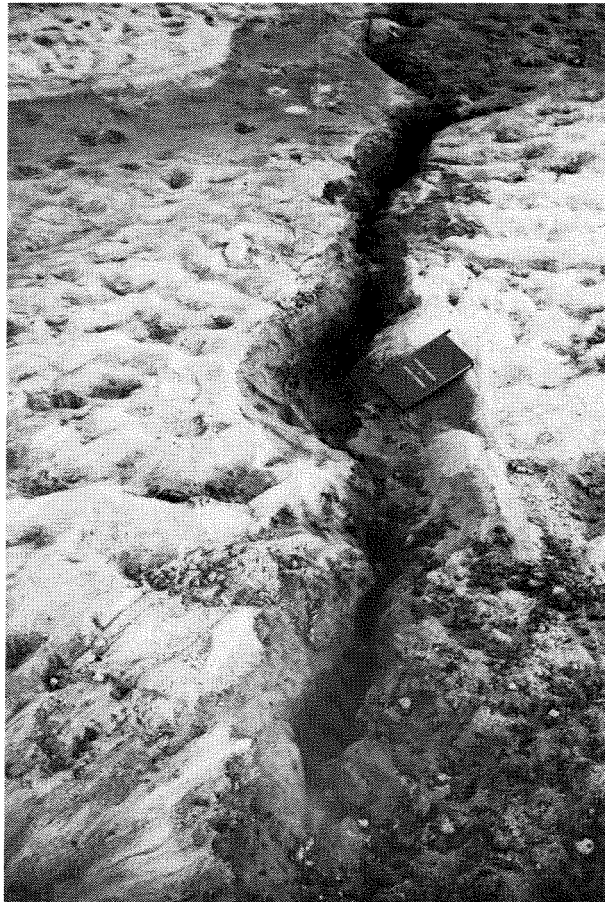
55. The Sudholz Fault in the bed of the Mortlock River. The fracture had been partly eroded and filled in by river flows.

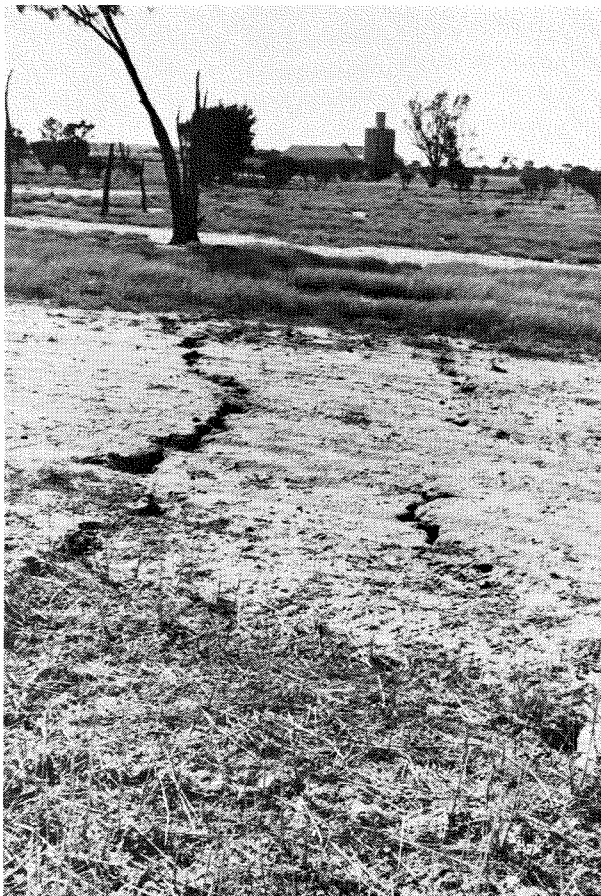
58. Subsidence graben 2 m wide and 5 cm deep on a major tension fault 2.5 km west of Meckering. The continuation of this fracture disrupted the floor and walls of the horizontal grain silo in the background.

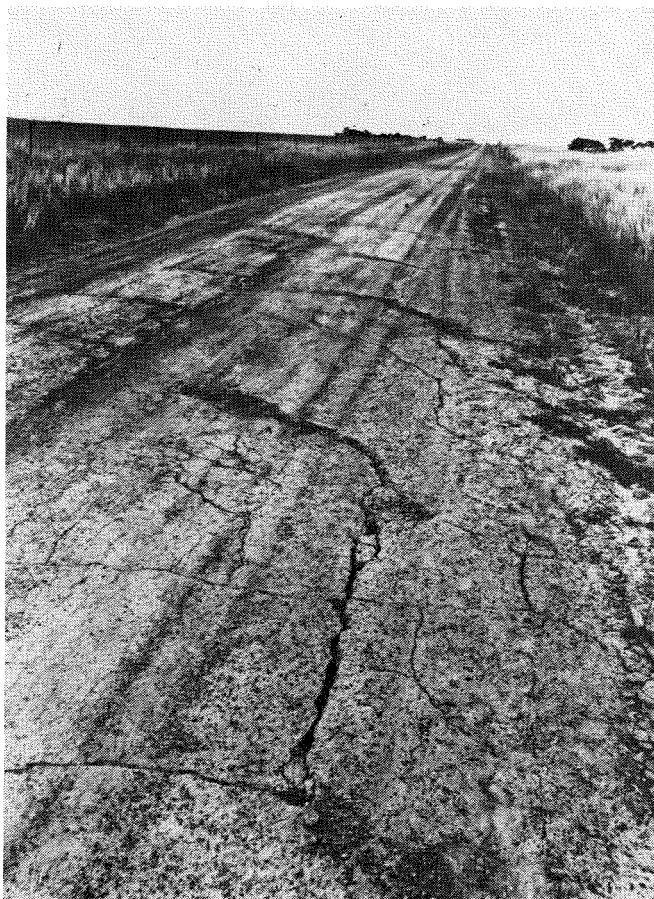
59. The Backscarp Zone: minor faulting on road 12865, 14 km south-southeast of Meckering.

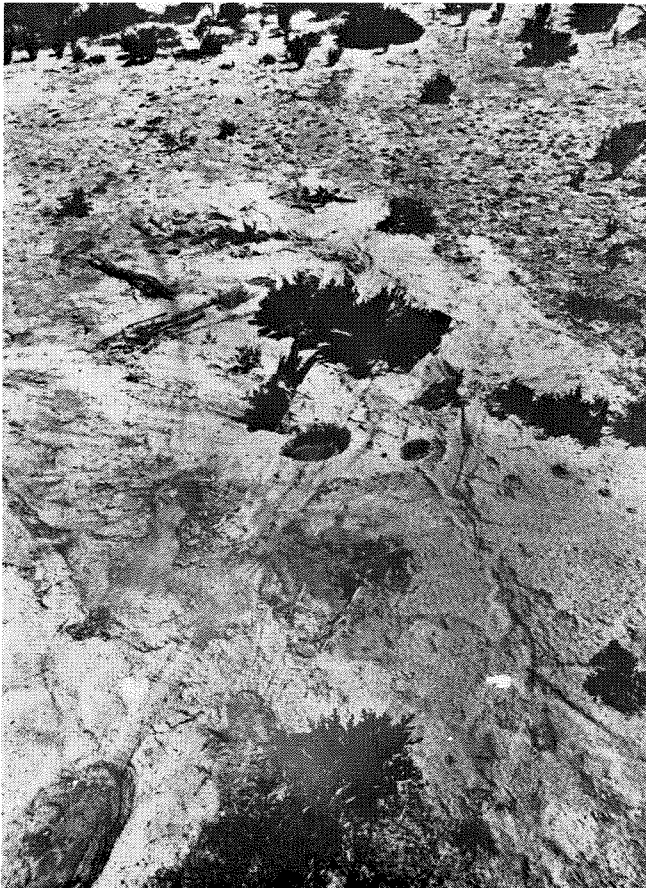
64. A small 'sand volcano' in the Mortlock River, 400 m west of Meckering. The 'vent' is 7.5 cm in diameter and emitted sand and salt water.

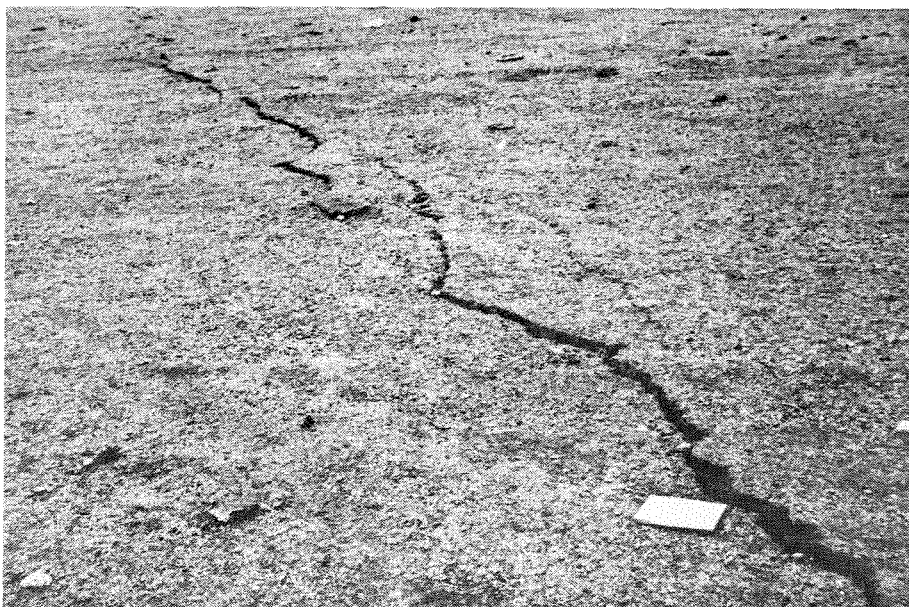
83. Part of the Calingiri Chordal Fault, showing open fractures downthrown 4 cm to the east.

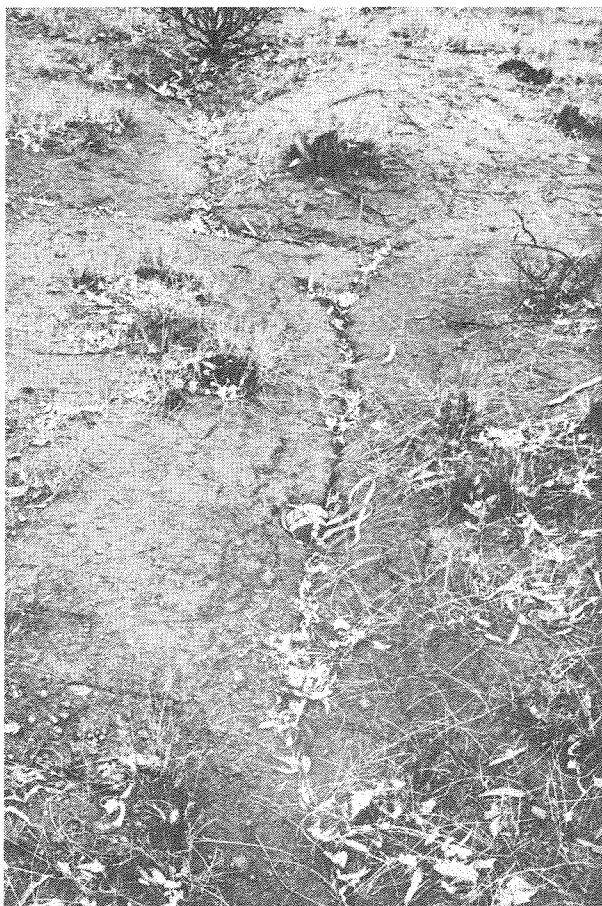
84. Eroded fissures, infilled with leaves and debris, at the southern end of the Calingiri Chordal Fault.
