ELLENDALE DIAMOND MINE

Managing an abandoned mine as a future resource

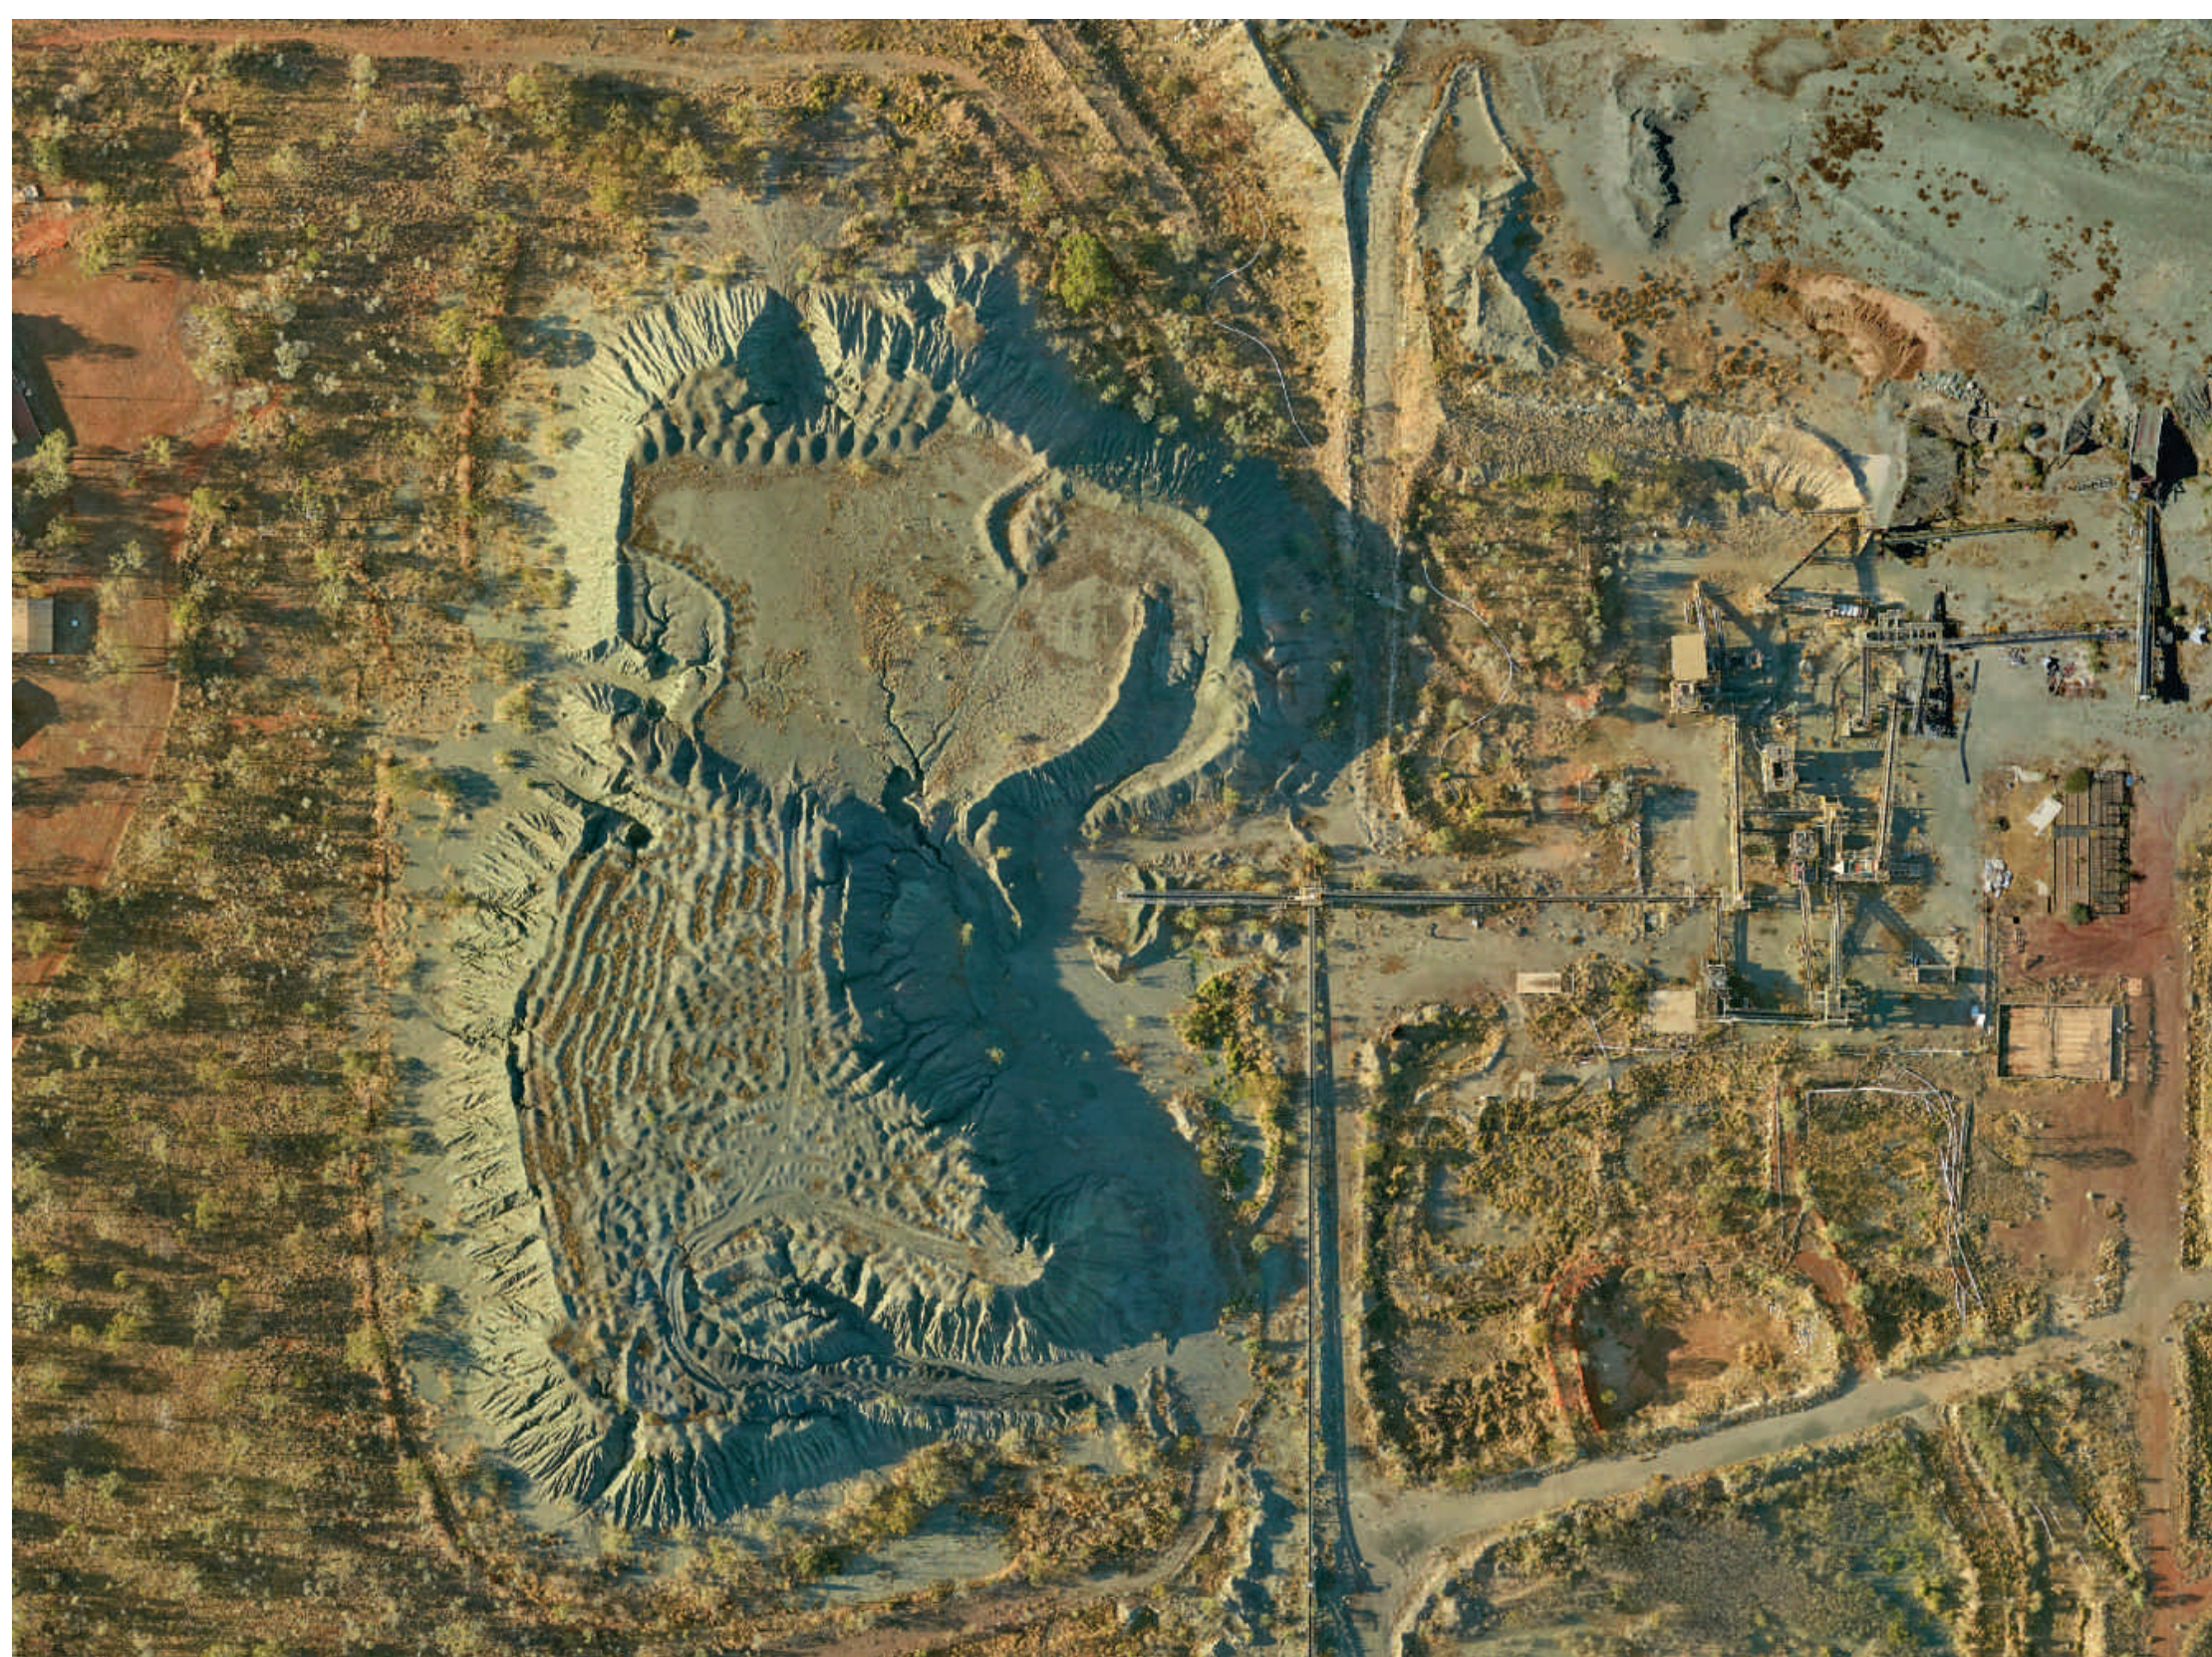
E9 Noise Bund indicating significant landform erosion

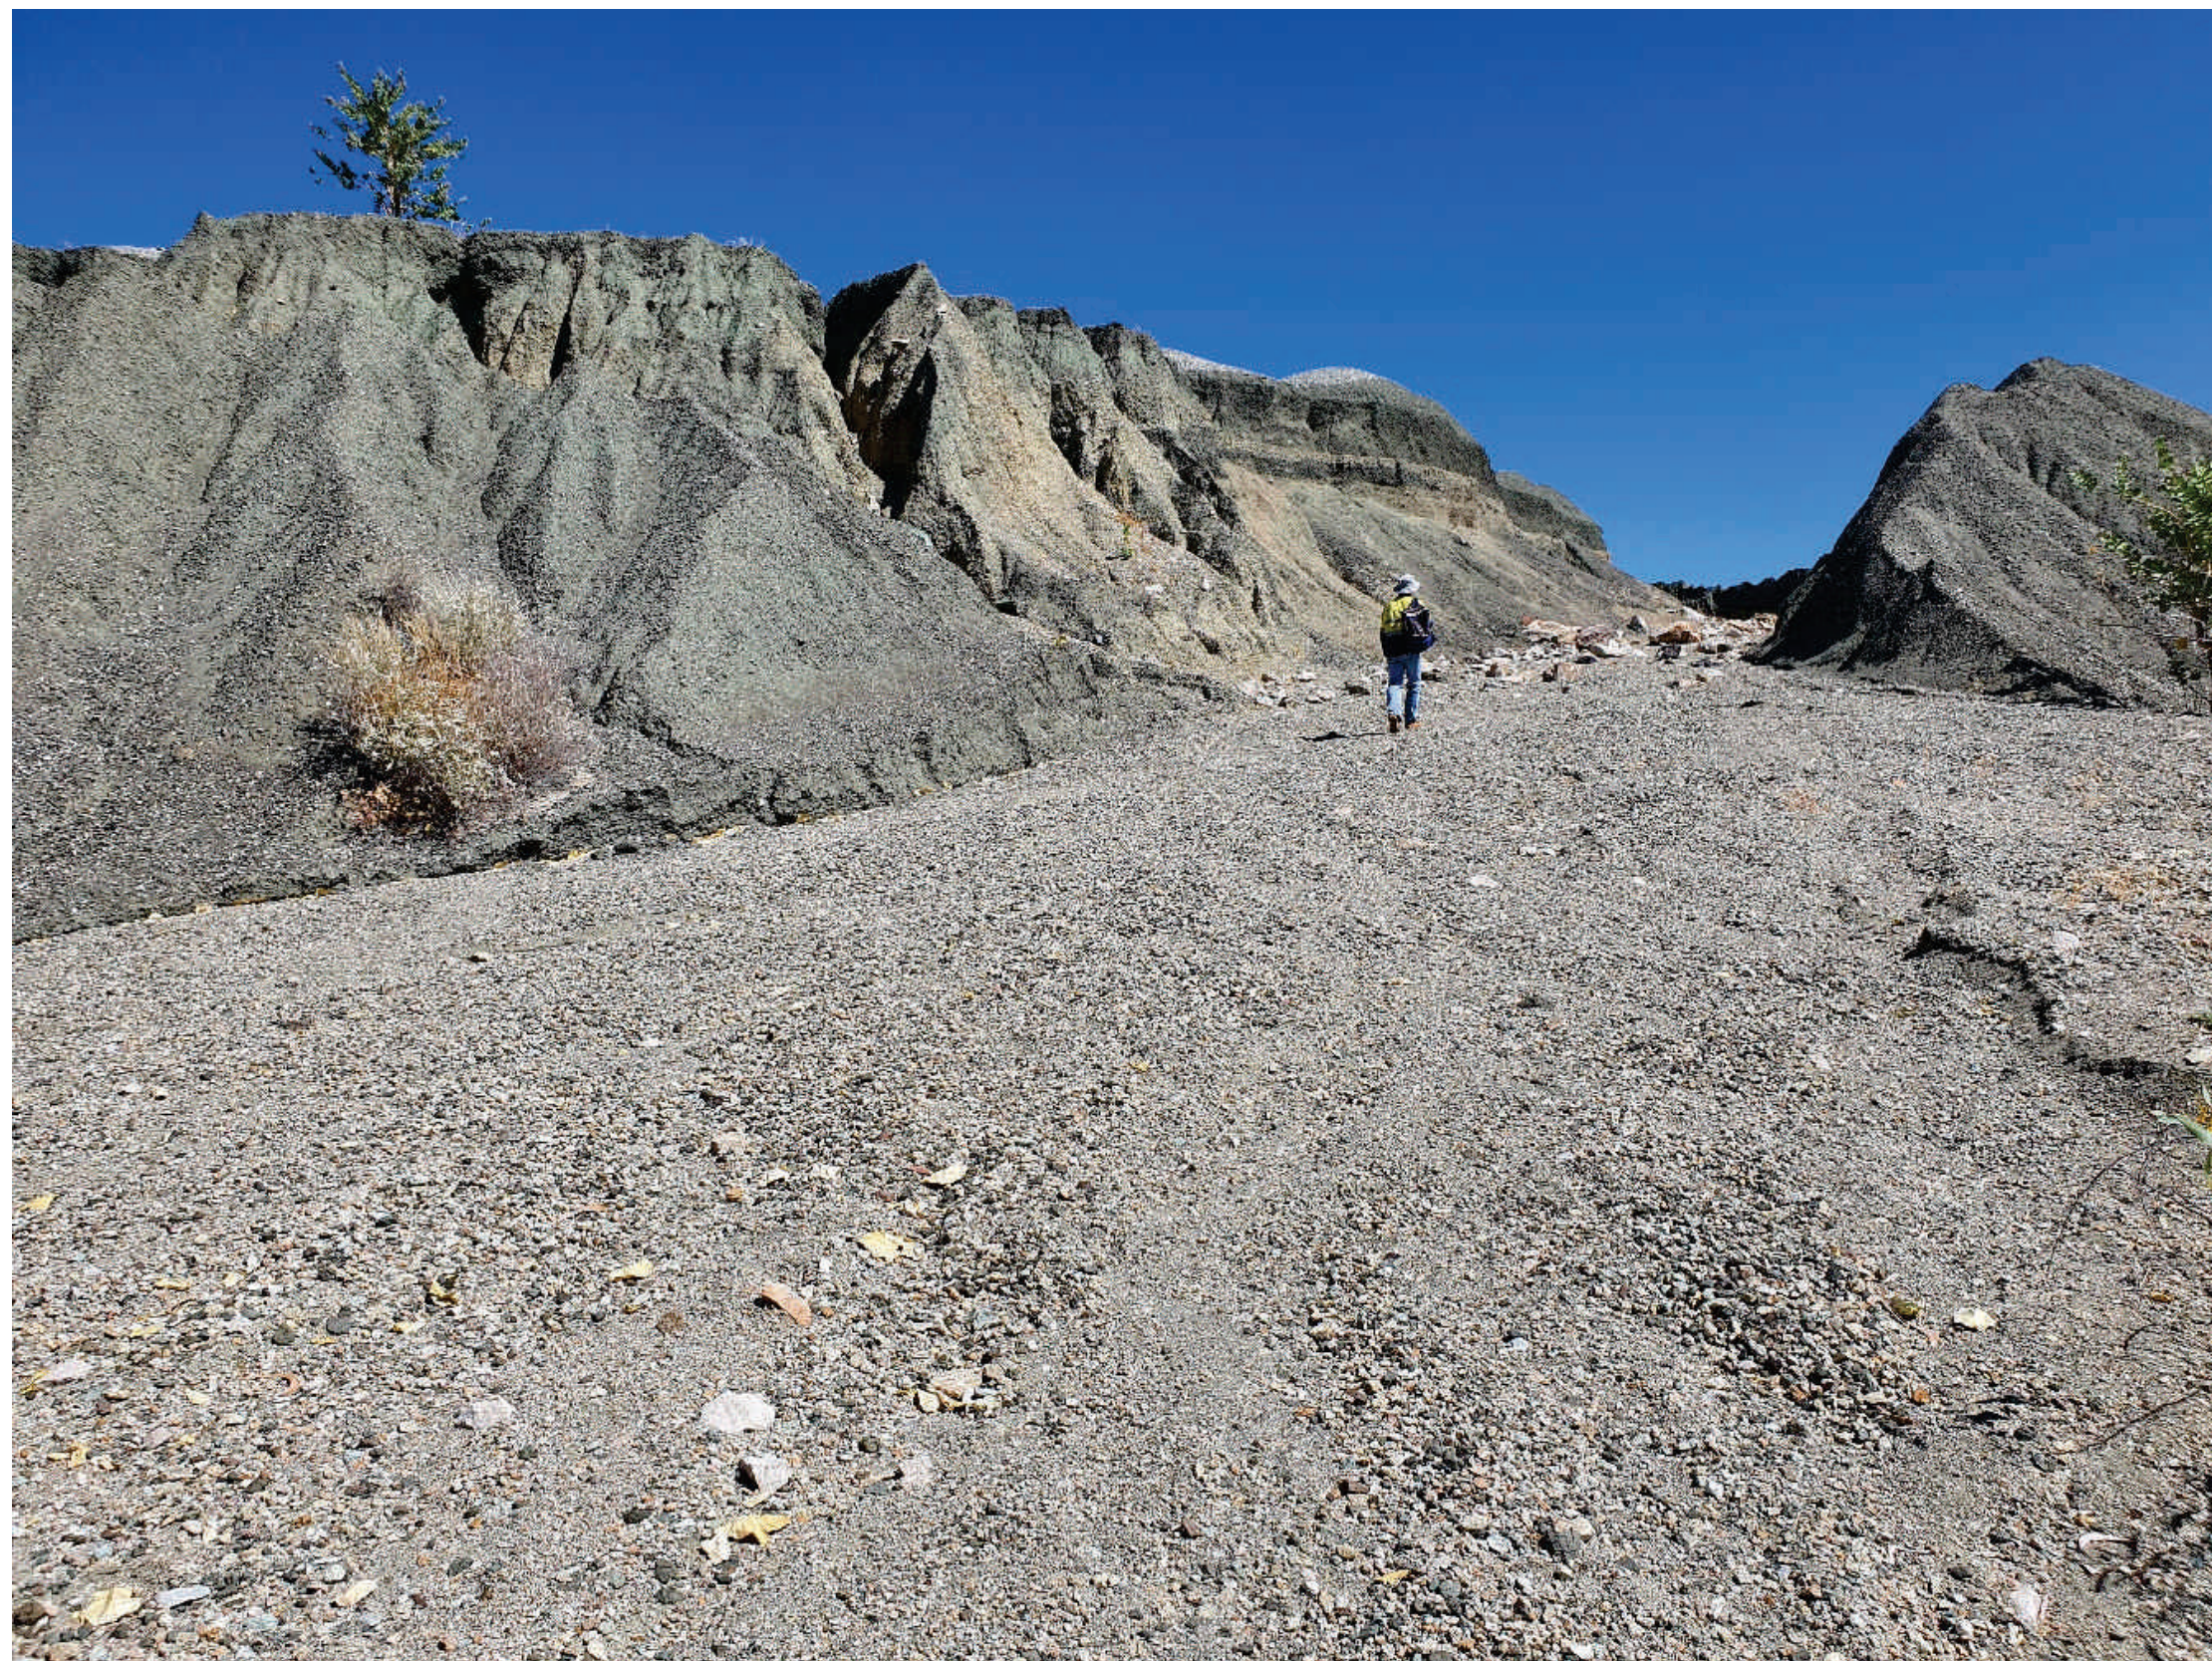
E4 Lights Stockpile erosion blowout and sediment fan

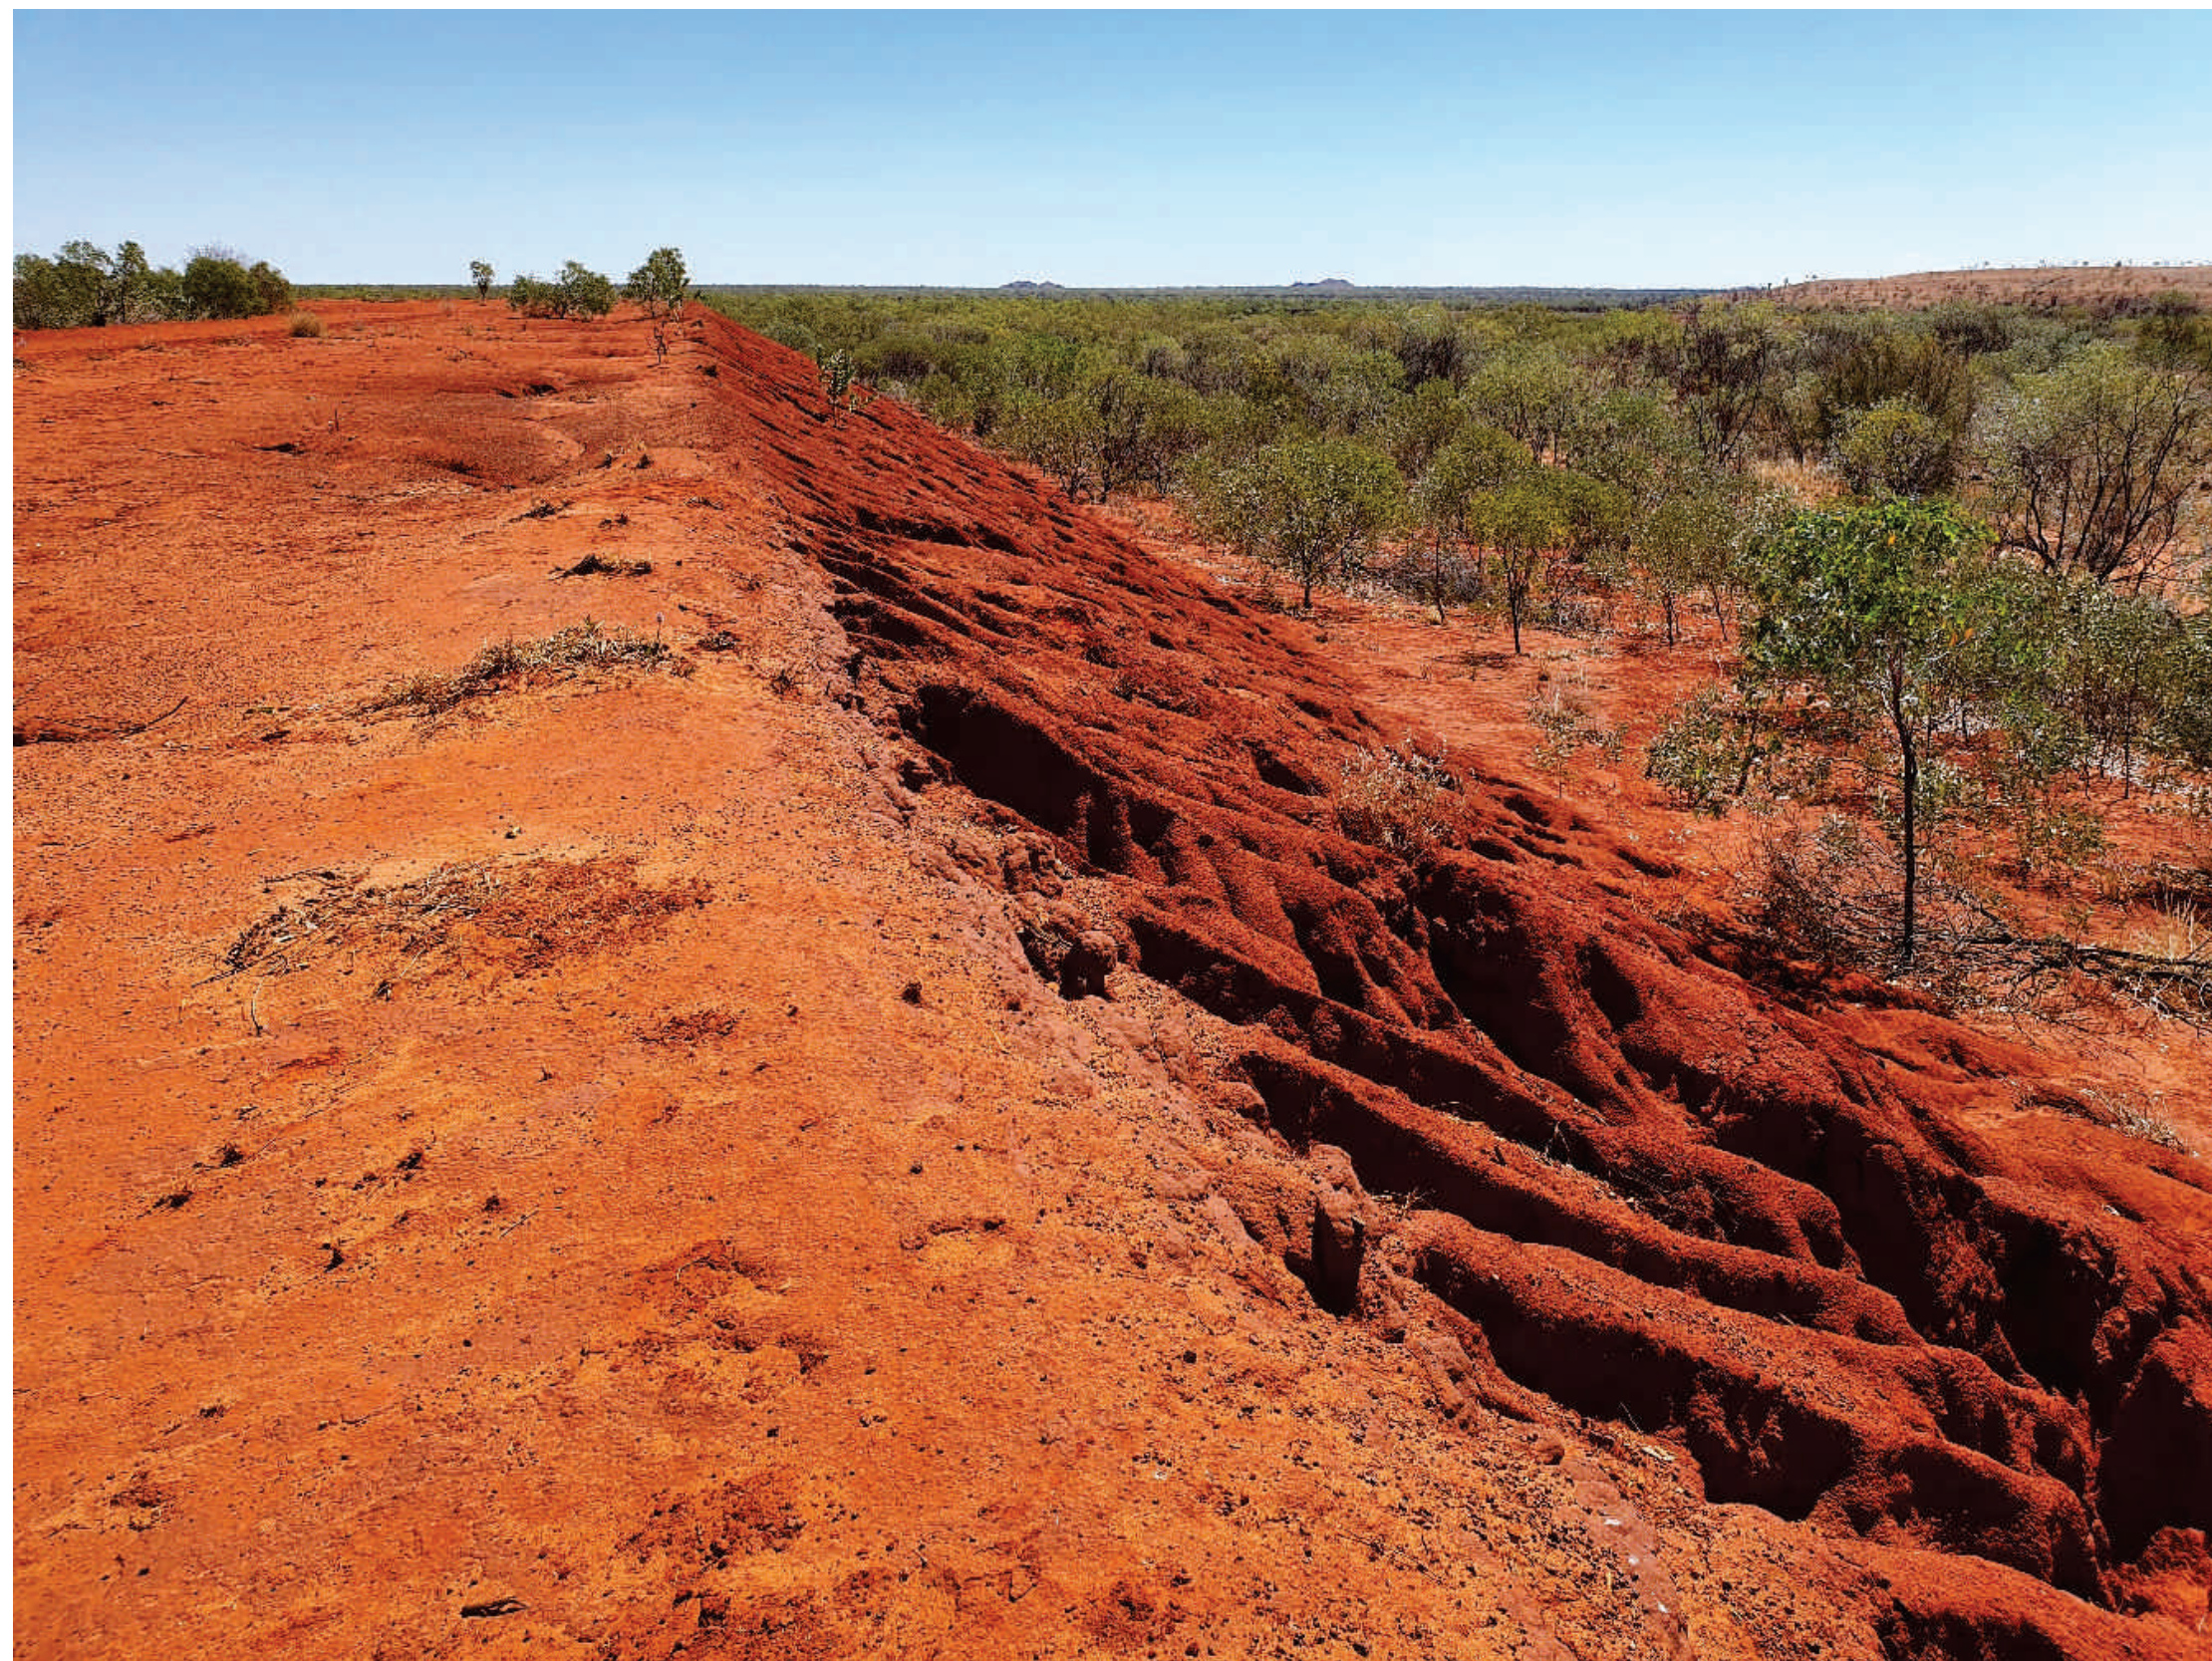
E4 TSF 2A northwestern wall showing significant surface erosion, gullying and tunnelling

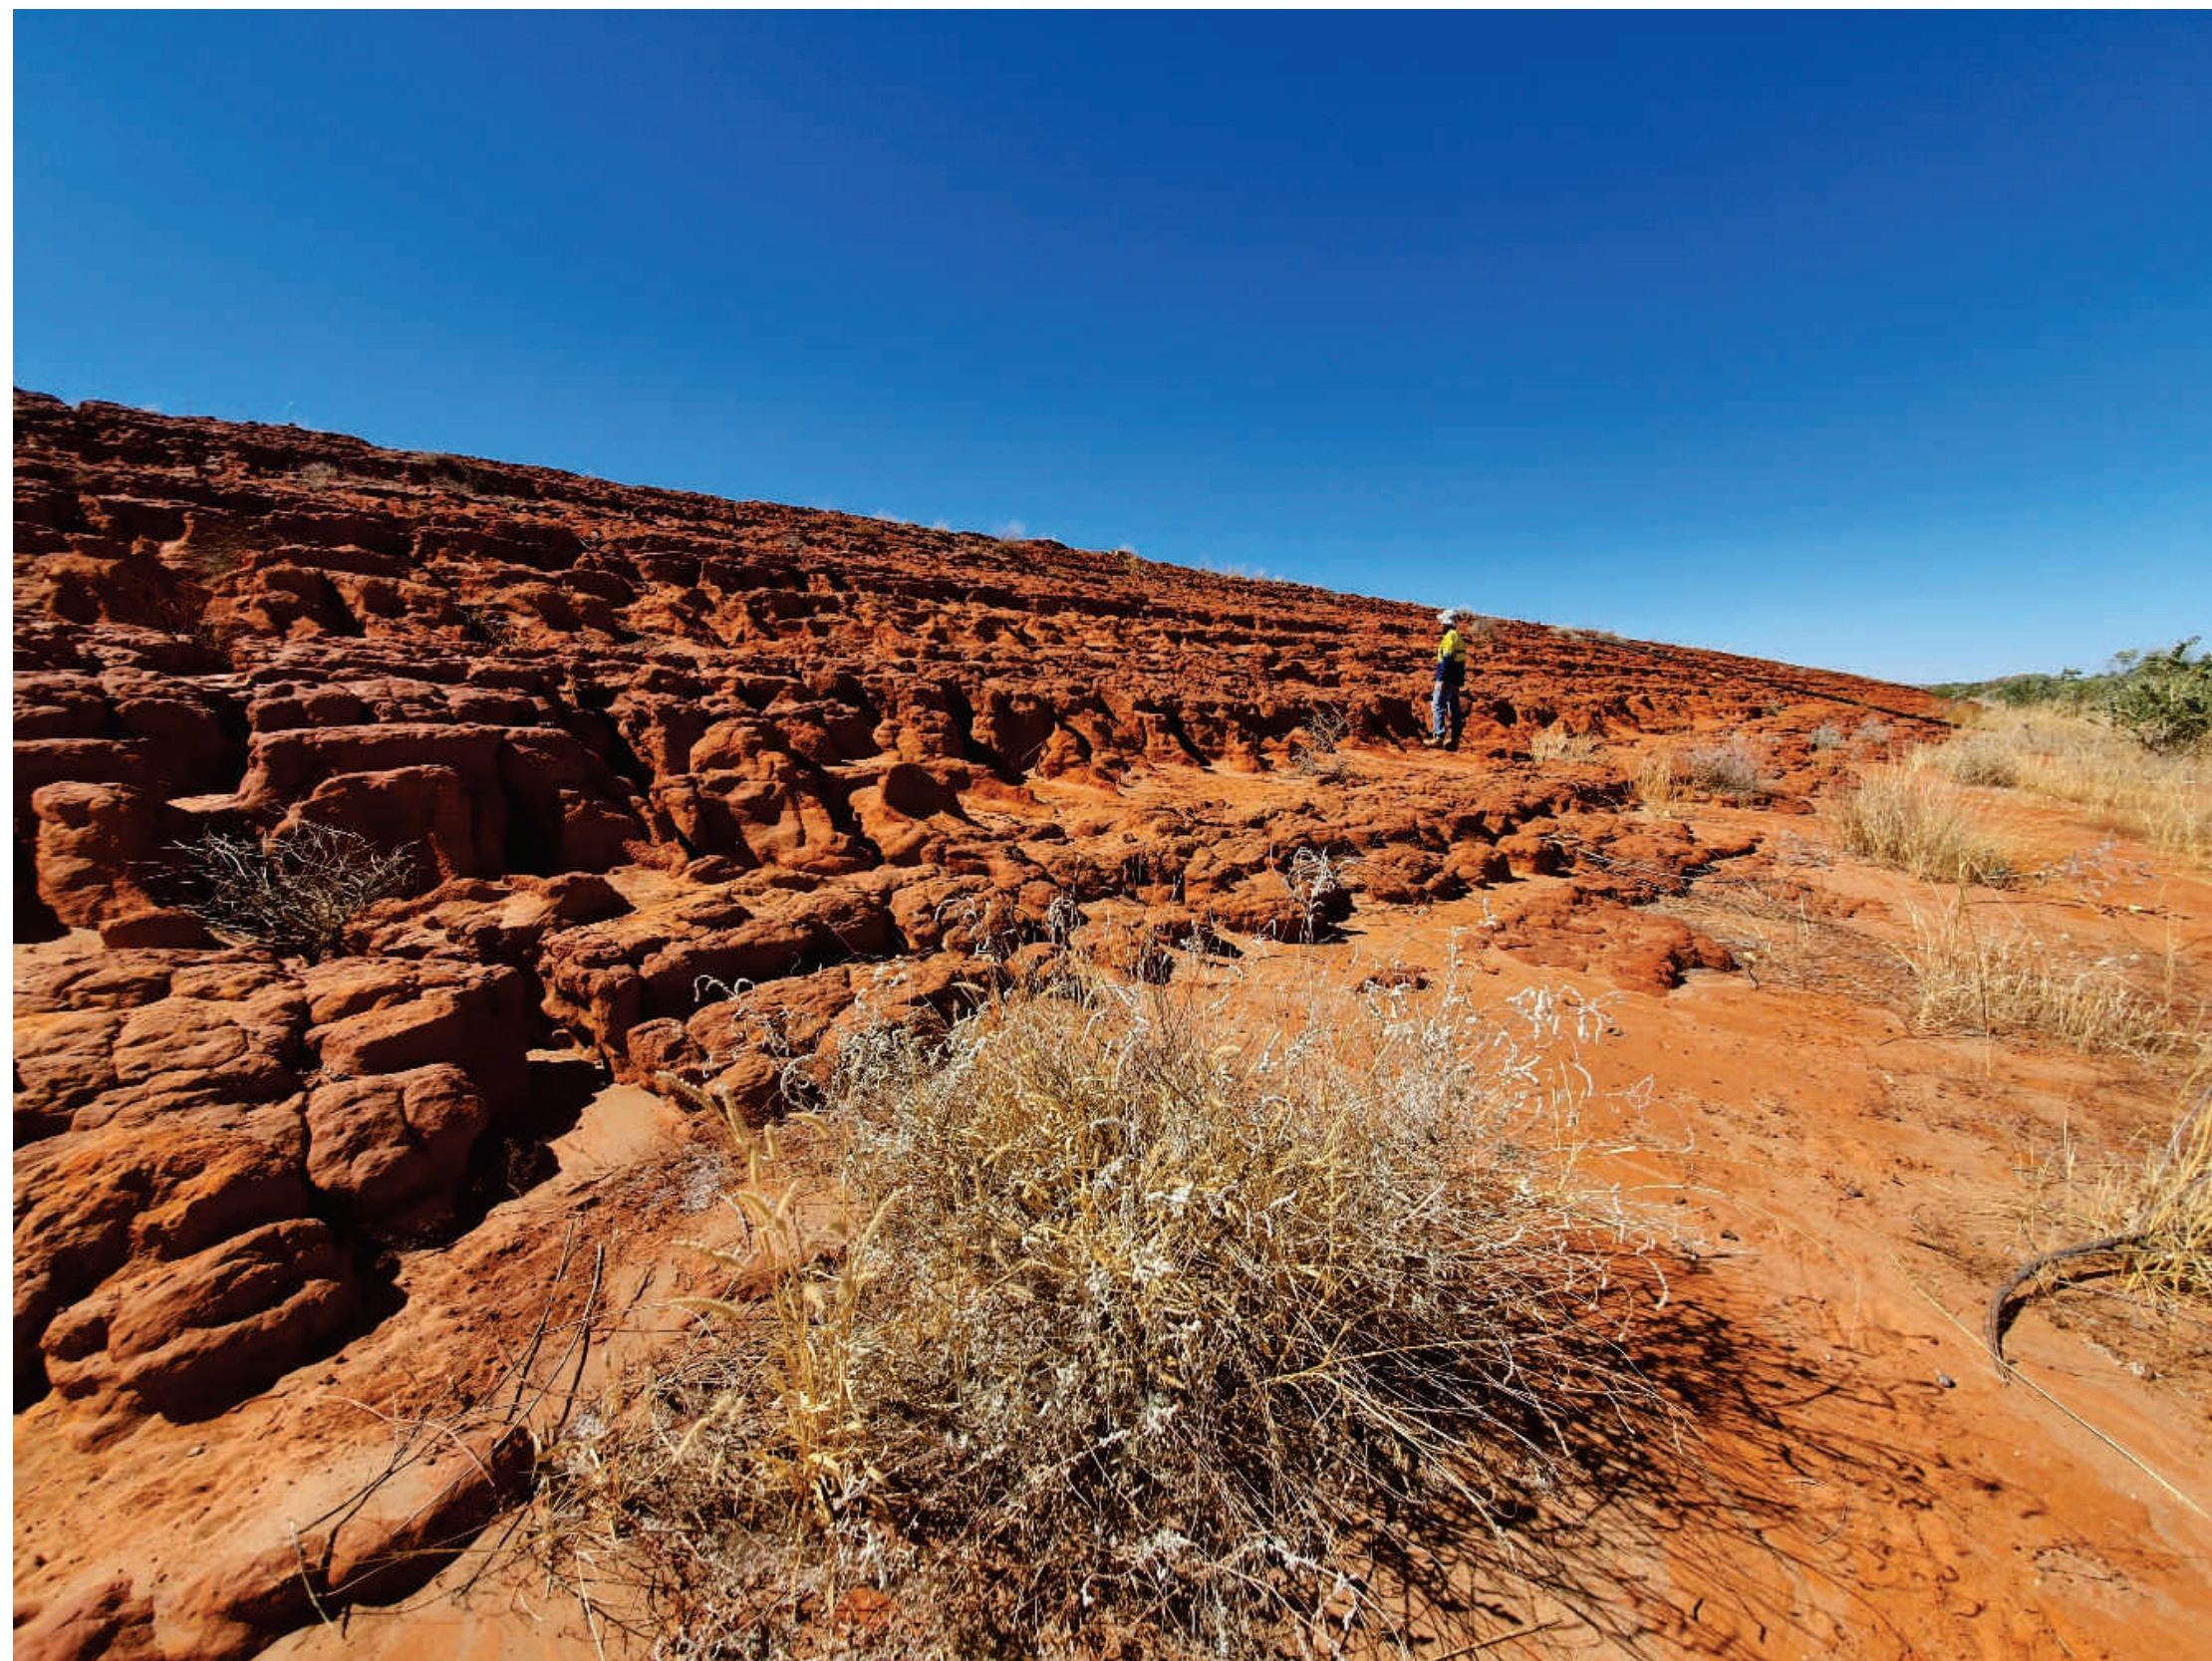
E9 TSF 1D significant gully erosion on the western wall of Cell 3

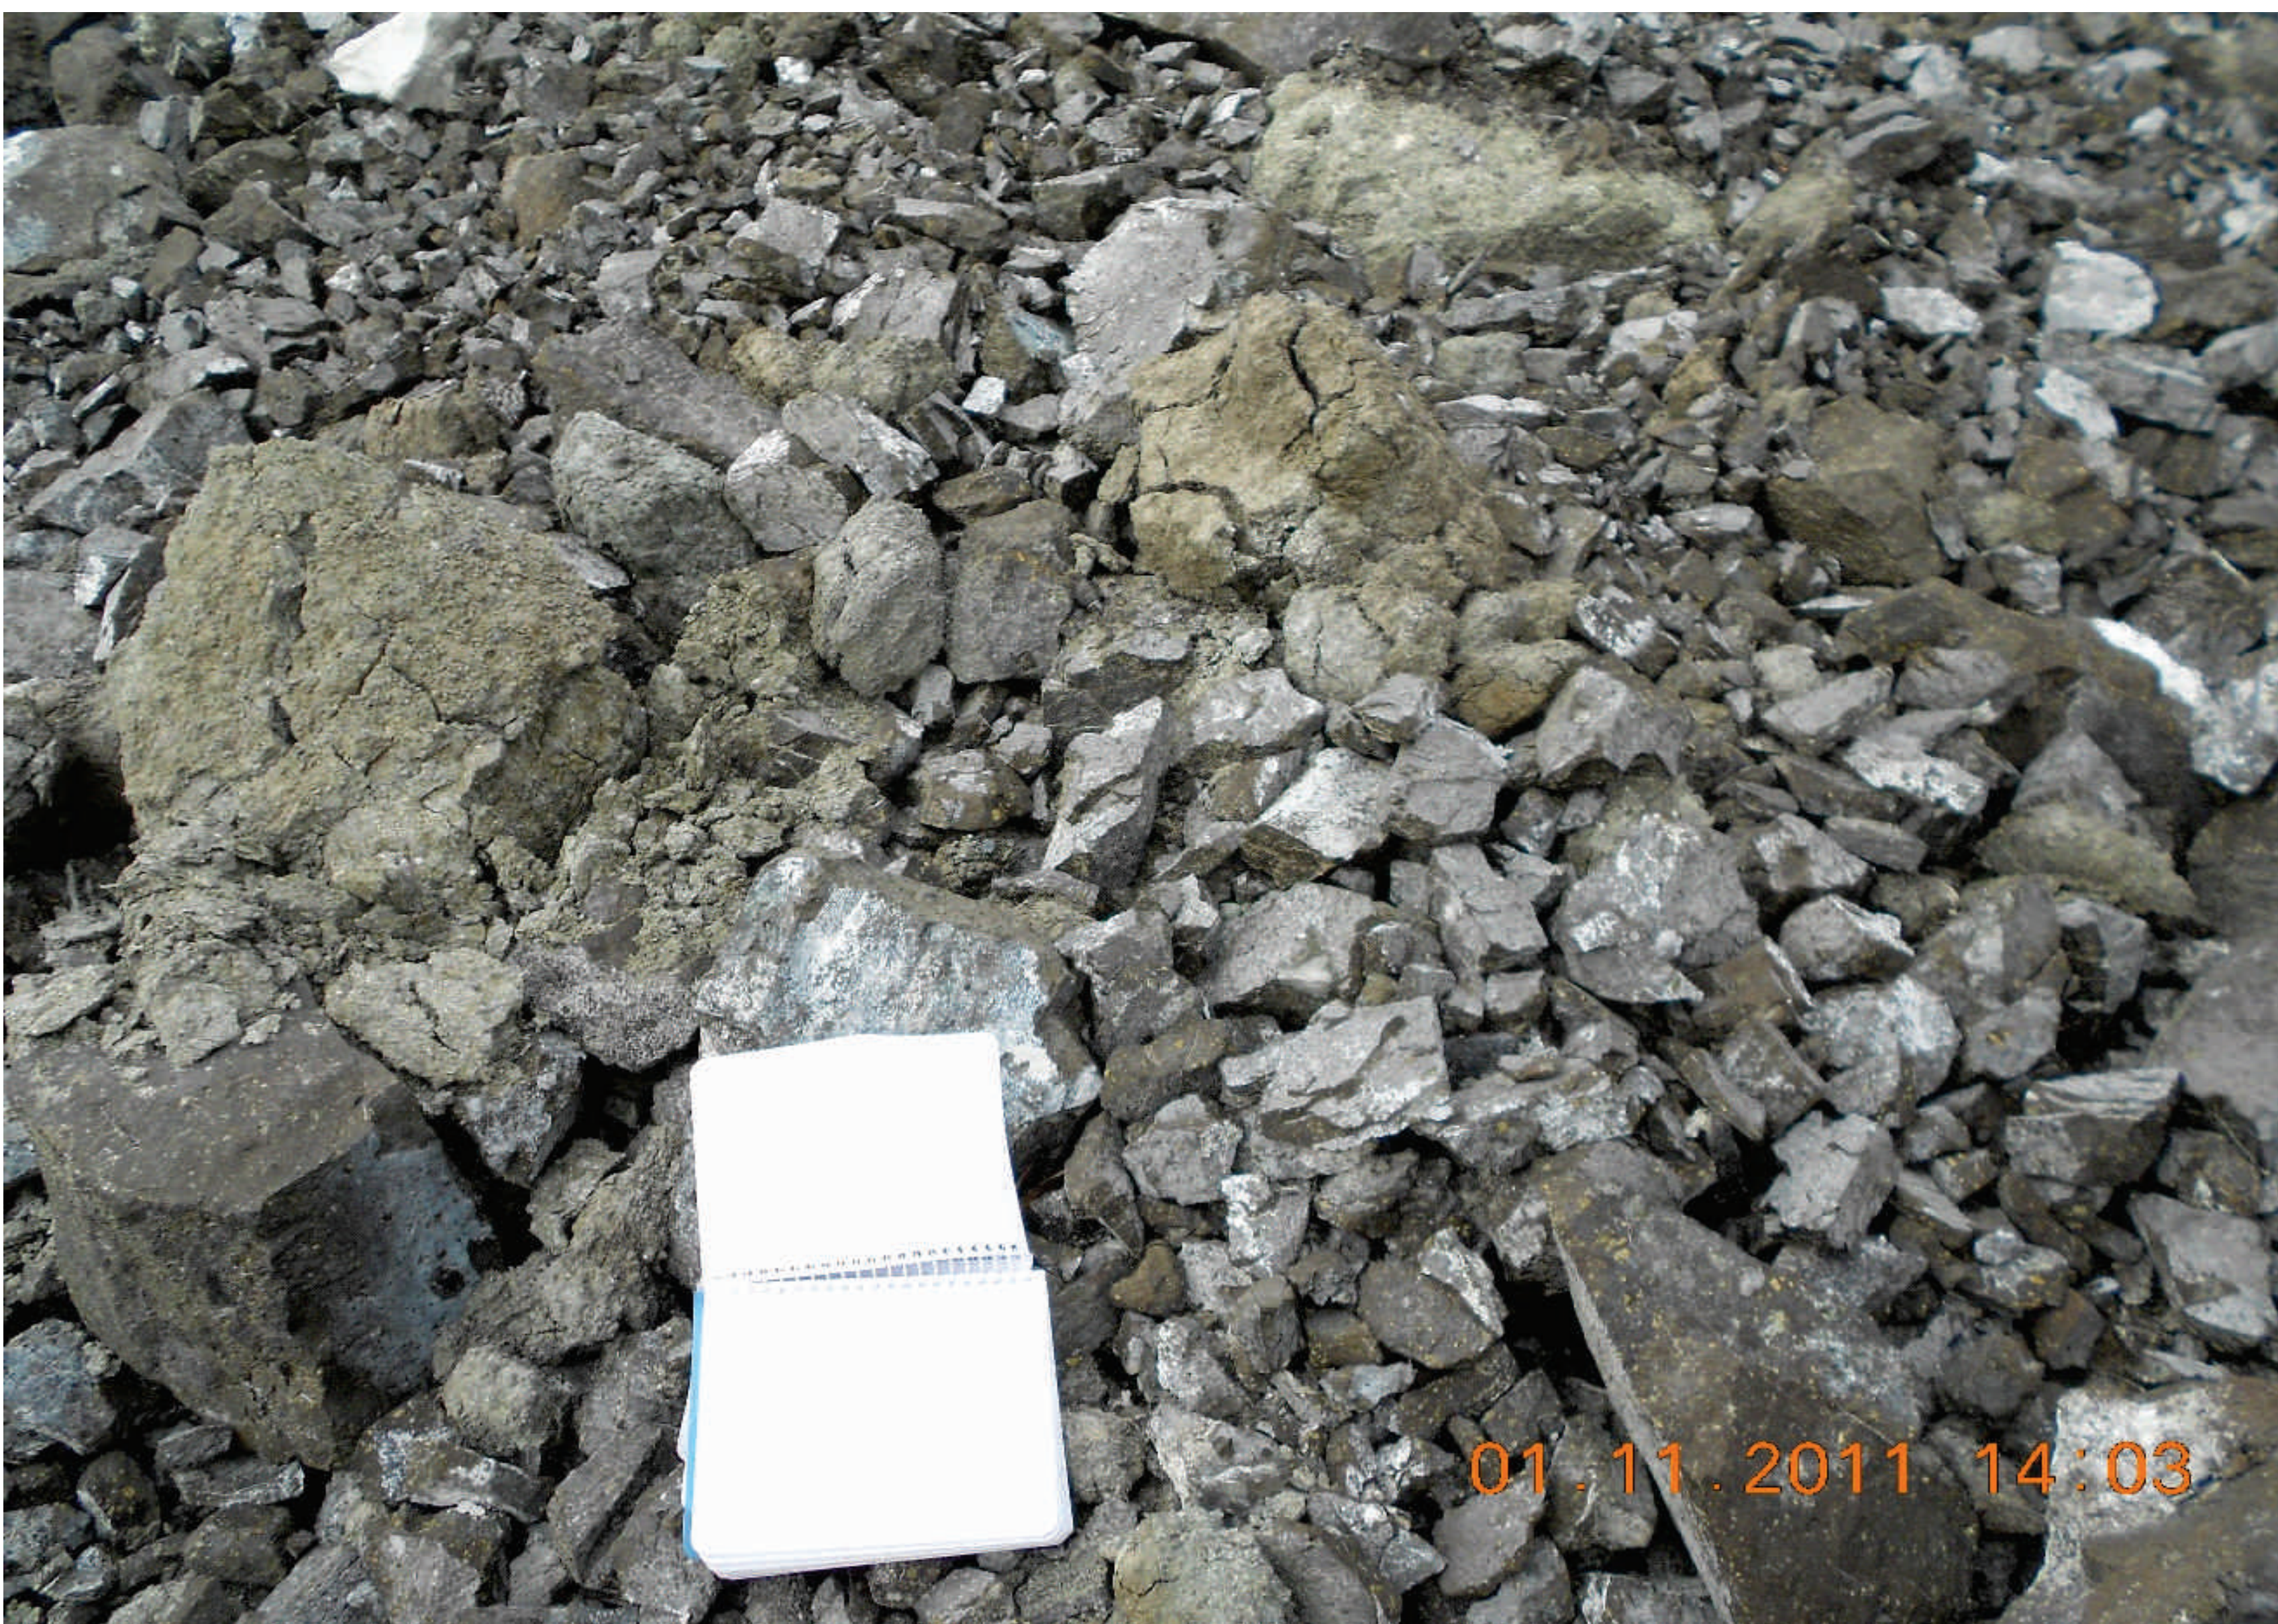
Fresh magmatics

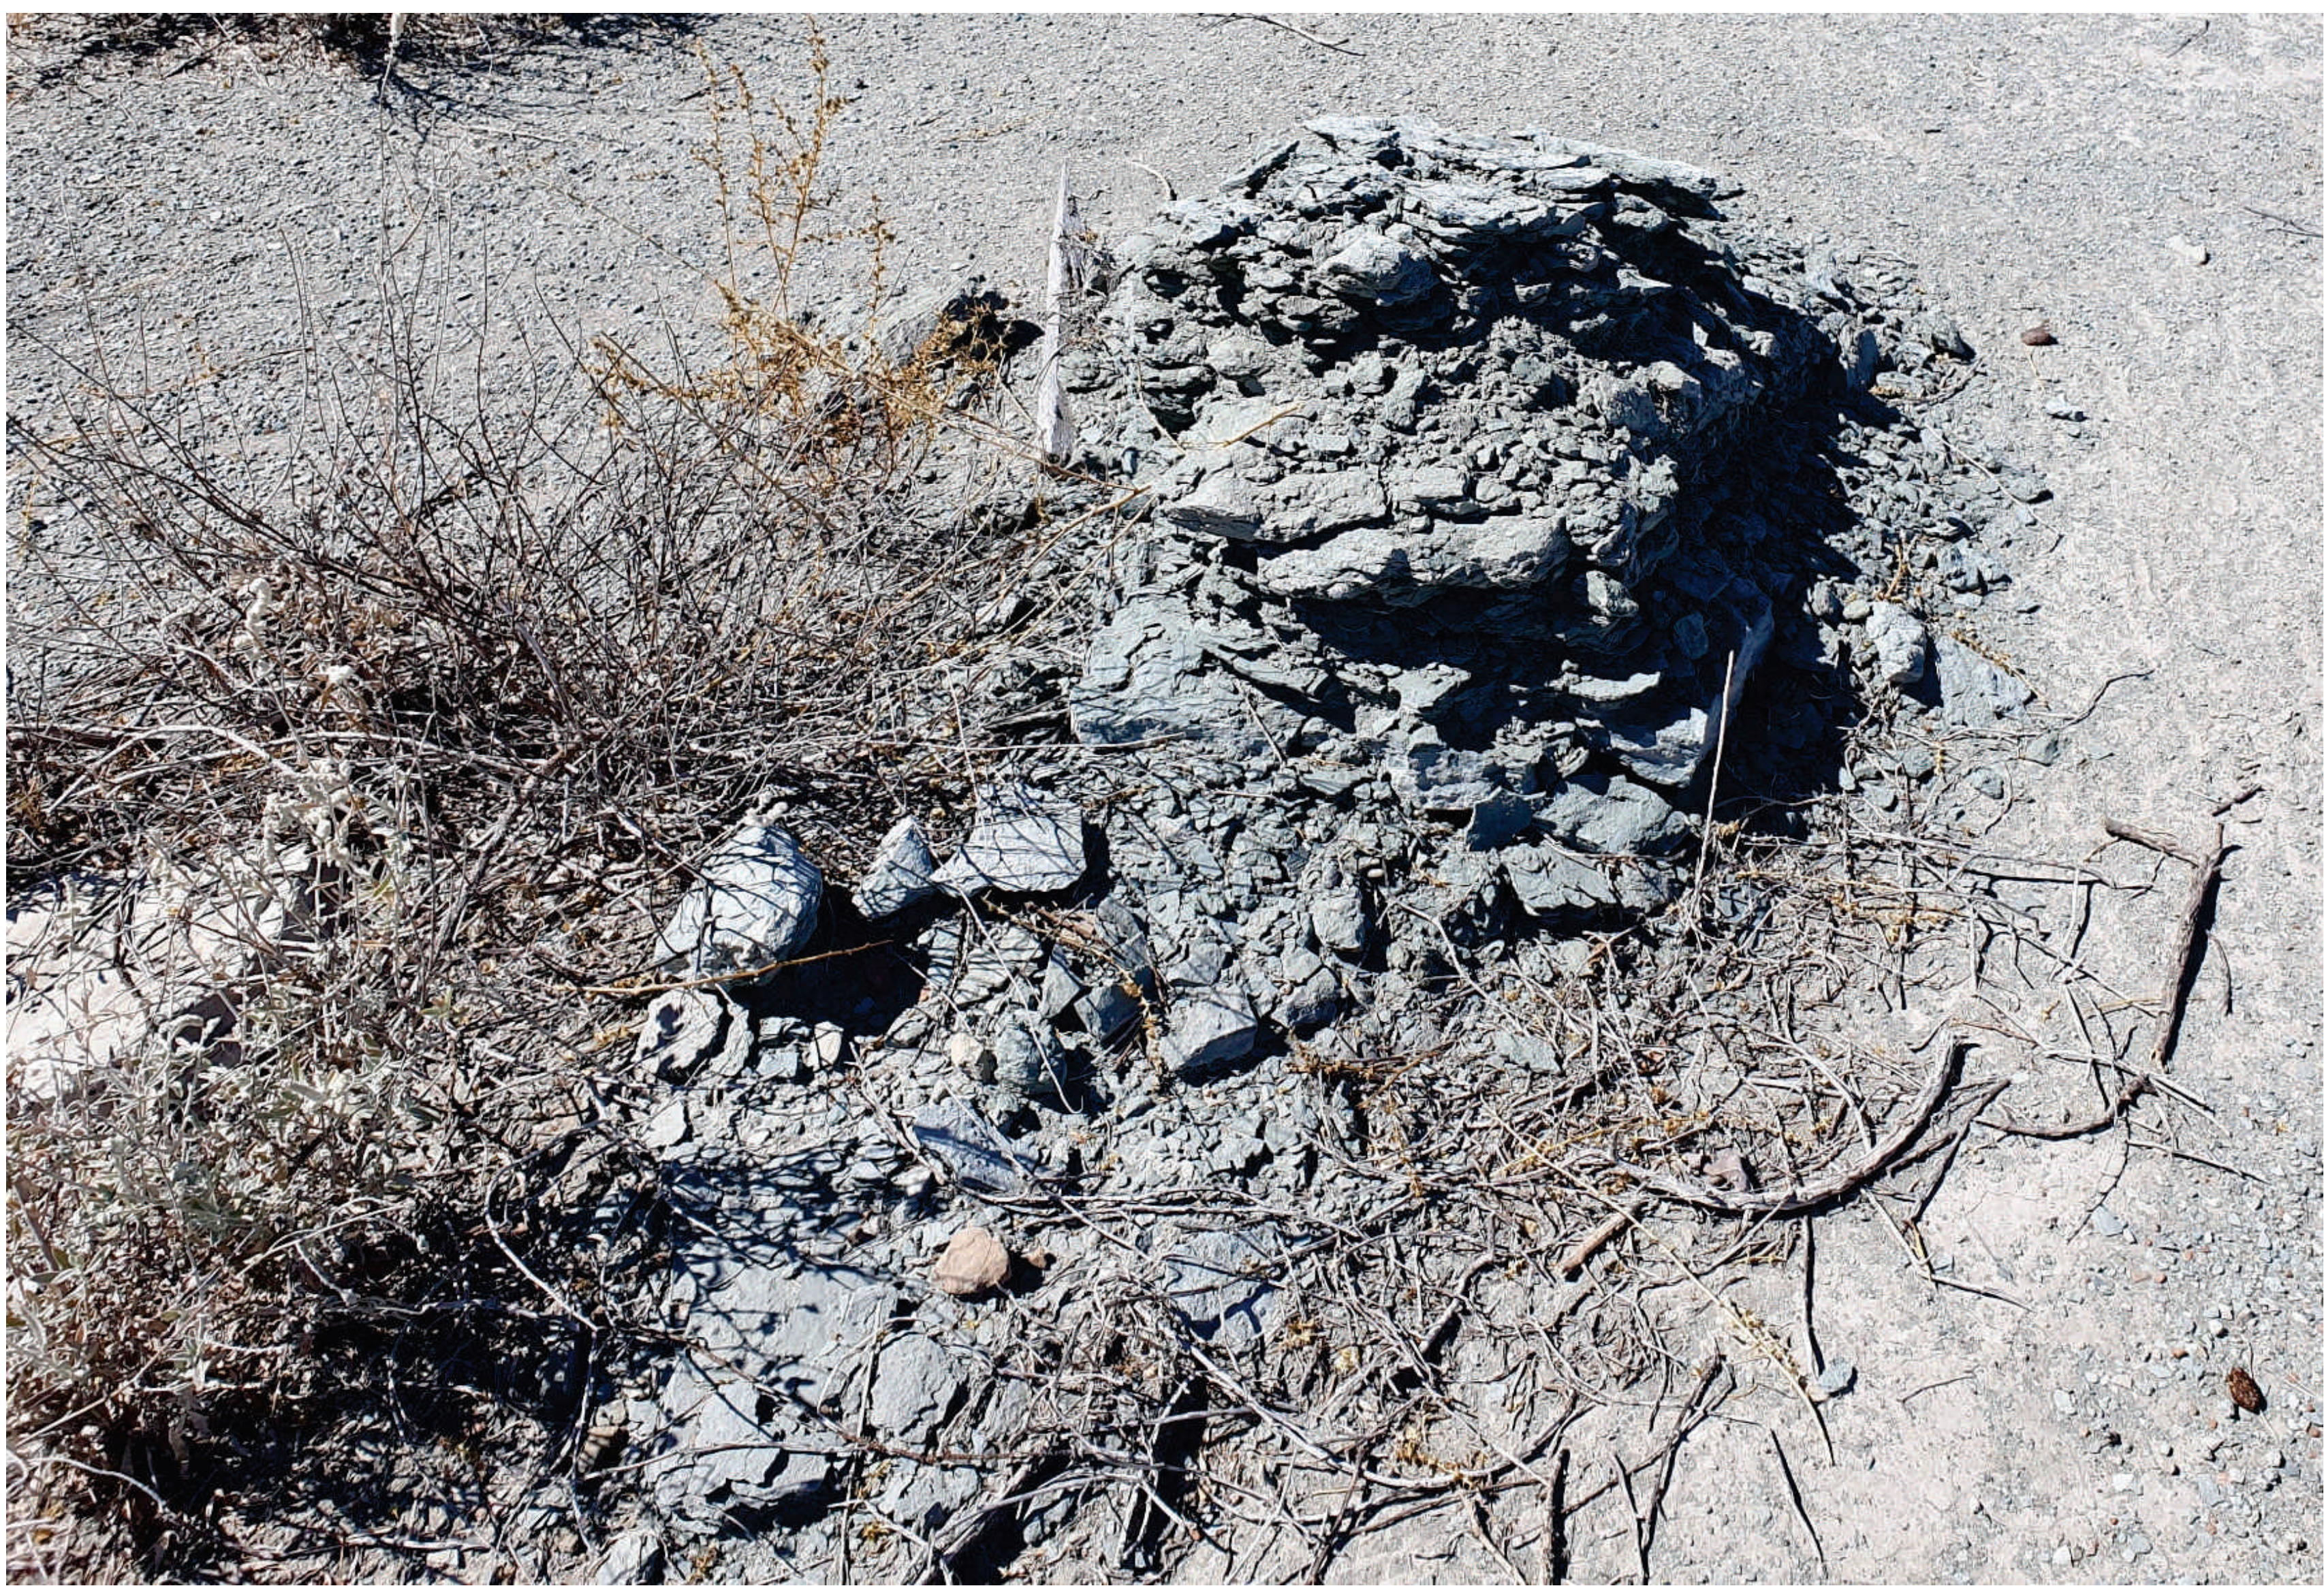
Large magmatic rocks weathering to dust
