ELLENDALE DIAMOND MINE

Managing an abandoned mine as a future resource

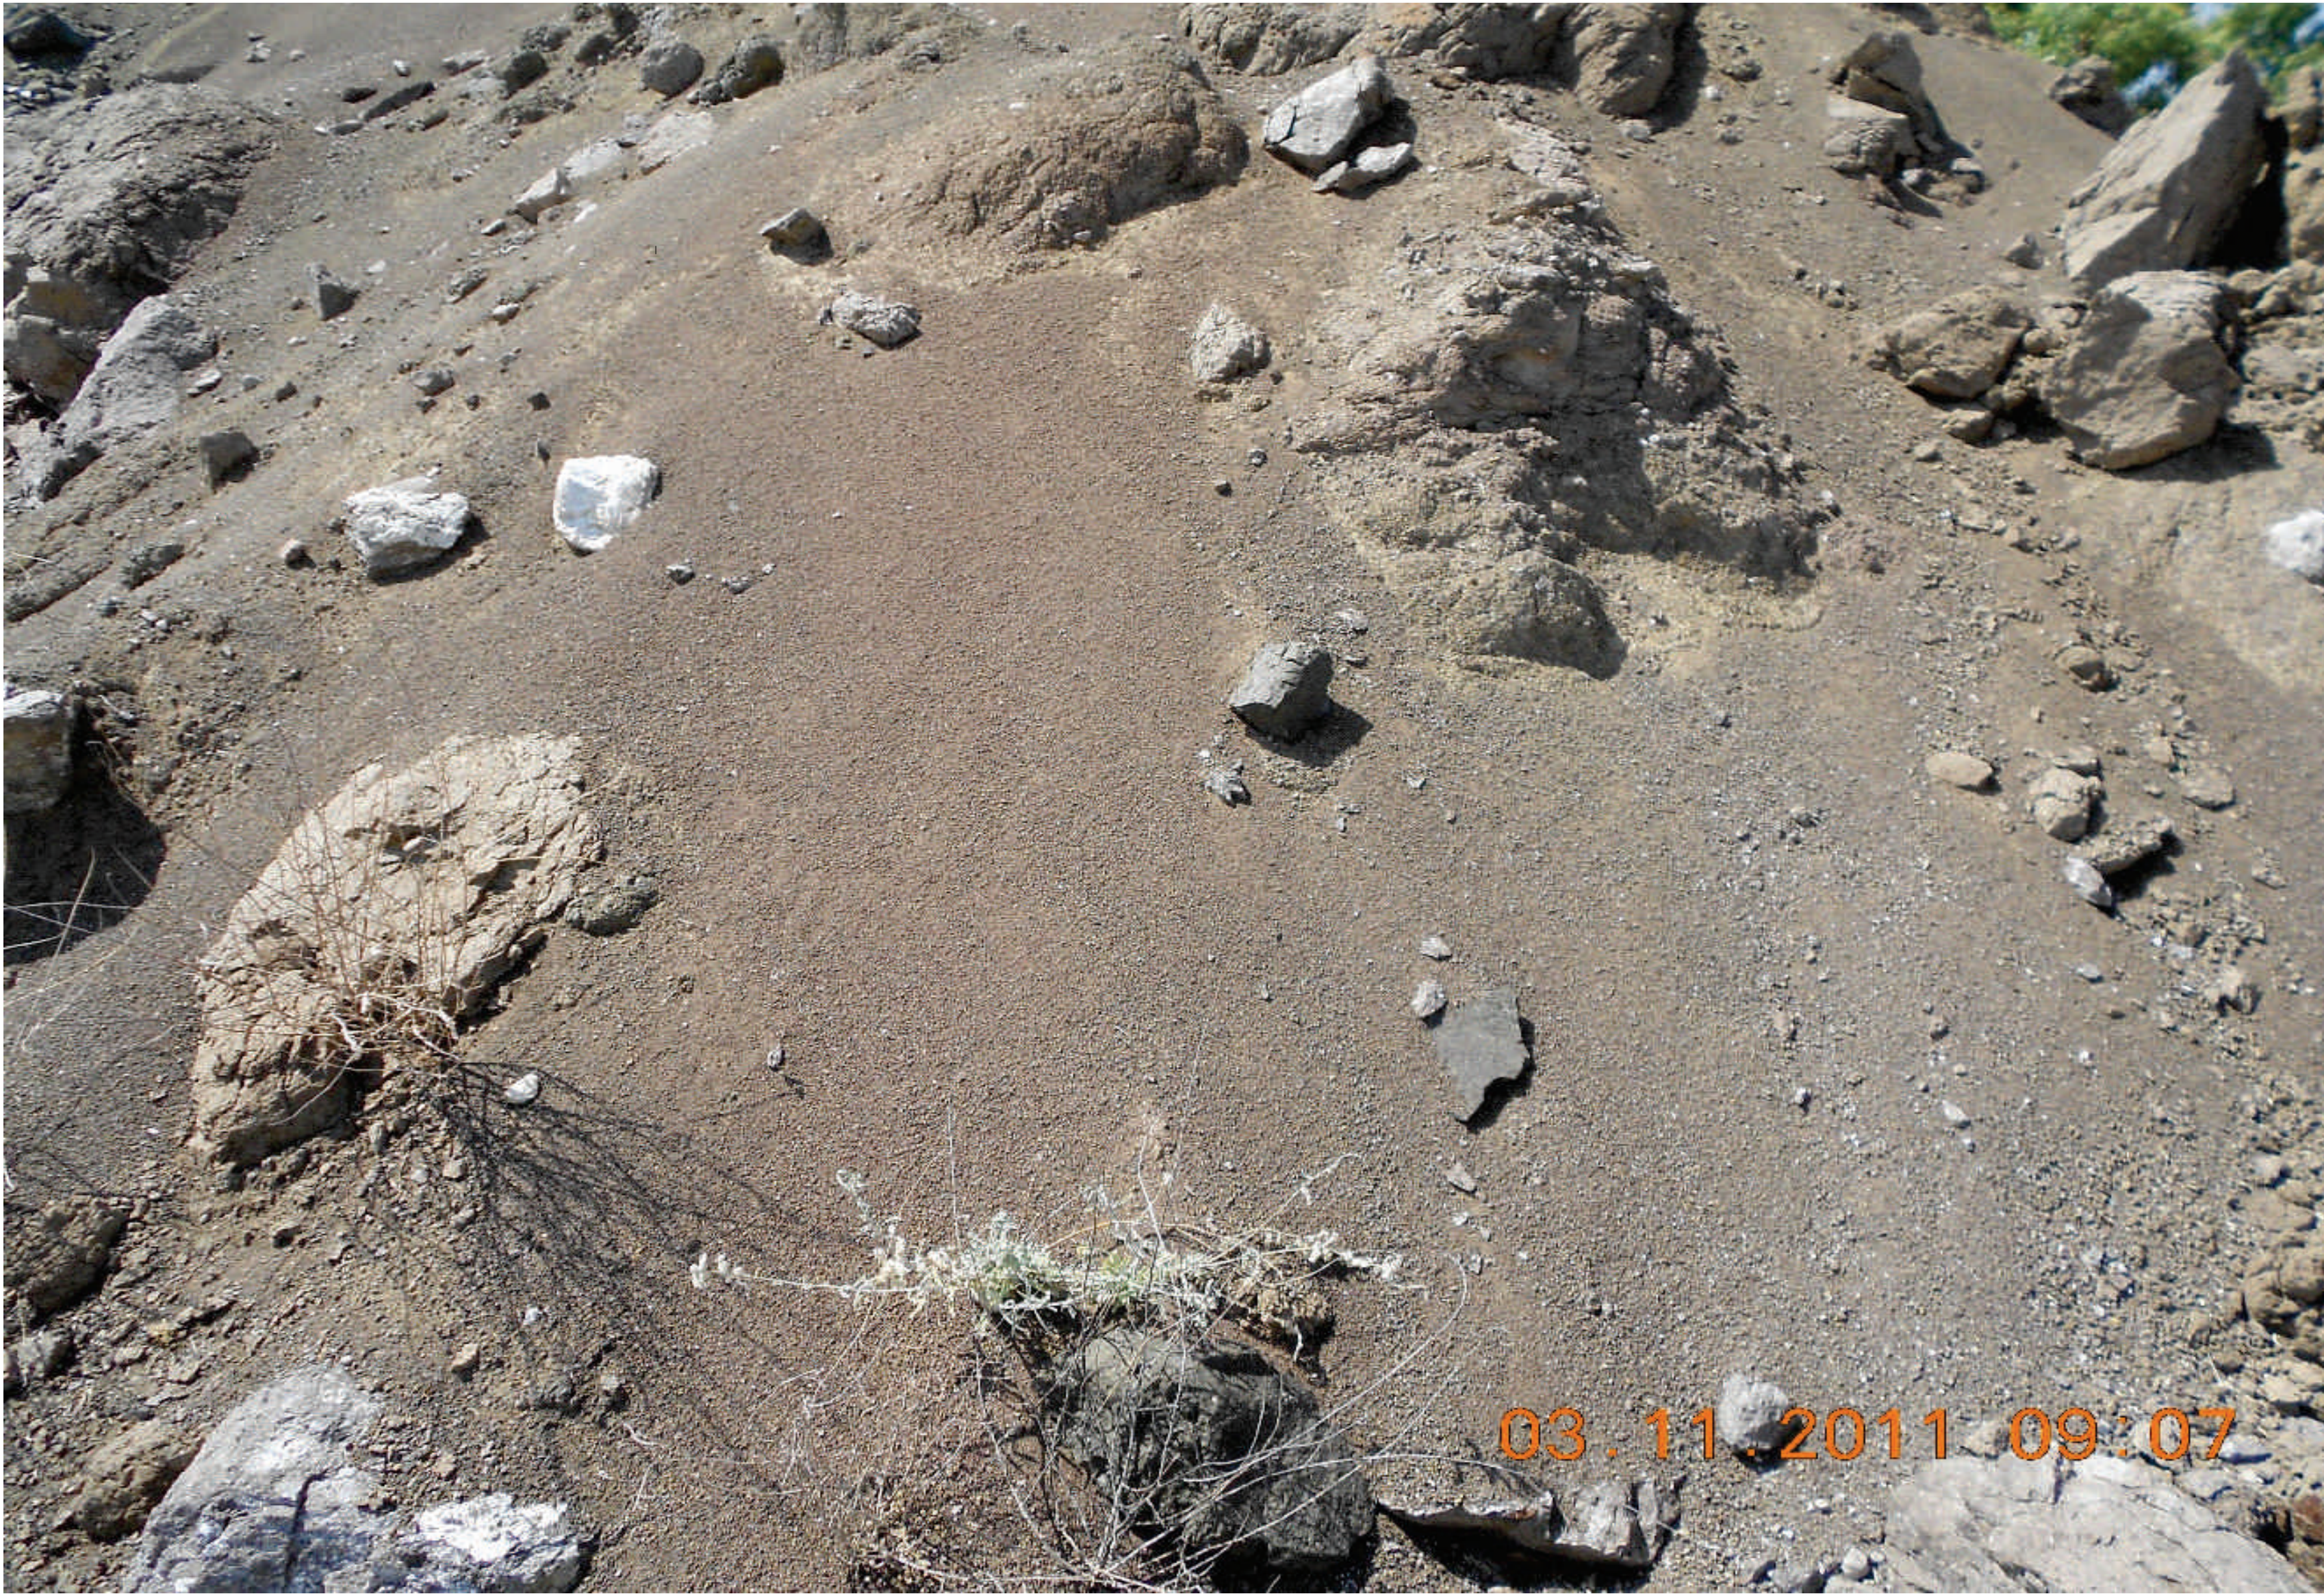
Five-year-old weathered magmatics

Landform remediation will incorporate appropriate rock armouring and modifications to the current batter design to enable long-term surface stability.

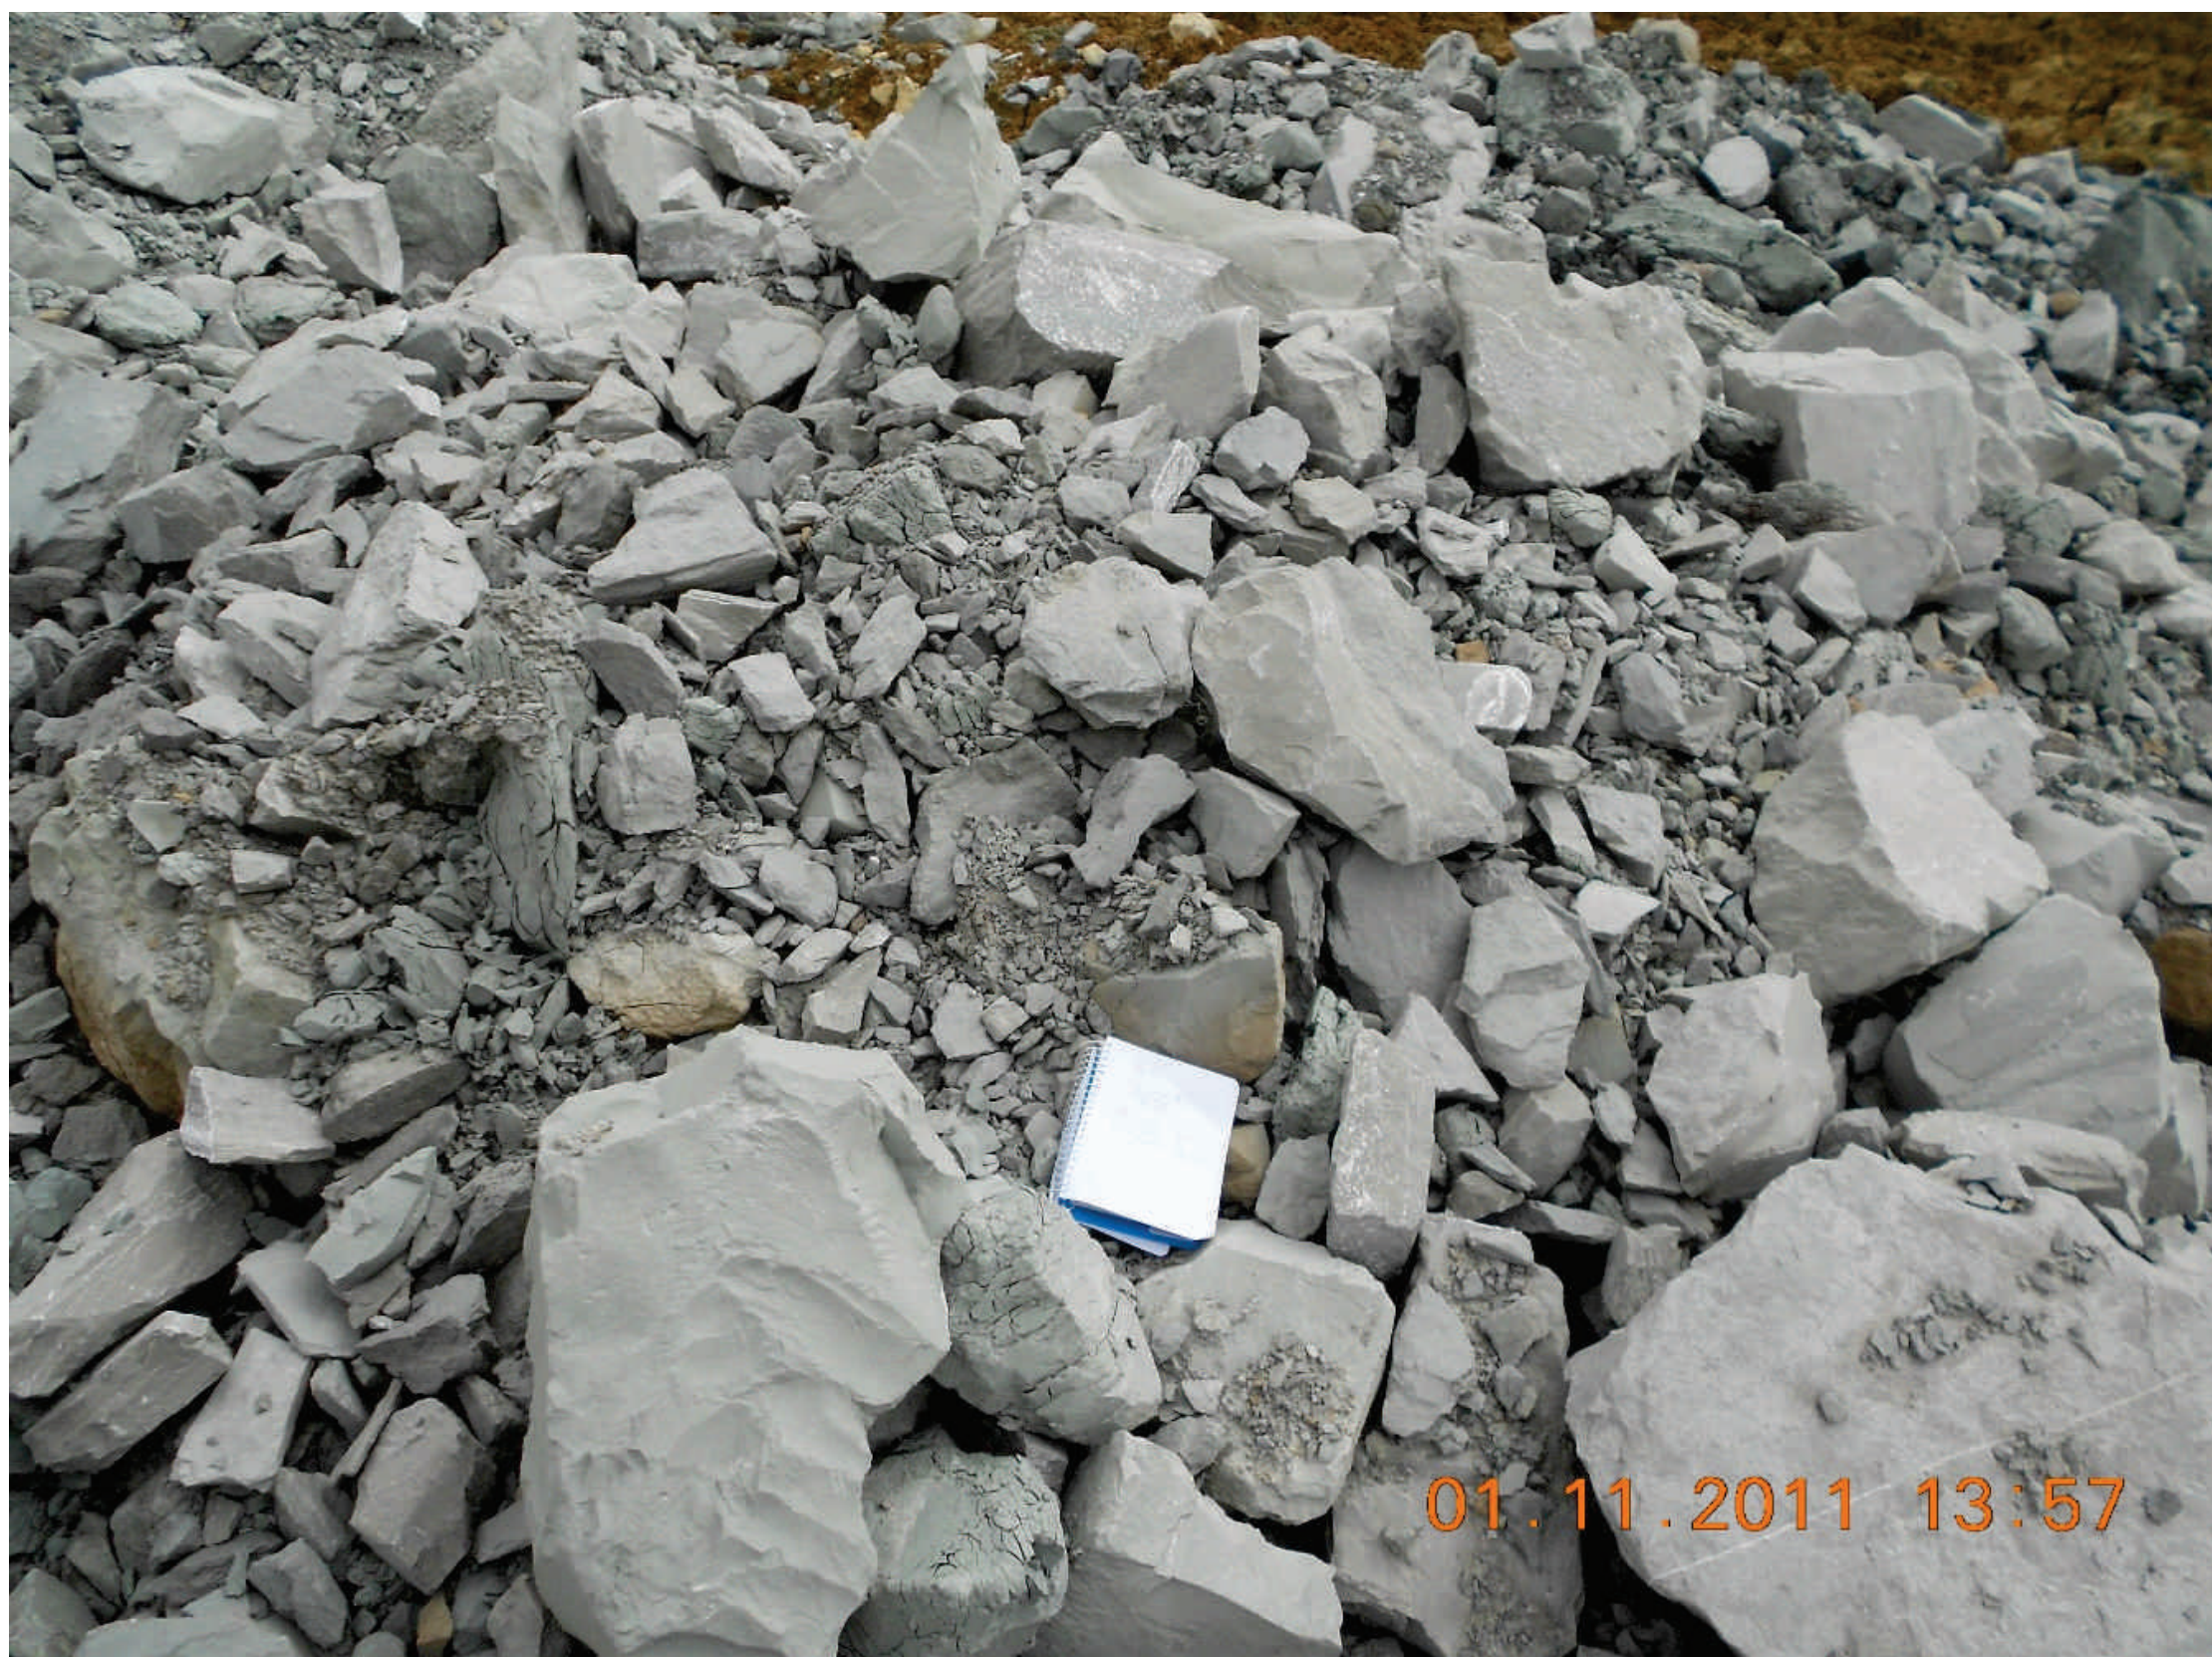
Fresh siltstone

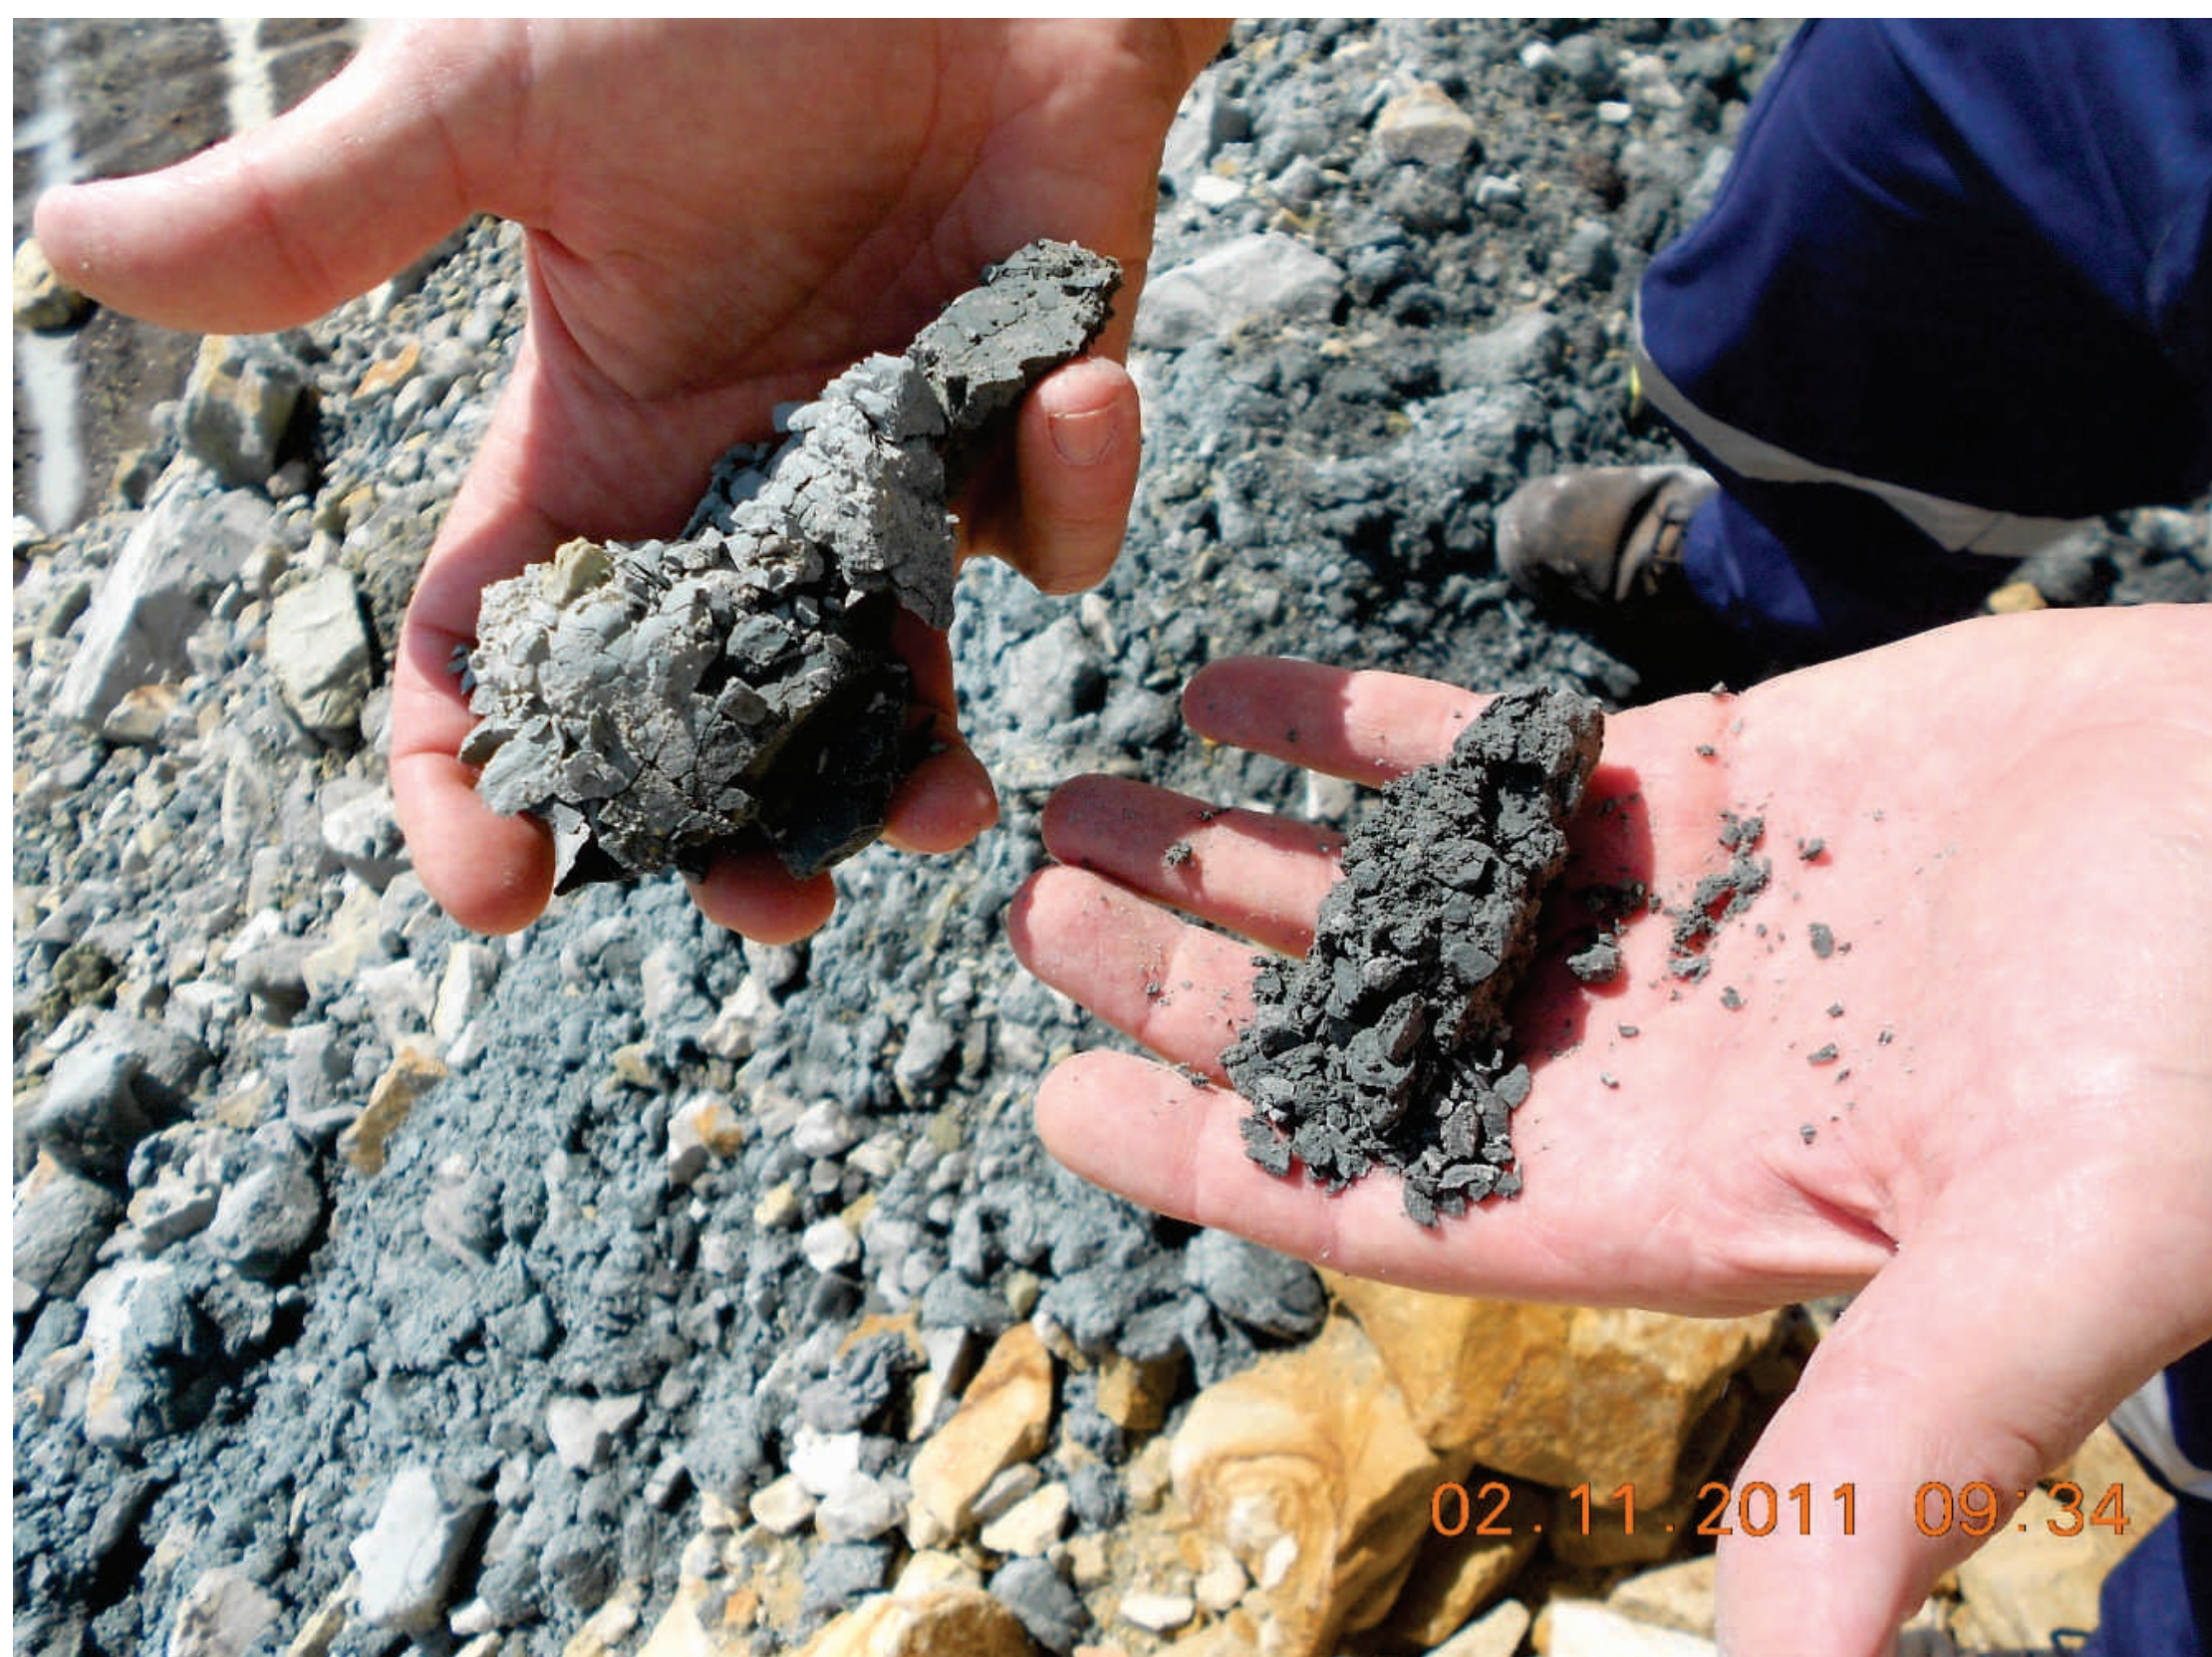
Weathered siltstone

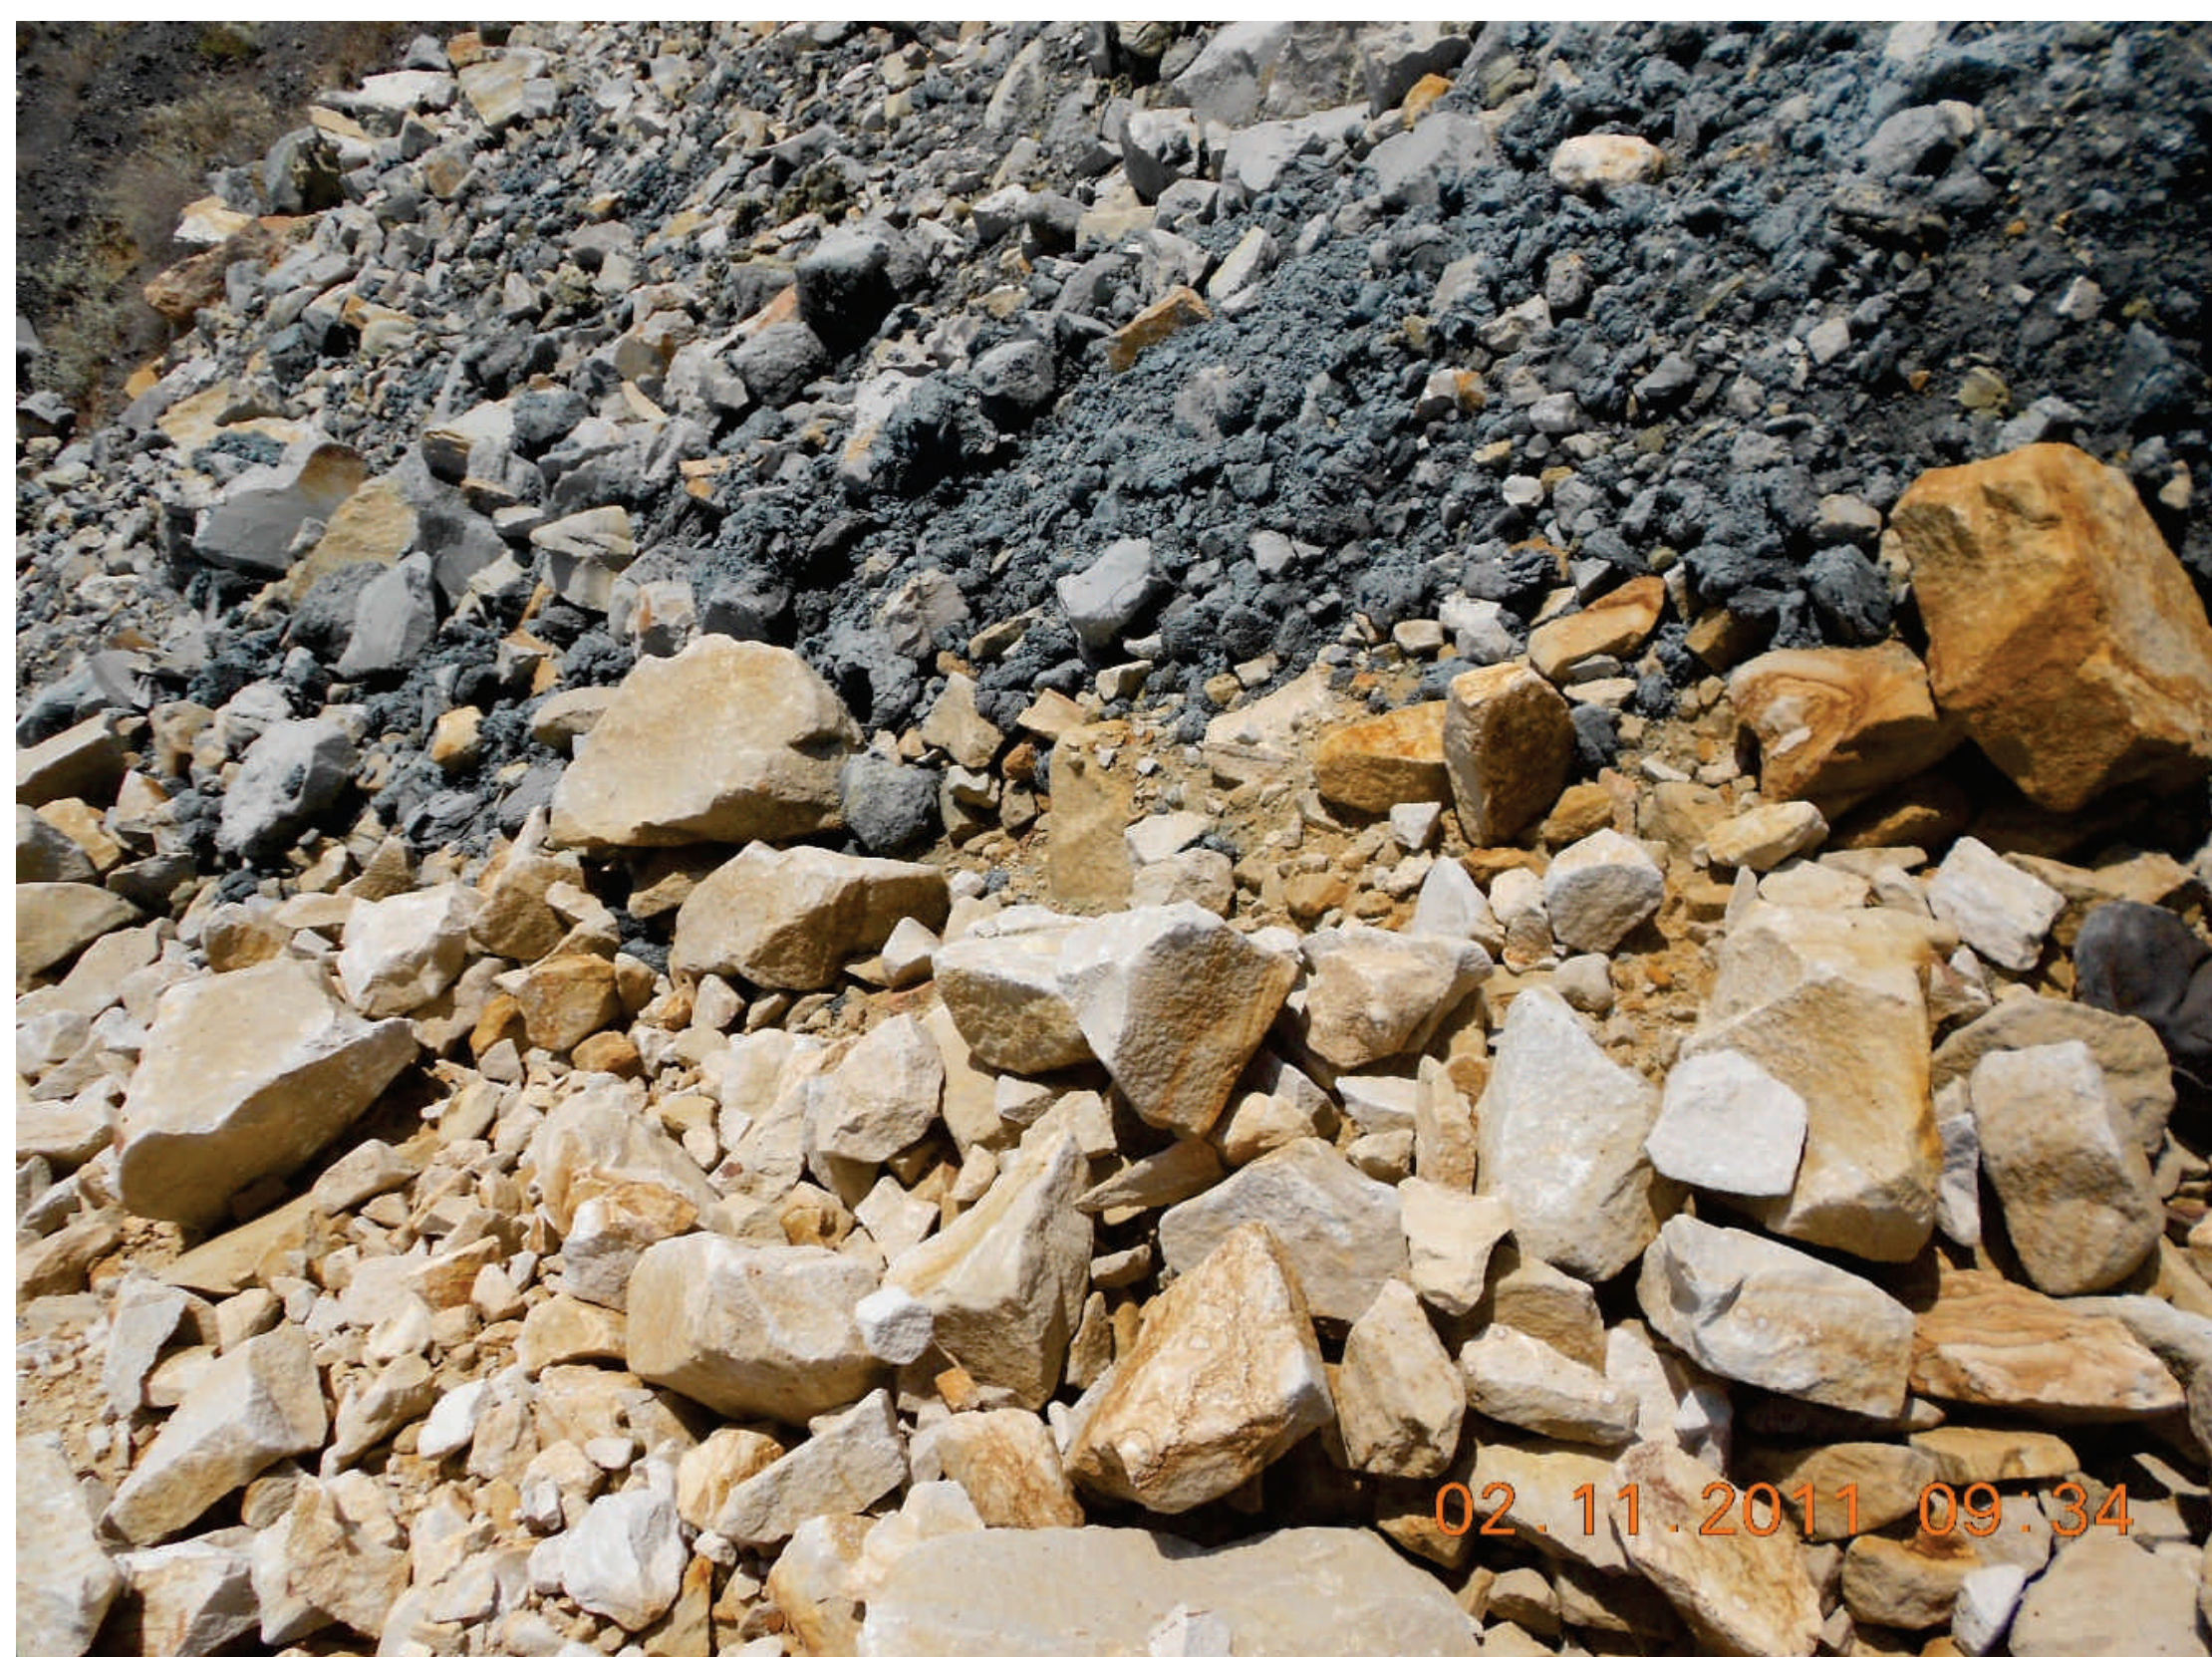
Weathered siltstone (top), weathered sandstone (bottom)
