GEOLOGICAL SURVEY
OF
WESTERN AUSTRALIA

REPORT 11

THE CADDOUX EARTHQUAKE,
2 JUNE 1979

By
J.D. Lewis
N.A. Daetwyler
J.A. Bunting
and J.S. Moncrieff

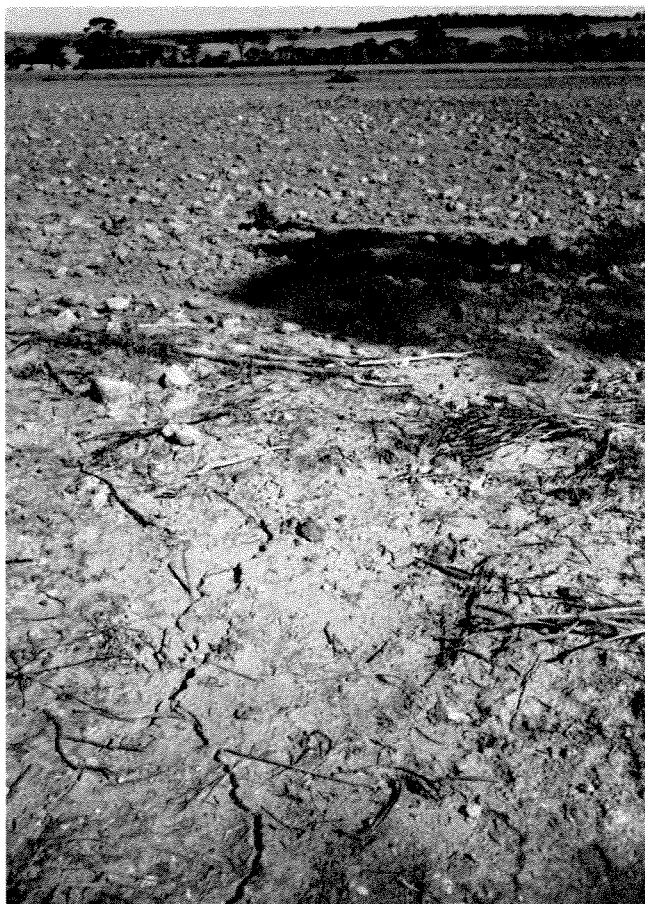
Figure 9. Tension crack 1.2 km from the southern termination of the Robb Fault (GSA 18739)

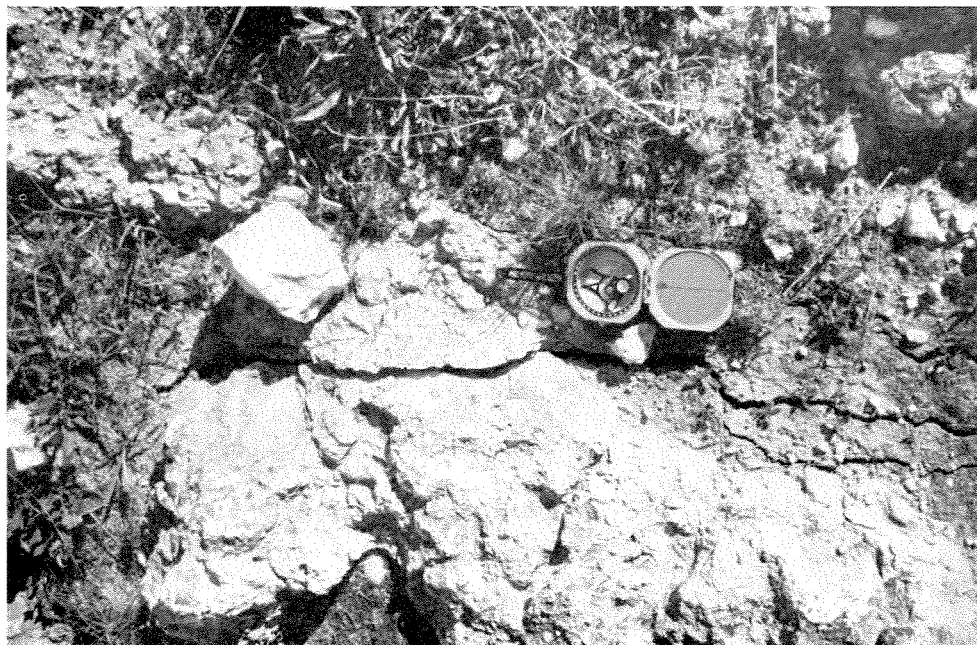
Figure 10. Tension crack in a granitic outcrop, 3 km from the southern termination of the Robb Fault (GSWA 18740)

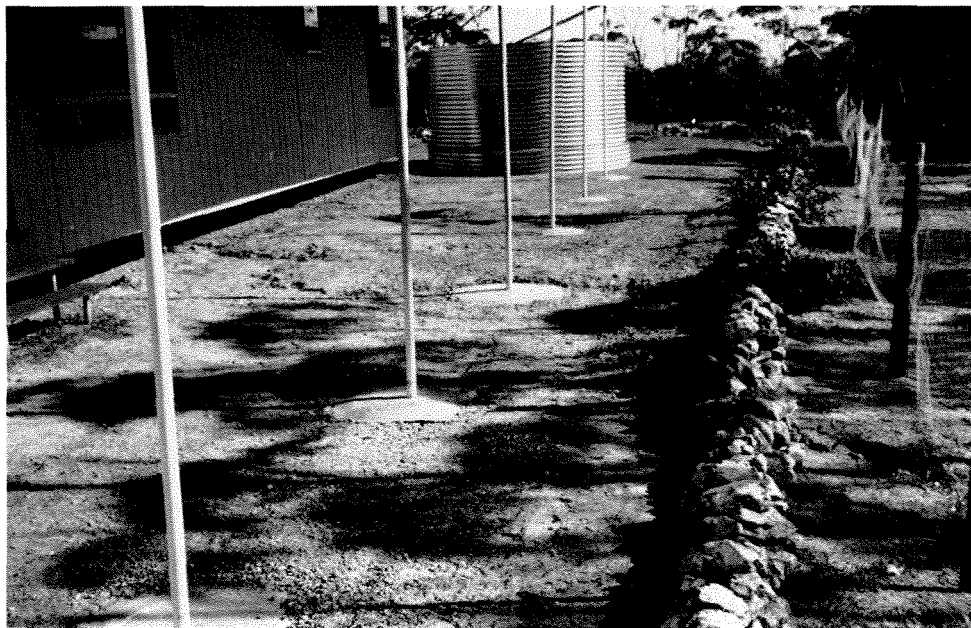
Figure 11. A branch of the Robb Fault passing beneath a house on the Shankland property: the right-lateral thrust fault passes between the third and fourth verandah poles and gives a small apparent left-lateral displacement of the stone wall (GSWA 18741)

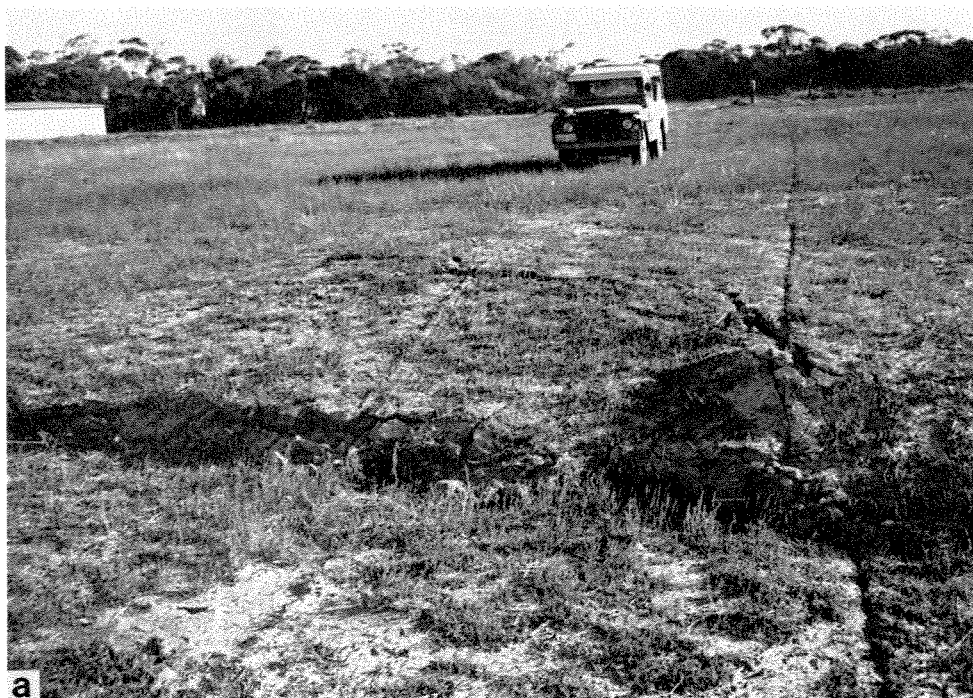
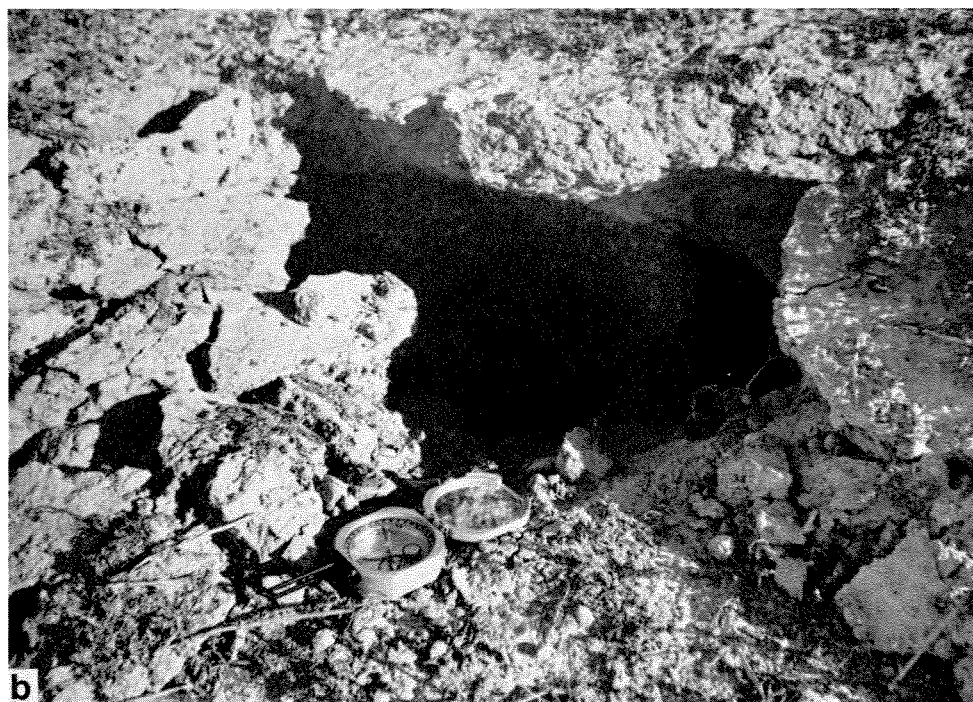
the Robb Fault. At the southern end of this fault an anomalous left-lateral displacement was seen (Fig.13a), probably caused by the 145° strike of this section relative to the overall strike of 020° for the Robb Fault. This section of the fault also provided the only exposure of the plane of the Robb Fault; about 100 m east of the Shankland house it was exposed in cemented laterite gravel and dipped 34° to the southwest with a strike of 122° (Fig. 13b).

Figure 13. The Robb Fault northeast of the Shankland house:
 (a) note apparent left-lateral displacement of old wheel
 tracks and tension cracks to the rear of the collapsed
 scarp, (b) an exposure of the thrust plane dipping at 34°
 towards 212° (GSWA 18743)

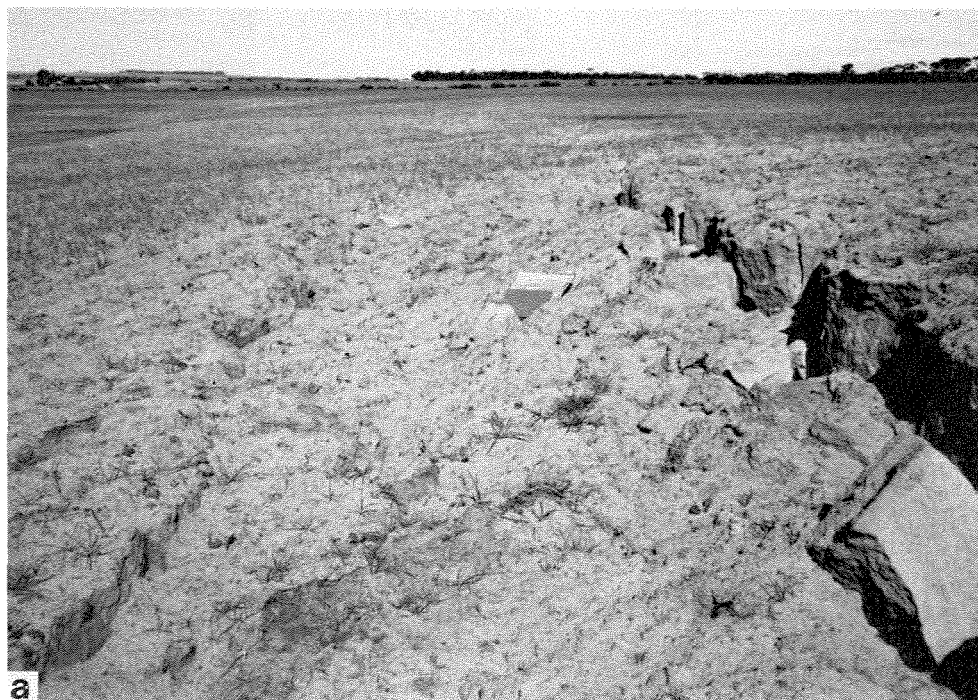
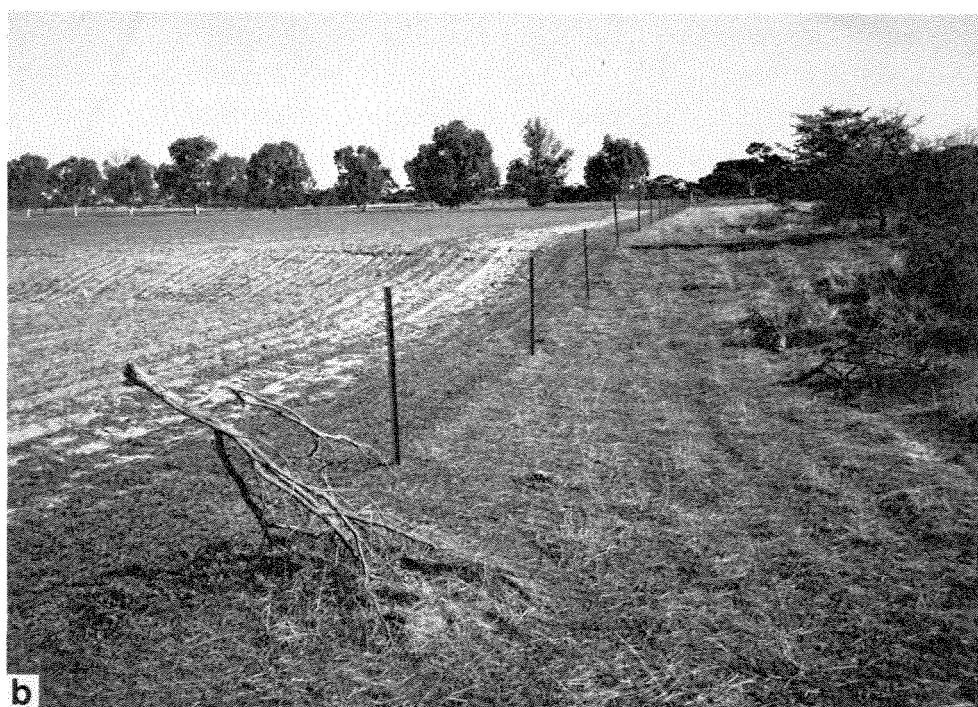
Figure 15. The Robb Fault northeast of Cadoux golf course: (a) collapse of the upthrust block. Note the major tension fracture at the crest and the graben-type structure in the collapsed material. The throw of the fault at this point is 1.4 m (b) Throw of 0.68 m on fence line 0.55 km north of the Koorda road. (GSWA 18745)

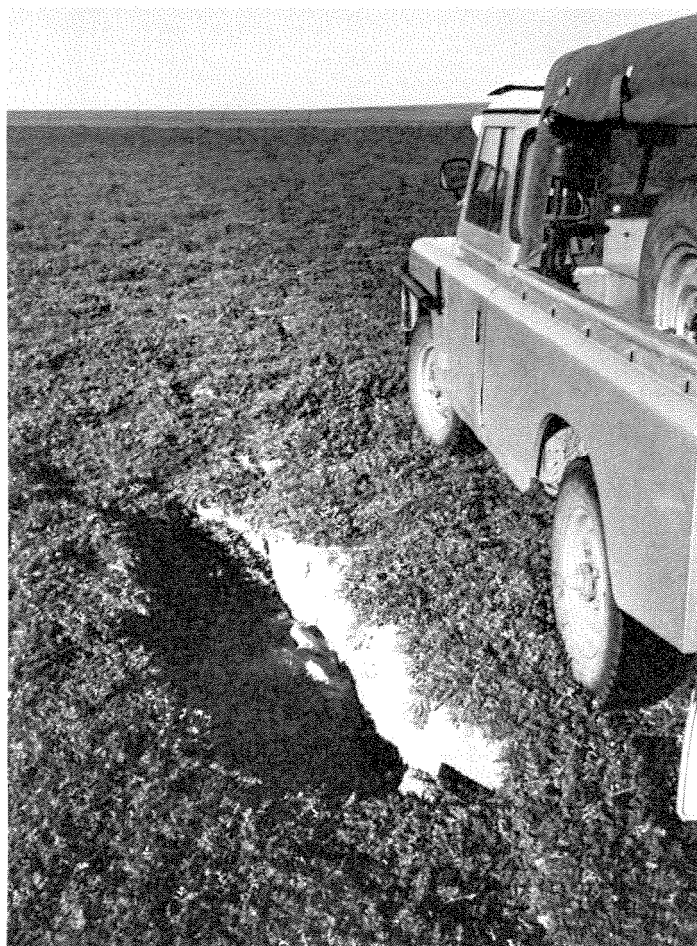
Figure 16. Collapse structure on a minor fault south of the Cumming Fault and 400 m south of the Cumming house (GSA 18746)

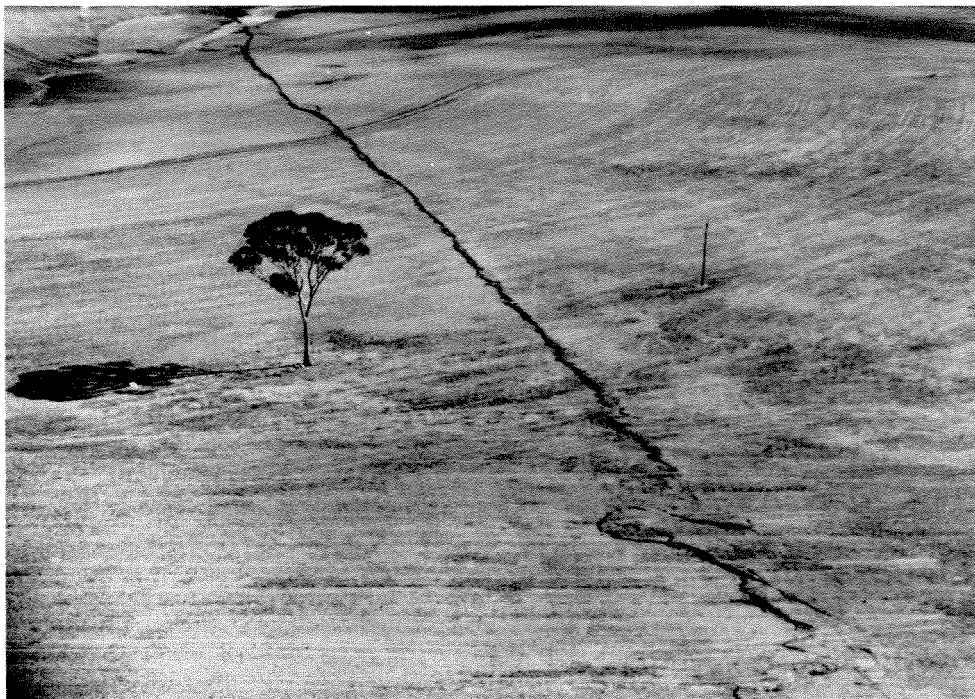
Figure 17. The Lone Tree Fault, looking northwest from above the Kalannie road. The scissors fault in the foreground is also shown in Figure 19 (photo: W.A. Newspapers) (GSWA 18747)

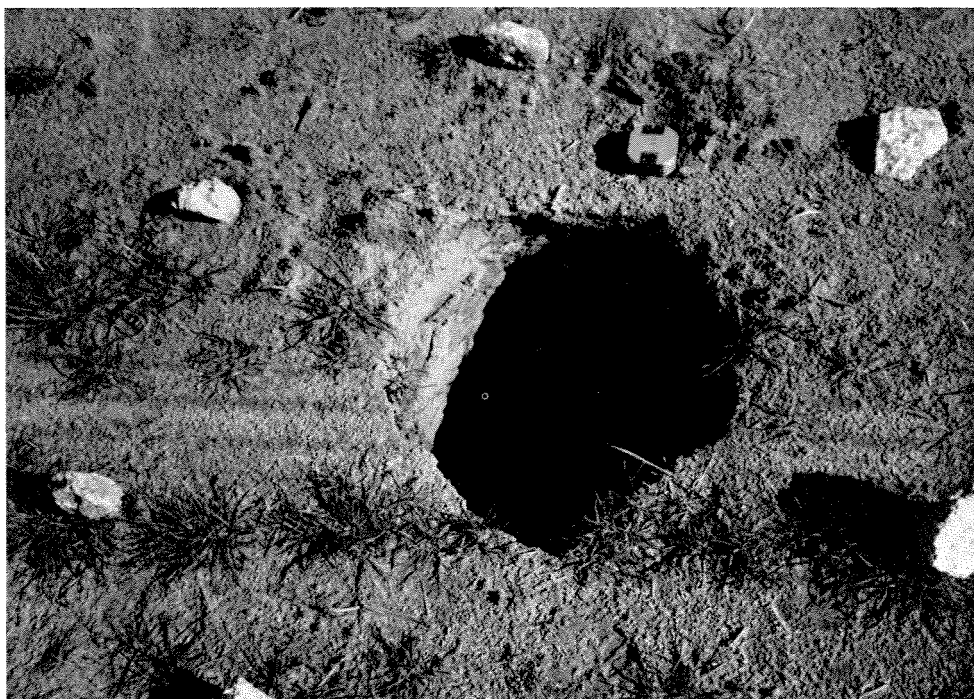
A feature of the Carter Thrust Zone was the presence of circular or elliptical holes up to 1 m across and 1 m deep (Fig.22). They were unrelated to tension cracks, although they did occur in the vicinity of major tension cracks a few metres back from the thrust scarps. The holes, of which three were found, were probably caused by the collapse of a cylinder

Figure 22. Collapse structure 0.6 m across behind the Carter Main Thrust (GSWA 18753)

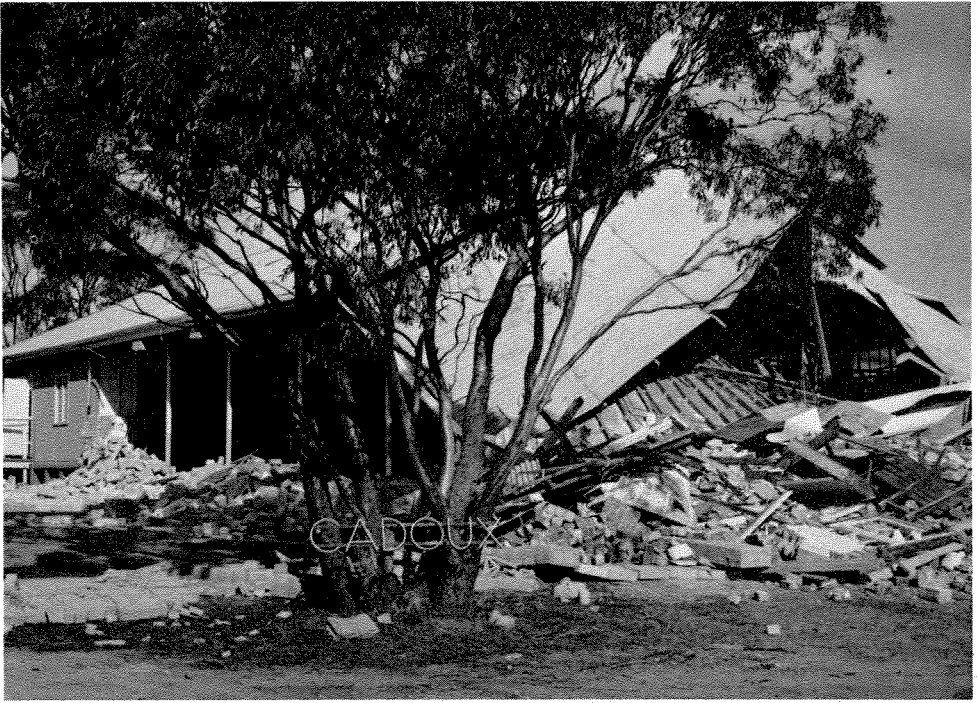
Figure 29. Cadoux Town Hall: the western wall and the block wall on the northern side have suffered total collapse. The frame structure at the rear of the building remains intact (GSWA 18762)

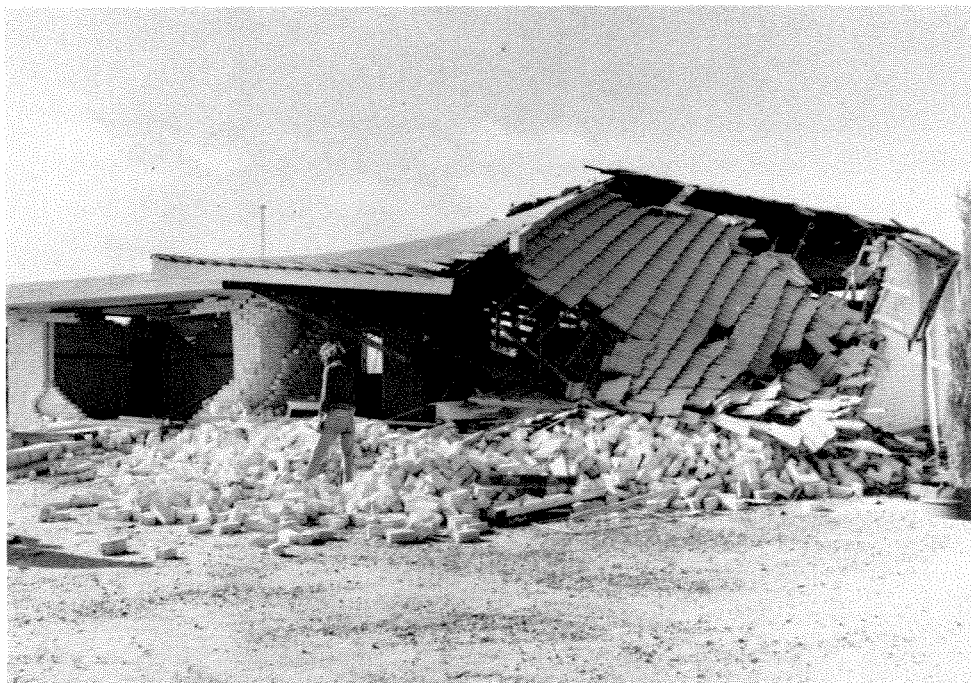
The Masonic Lodge was constructed of unreinforced silica-bricks with a heavy tile roof (Fig. 30). The building suffered almost total collapse.

Figure 30. Cadoux Masonic Lodge: the western walls collapsed westward causing partial collapse of the roof (photo: W.A. Newspapers) (GSA 18763)

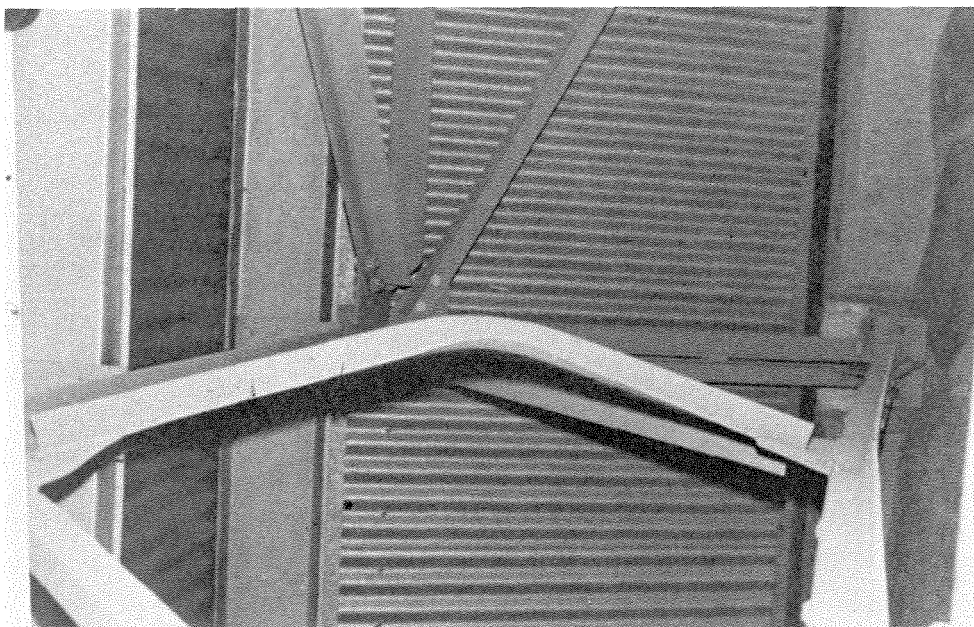
Figure 32. Distorted roof trusses, Co-operative Bulk Handling grain storage facility (GSWA 18765)

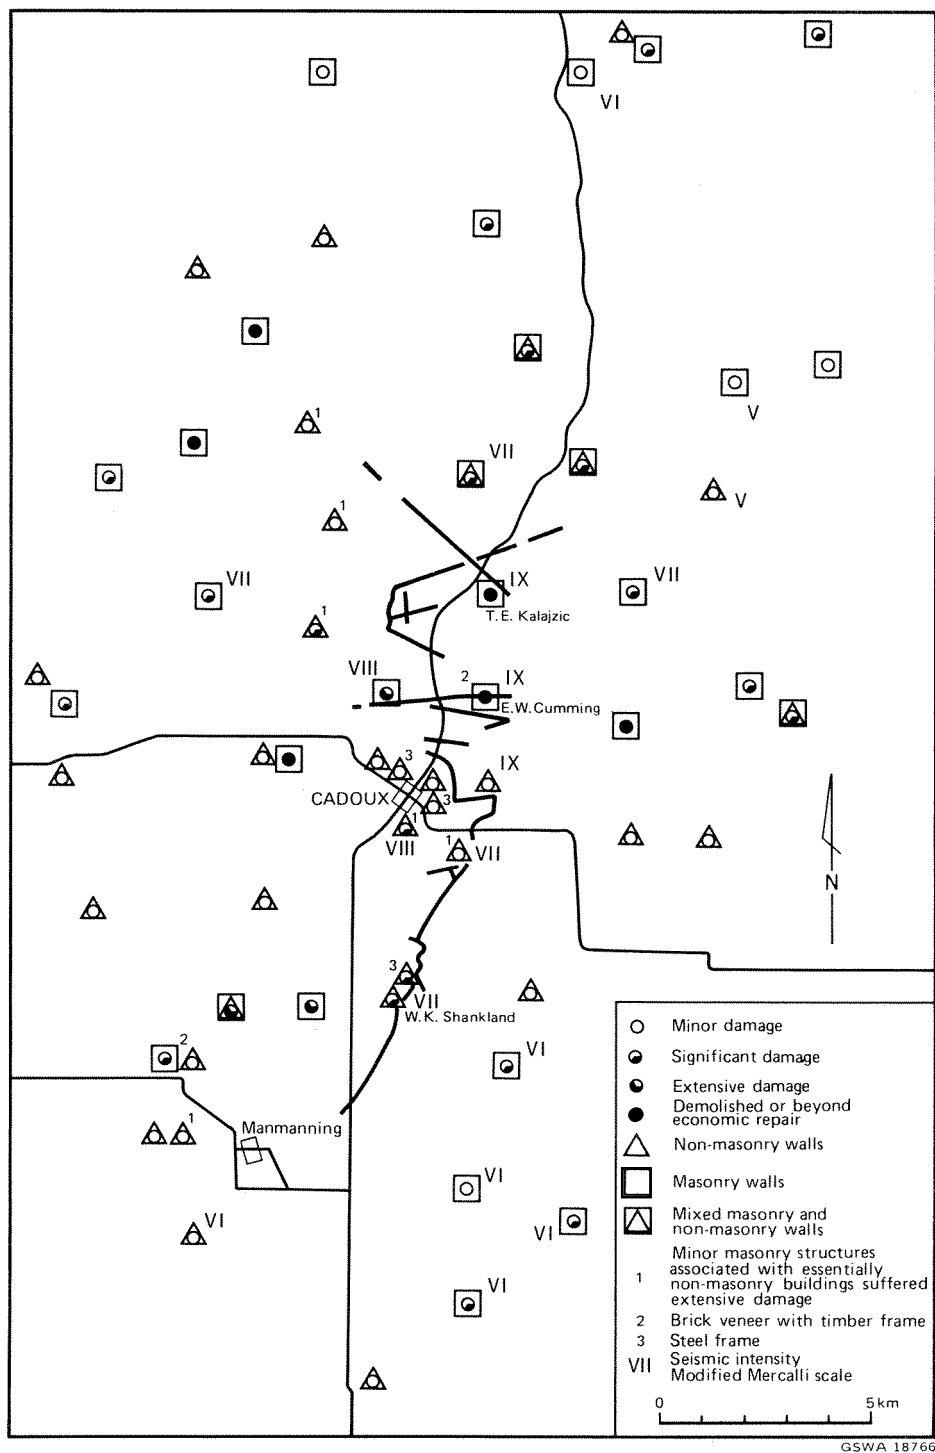
Figure 33. Damage to private dwellings in the Cadoux area

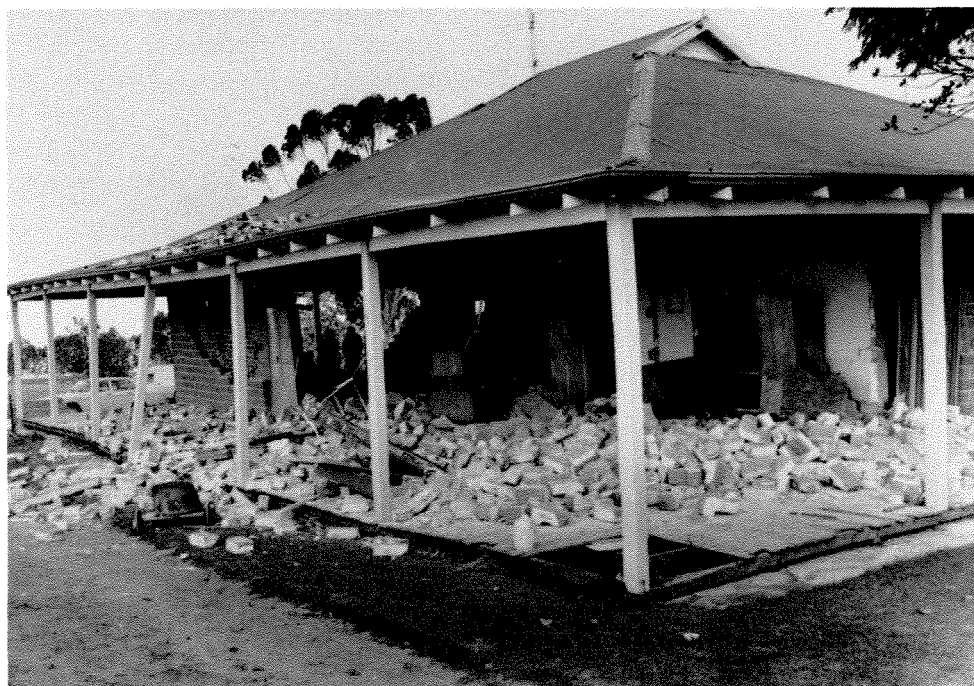
Figure 34. Damage to the house of Mr. E.W. Cumming: brickwork has collapsed while the timber-framed verandah and roof have remained intact (photo: W.A. Newspapers) (GSA 18767)

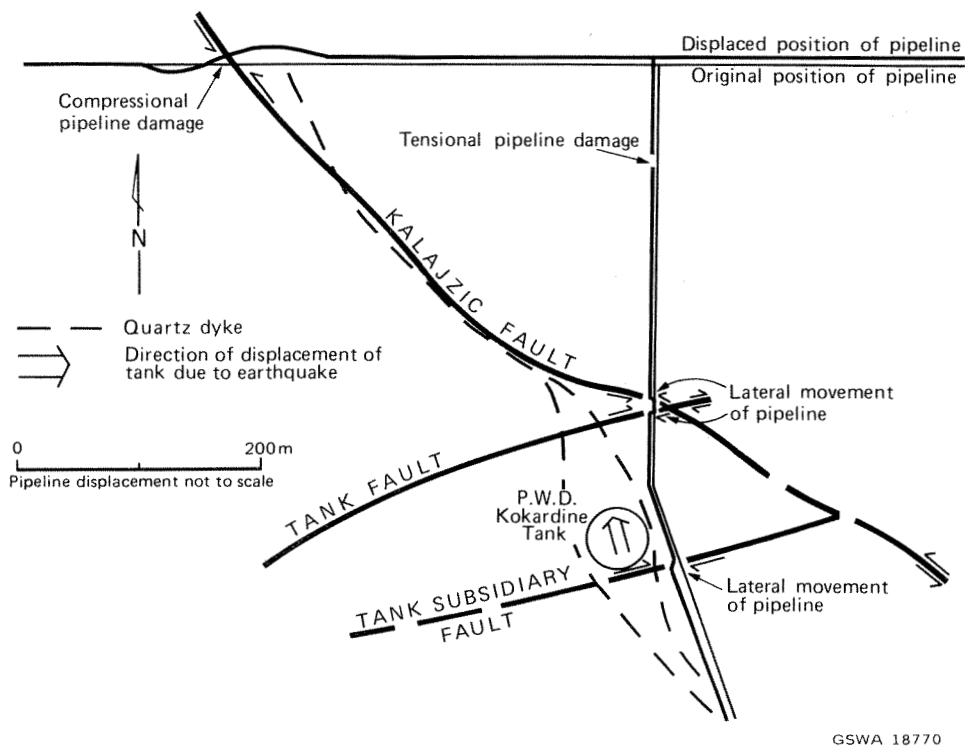
Figure 37. Earthquake damage to PWD pipelines in the vicinity of Kokardine tank. Relative movements are shown assuming the wedge between the Kalajzic and Tank Faults has remained stationary

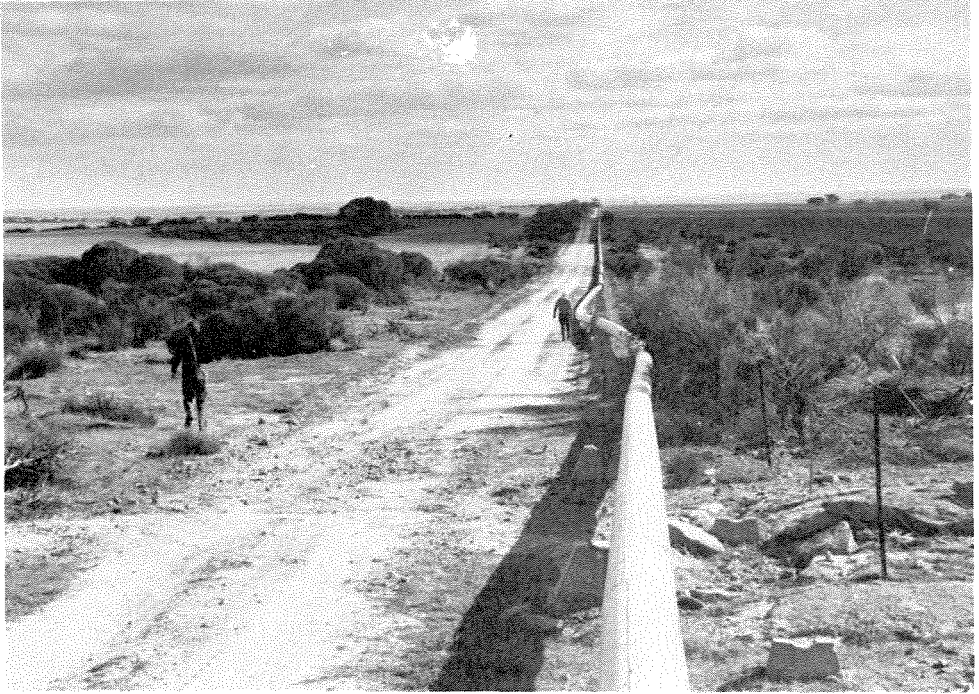
Figure 38. Damage to water pipeline where it crosses the Kalajzic Fault: the pipeline has failed through left-lateral movement and compression (see Fig. 39a) (GSWA 18771)

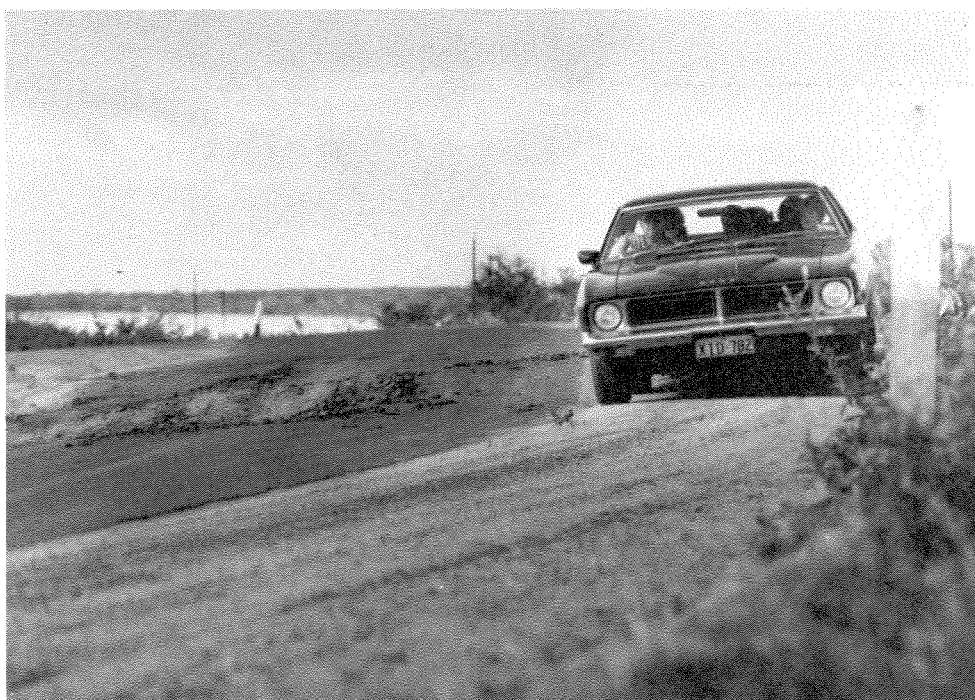
Figure 41. Road damage at the scarp of the Cumming Fault
(photo: W.A. Newspapers) (GSWA 18774)

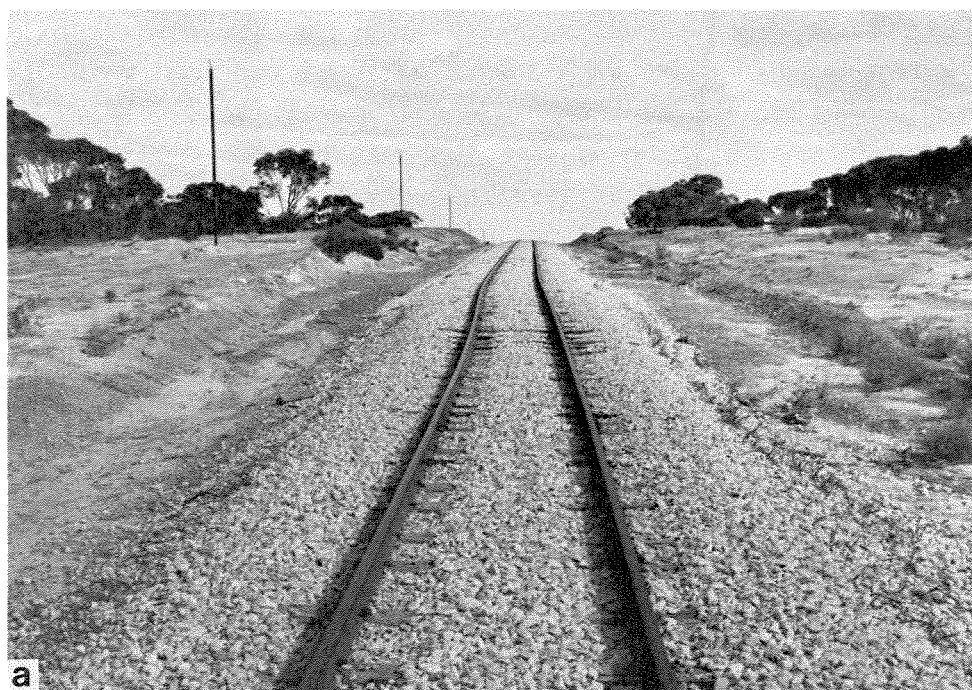
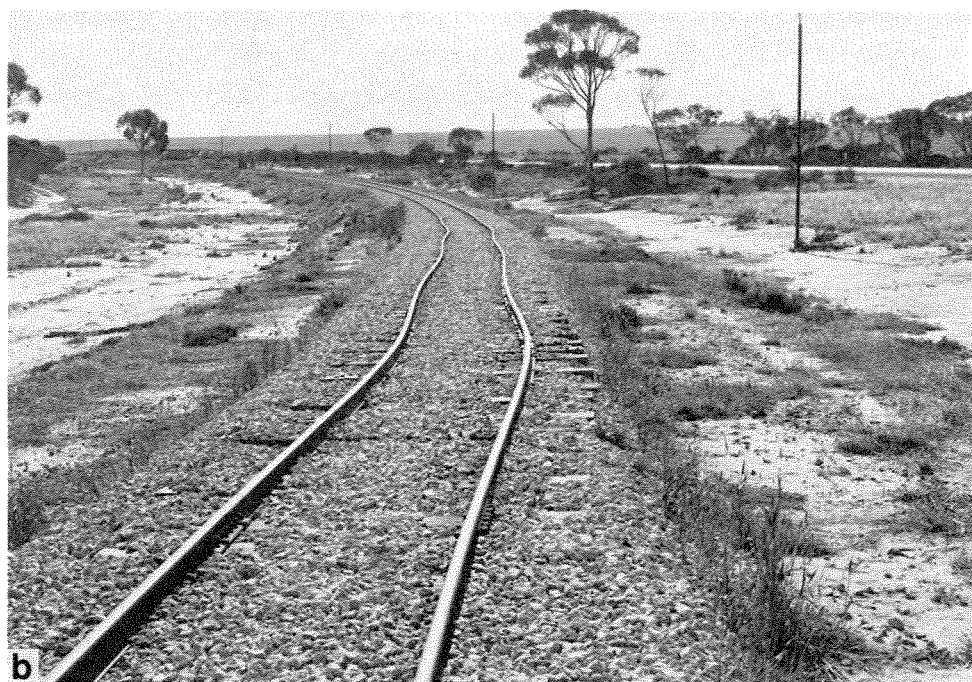
Figure 42. Damage to the railway line north of Cadoux:
(a) vertical and left-lateral displacement at the Kalajzic Fault, (b) compressional damage about 1.3 km north of Cadoux (GSWA 18775)

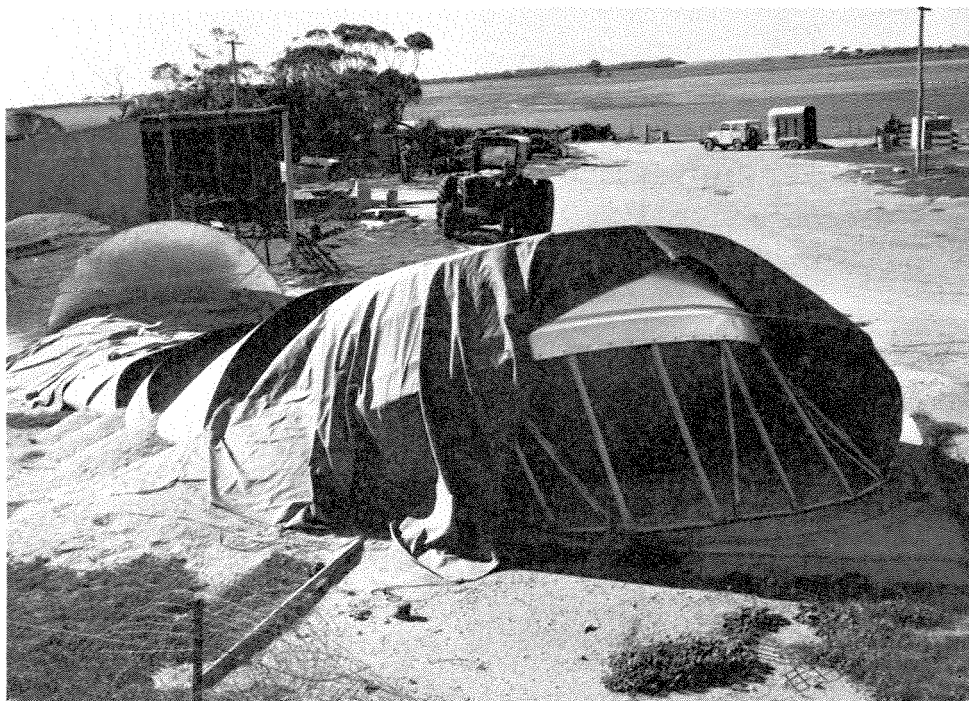
Figure 44. The collapse of a wheat silo on the Robb property: the silo has fallen to the northeast (047°) while the base has moved north (001°) (GSWA 18777)

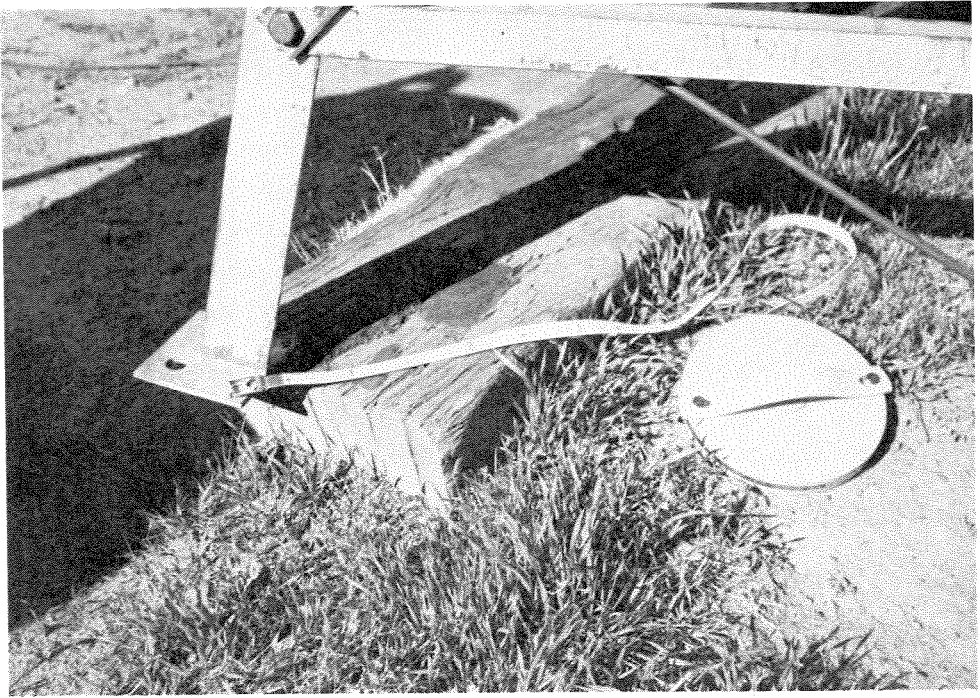
Figure 45. Movement of a fuel bowser in the Robb farmyard: a displacement of 0.21 m is visible for the foot of the structure (GSWA 18778)

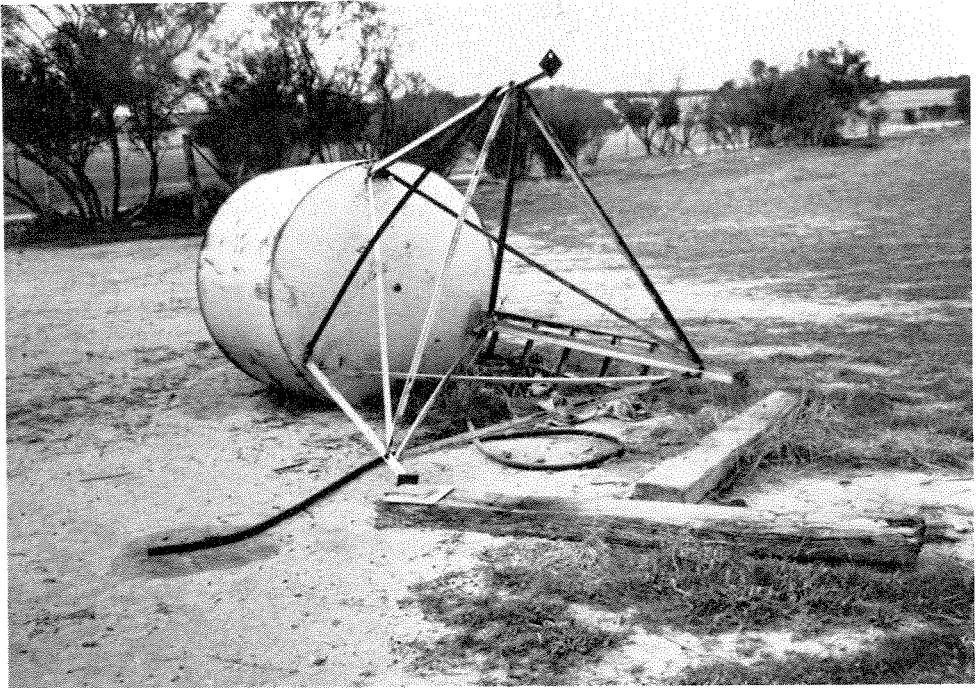
Figure 46. Overturned fuel bowser on the Robb property, looking northeast (GSWA 18779)
