## Managing an abandoned mine as a future resource: Ellendale diamond mine

T Read

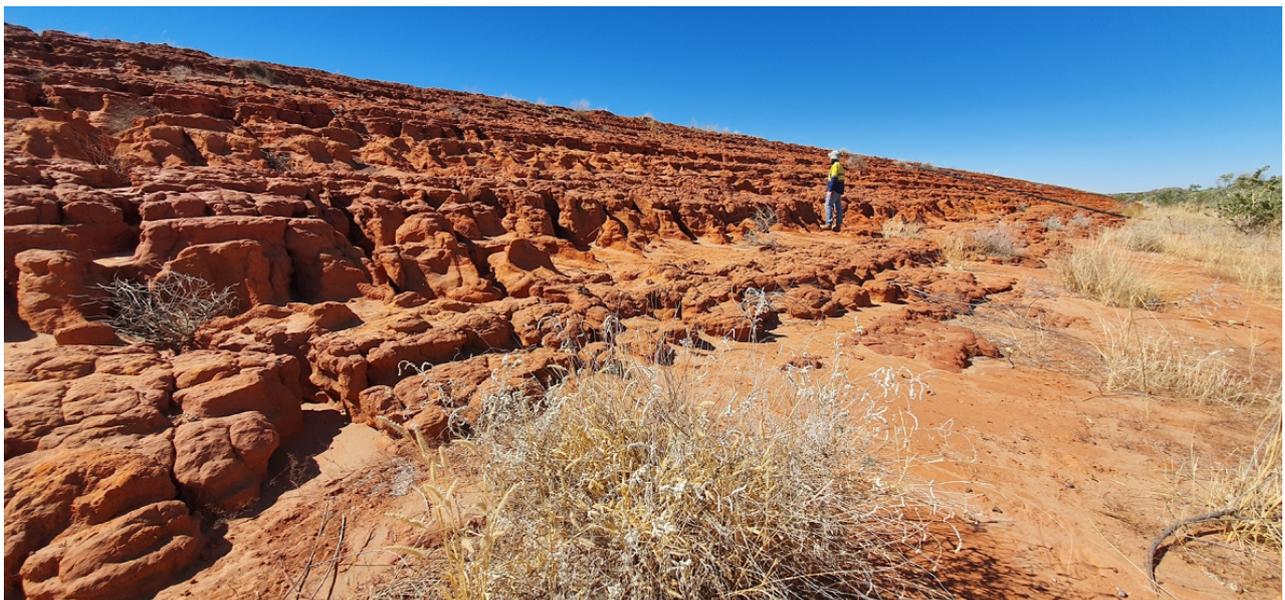
facilities (Fig. 1). These constructed landforms show varying degrees of erosion across the landform surfaces; on some structures the significant level of erosion has the potential to lead to wall instability and, under extreme conditions, wall failure if no remediation action is taken.

Studies undertaken on the main waste materials confirmed the cohesiveness of the material types as being too low to resist the erosive force of surface water flows across current batter designs. The weathering rate of the waste materials is a major contributing factor affecting erosional stability, with both siltstone and magmatic wastes breaking down from blocky waste rock to very fine-grained particles after being blasted, excavated, transported and exposed to the elements.

**Figure 1.** Ellendale 9 TSF-1D Cell 3 western wall, indicating significant gullying and sediment deposition. Gullies are greater than 2 m deep and extend from crest to toe. Remediation options will include rock armouring and modifications to the outer batter slope angle

Landform remediation options include the use of rock armouring utilizing the blocky sandstone material and adoption of modifications to the current batter design to reduce run-off potential. This will result in a more stable landform into the long term, reducing the potential for environmental impacts, and will preserve the Ellendale site for future use.
