**RECORD  
2003/9**

# **INVENTORY OF ABANDONED MINE SITES PROGRESS 1999–2002**

**by W. R. Ormsby, H. M. Howard  
and N. W. Eaton**

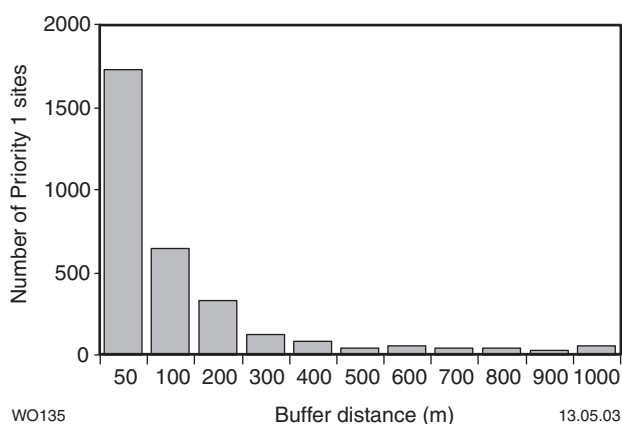
**Figure 7. Number of Priority 1 sites within a set buffer distance from a feature**

As can be seen from the data presented in Figure 7, there is a distinct break in the data at 200 m, suggesting that this is an appropriate buffer distance. Examining the resultant selected Priority 1 MH sites, non-selected sites, and WABMINES points in ArcView tested this suggestion, and the 200-m buffer distance was found to closely correspond with manual selections, with the exception of some areas now under infrastructure. Priority 1 MH sites in areas under infrastructure were manually deemed as being completed if fieldwork was finished in the surrounding area.

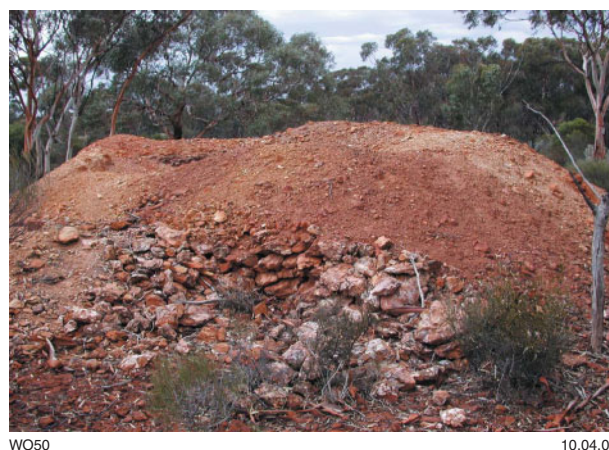
Figure 16. Typical shaft with a full bund, between 1 and 3 m high (13.5 km east of Boulder; Zone 51, MGA 369080E 6592470N)

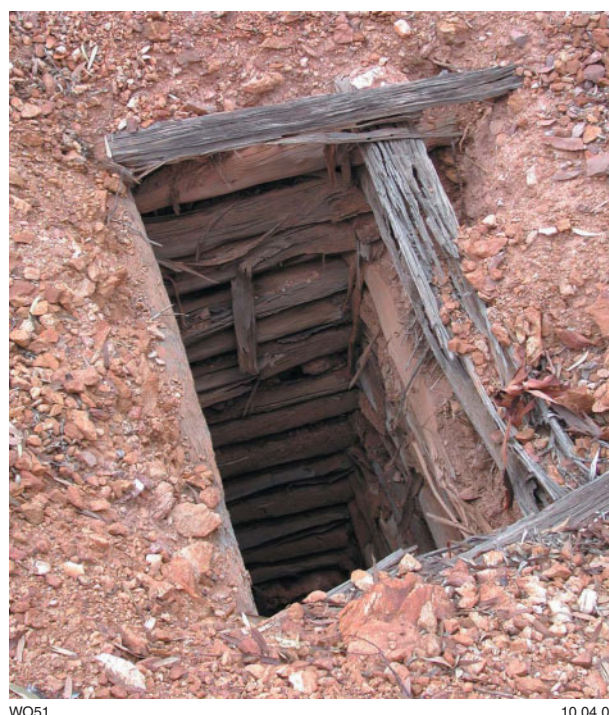
Figure 17. Timbered collar of the shaft shown in Figure 16. Shaft is 2.2 m long, 1 m wide, and 5–10 m deep

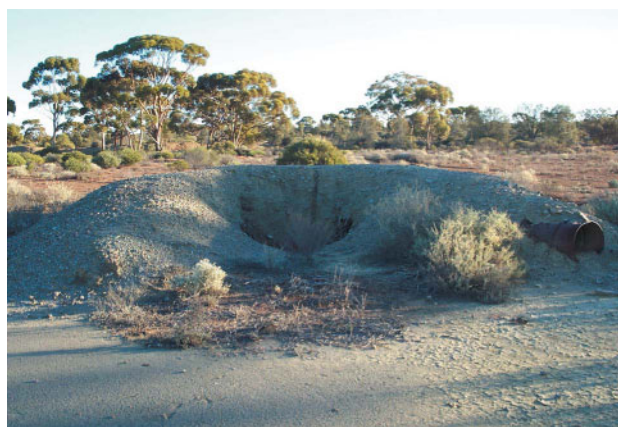
WO52

**Figure 19.** Typical shaft with a partial bund up to 1.1 m high. The shaft is 1.4 m long, 1 m wide, and 5–10 m deep (9 km northwest of Bardoc; Zone 51, MGA 330813E 6649318N)

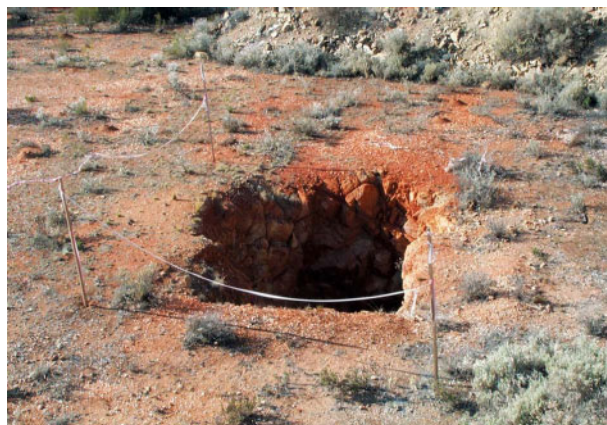
WO54

Figure 22. Shaft with no bund. The shaft is 3 m long, 1.5 m wide, and more than 10 m deep (1.5 km southeast of Broad Arrow; Zone 51, MGA 348497E 6624626N)

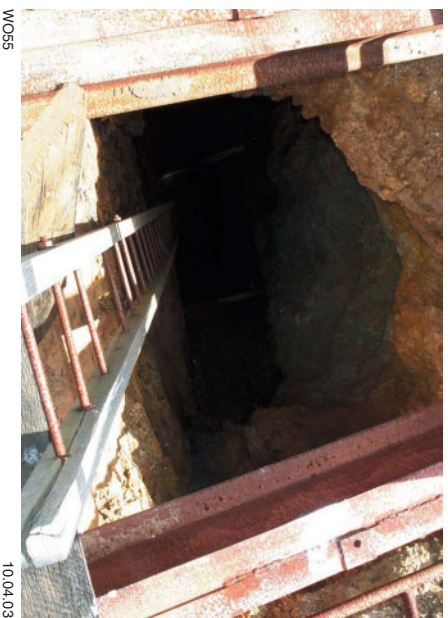
**Figure 24.** Shaft with ladder access (2 km northeast of Kundip; Zone 51, MGA 240126E 6269731N)

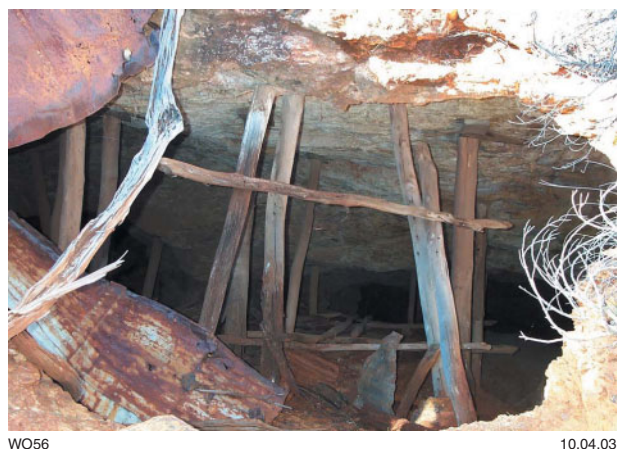
**Figure 25.** Open stope, 3 m long, 3 m wide, and 5–10 m deep, with a  $40^\circ$  dip (7 km north of Coolgardie; Zone 51, MGA 323408E 6580870N)

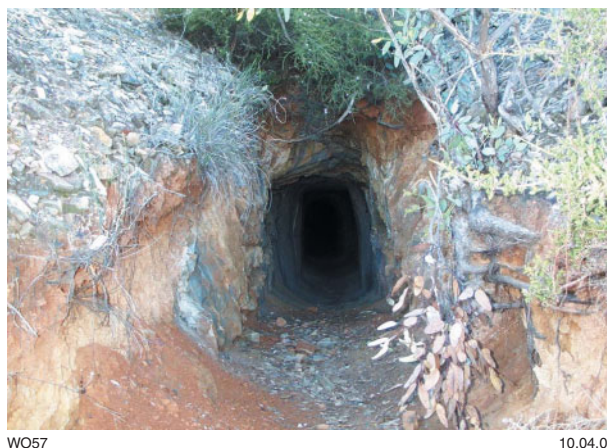
**Figure 28. Adit of 1.5 m height and 1 m width (9 km east of Ravensthorpe; Zone 51, MGA 235048E 6277910N)**

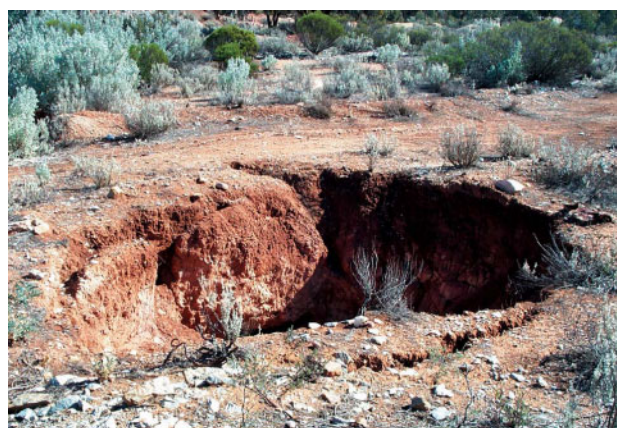
WO58

**Figure 30.** Subsidence caused by the collapse of underground workings. Feature is 3.5 m long, 2.5 m wide, and 1–2 m deep (10 km north of Coolgardie; Zone 51, MGA 323625E 6584400N)

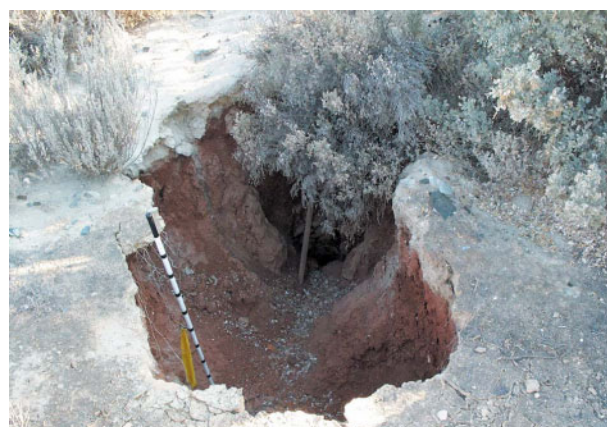
Figure 32. Large collapsed drillhole (0.5 km north of Kunanulling; Zone 51, MGA 314880E 6604500N). Stick is 1 m long

There are 53 collapsed drillholes recorded in the database, and these represent significant collapse or subsidence of a drillhole collar (Fig. 32). The extent of subsidence or collapse caused by a collapsed drillhole is small compared with most other underground features, with mean dimensions at the surface of 0.9 m length and 0.6 m width (Table 14).

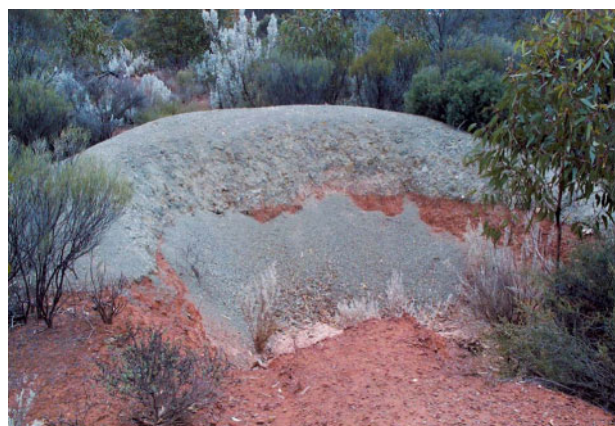
Figure 33. Typical collapsed shaft, 3 m long, 2 m wide, and 1 m deep, with a partial bund to 1 m height (5.5 km northeast of Coolgardie; Zone 51, MGA 327554E 6578720N)

The category of collapsed shaft has 1379 features recorded since its introduction in late May 2002. A collapsed shaft is less than 2 m deep, but shows evidence of greater original depth (Fig. 33). This evidence may include a substantial volume of bund material, or remnant collar material. Collapsed shafts are now most commonly between 1 and 2 m deep (Fig. 34a).

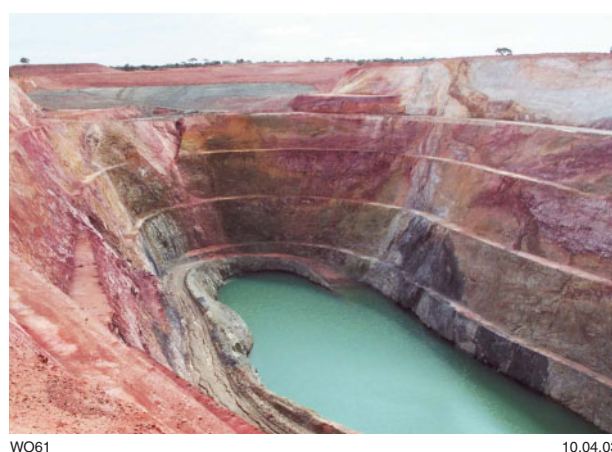
Figure 36. Typical deep pit/quarry, 300 m long, 180 m wide, and more than 20 m deep, with a limited access ramp (1.5 km south of Broad Arrow; Zone 51, MGA 339482E 6629793N)

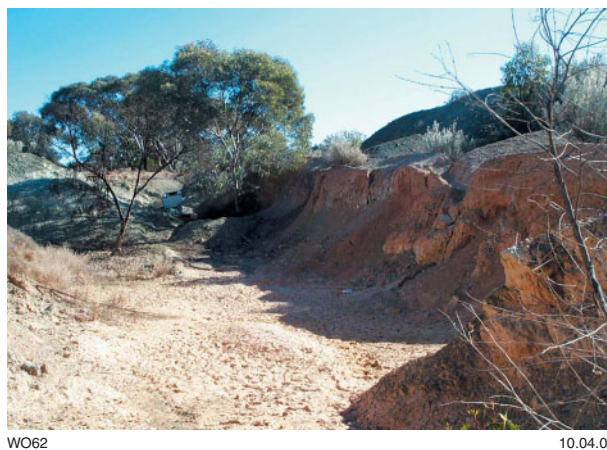
**Figure 38. Typical shallow pit/quarry, 40 m long, 10 m wide, and 2.6 m deep (6.5 km northeast of Coolgardie; Zone 51, MGA 329220E 6579005N)**

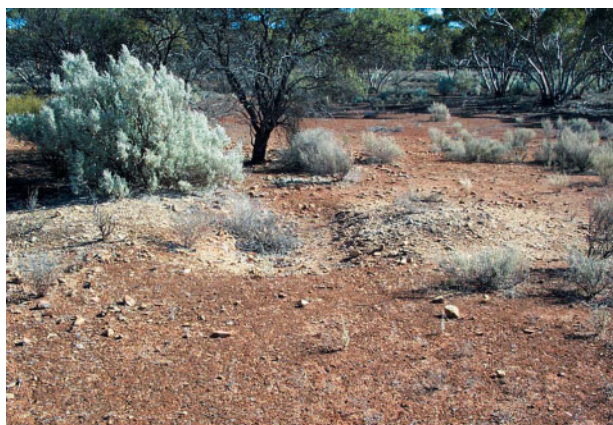
**Figure 45. Typical old shallow working, less than 0.5 m deep (6 km south of Coolgardie; Zone 51, MGA 324062E 6568392N)**

Shallow workings constitute about 53% of the WABMINES database, and include pits, cavities, holes, or other uncovered excavations, that are less than 2 m deep (Fig. 45). Shallow workings have been subdivided into two types to highlight the different morphologies resulting

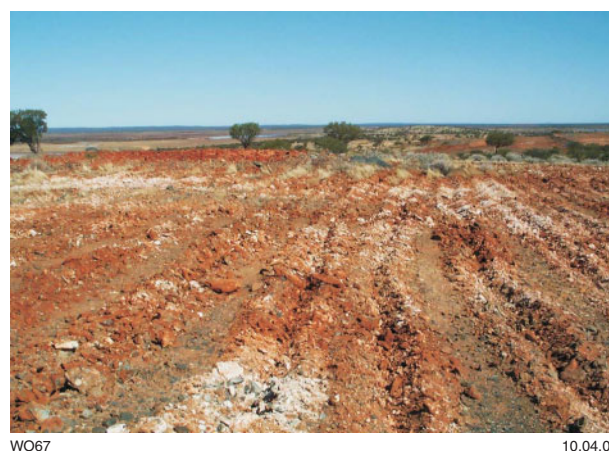
**Figure 49. Typical rehabilitated area showing ripped ground over workings (34 km north of Leinster; Zone 51, MGA 259148E 6940971N)**

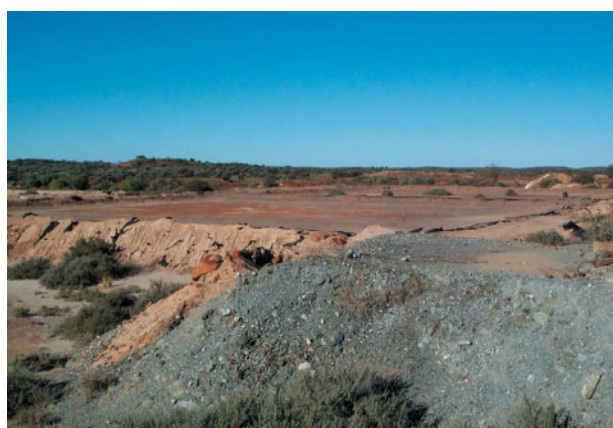
**Figure 56.** Typical leach pad, 75 m long, 40 m wide, and 2 m high; note the plastic lining (1.5 km south of Sandstone; Zone 50, 725744E 6900721N)

A leach pad is composed of mineralized materials stacked to permit wanted minerals to be effectively and selectively dissolved by application of a suitable solute (American Geological Institute, 1997). Abandoned leach pads are not common, with only 36 records in WABMINES (Fig. 56). They have mean dimensions of 73 m length, 45 m width, and 2 m height (Table 35). Wall-dip angles vary less than for tailings dams, ranging from 30° to 80°. Dispersion was recorded for seven leach pads for a distance of up to 800 m. Almost all leach pads (97%) were visible from a moderate distance (Table 36).

Most leach pads contain visible plastic lining (83%), and occasionally scrap metal or general rubbish is present. The majority of leach pads are rectangular (83%) and partially revegetated (75%). Only one pad was fenced.

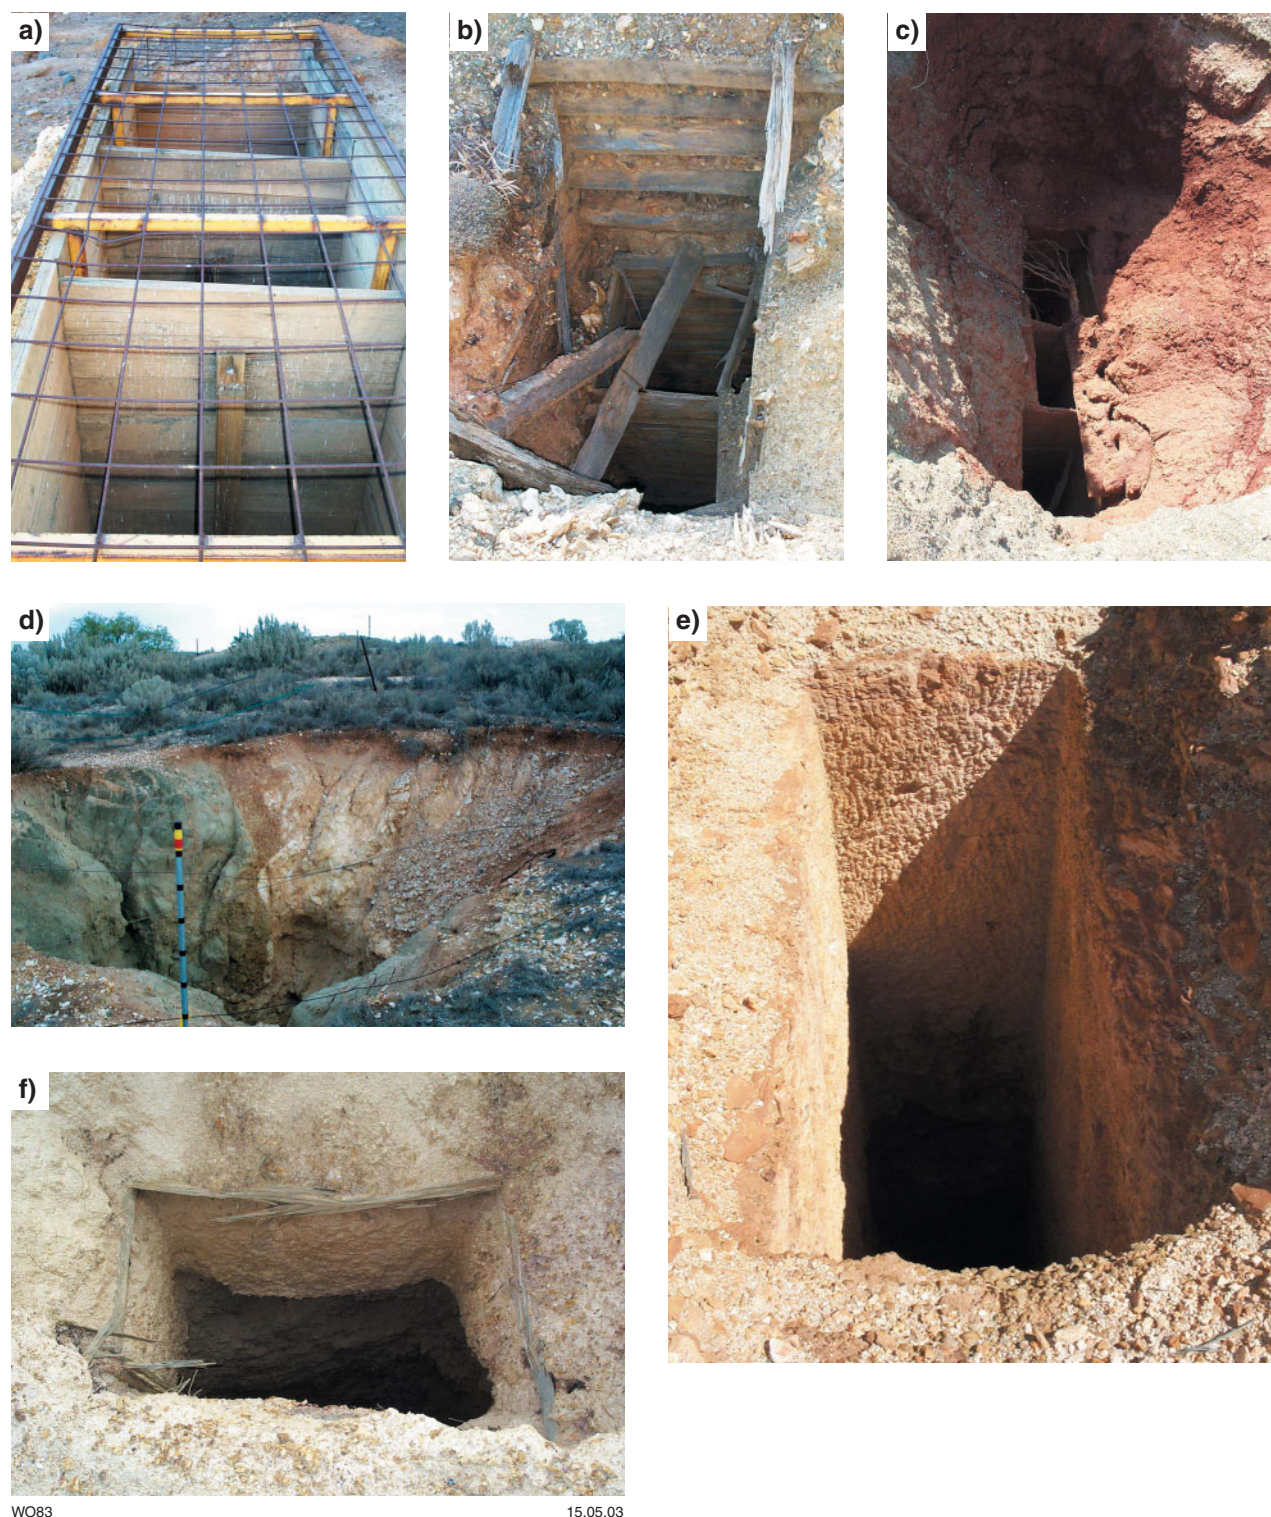
**Figure 64.** Various types of fences around shafts (with length  $\times$  width): a) poor-quality, collapsing, single-strand barbed wire and star picket fence, partial mesh seal and shaft (2  $\times$  1 m, >10 m deep) with no bund (4.5 km south of Coolgardie; Zone 51, MGA 325374E 6569731N); b) good-quality 2.5 m-high, three-strand barbed wire and close-spaced wire fence, and welded steel plate seal over a shaft (3  $\times$  2 m) and surrounding full bund (10 km southeast of Kunanulling; Zone 51, MGA 320385E 6595400N); c) typical fence, 1.2 m high, consisting of one strand of barbed wire and wide-spaced wire mesh with star picket posts, surrounding a shaft (1.5  $\times$  1.2 m, 5–10 m deep) with a full bund (6 km south of Bardoc; Zone 51, MGA 337874E 6636968N); d) damaged, three-strand barbed wire and close-spaced wire-mesh fence, with steel posts and cross beams, surrounding a shaft (2  $\times$  1.2 m, >10 m deep) with a full bund (in Kalgoorlie–Boulder; Zone 51, MGA 355788E 6594860N)

Fences and seals can indicate that a hazard is present, and prevent access to hazards. Fence and seal effectiveness ranges from poor (Fig. 64a) to very good (Fig. 64b).

A minimum of a single strand of wire between star pickets does not provide a barrier to entry, but can indicate that a hazard is nearby, even in the dark. However, these types of fences can be easily broken or damaged and may not even prevent accidental access. In Figure 64a the fence was placed too close to the shaft collar, and one star picket has fallen into the expanding area of collar subsidence. Two or three strands of plain or barbed wire are better than one, but still barely hinder access.

A more effective and quite common fence type consists of wide-spaced wire mesh or ringlock netting, normally with one or two strands of barbed wire at the top, and star pickets (Fig. 64c). These fences can prevent accidental access for people and livestock, and can deter wildlife. They are not normally intended to bear much load, and therefore tend to slacken with time. Occasionally this type of fence is constructed with sturdy, stained wooden or steel posts in a similar manner to agricultural fencing, and can be quite durable.

A 2 m-high chain-mesh fence supported with steel posts can be very effective in preventing entry by livestock, wildlife, and most people, especially if one or more strands of barbed wire are added to the top (Fig. 64b). However, determined people can either push underneath, or cut through this type of fence as shown in Figure 64d. Any type of fence can be vandalized, or have parts stolen for materials. For example, the upper steel supporting poles are missing in some fences of this type, resulting in a weakened structure that is prone to failure.

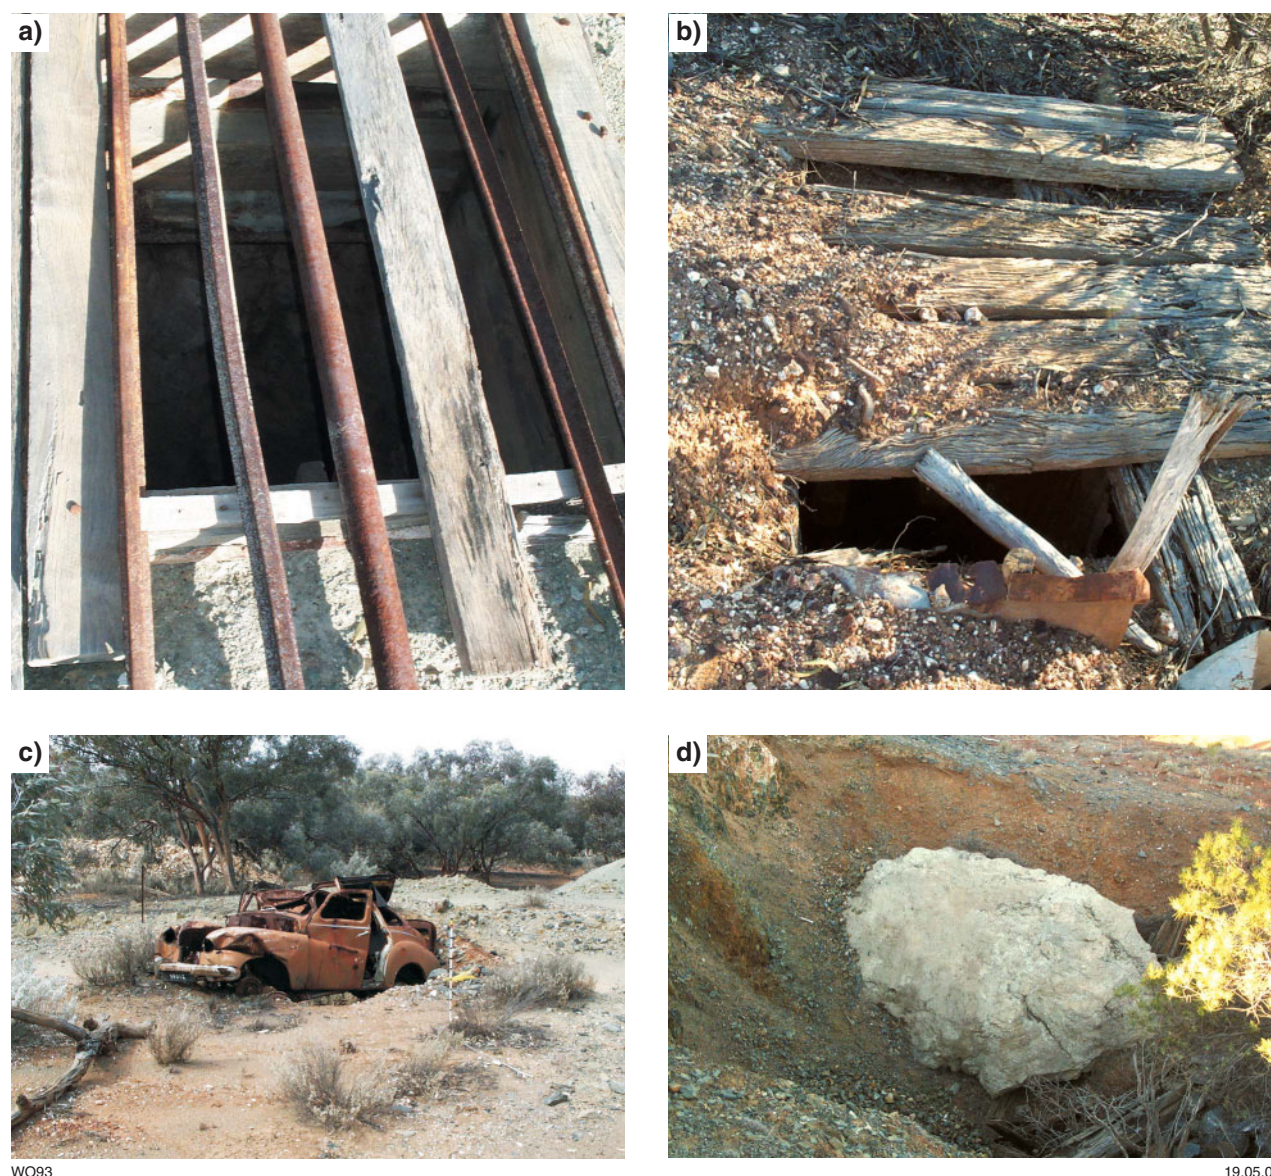
**Figure 65.** Various types of seals: a) partial seal of loose timber and steel rails has improved the visibility of this shaft ( $1.3 \times 1.3$  m, >10 m deep), but may not prevent accidental entry (6 km northeast of Coolgardie; Zone 51, MGA 328239E 6579062N); b) partial seal of loose timber partially conceals this shaft ( $1.5 \times 1$  m, 5–10 m deep; 10 km southwest of Coolgardie; Zone 51, MGA 319700E 6565450N); c) car disguises a shaft ( $3 \times 3$  m, 5–10 m deep), but may not protect from accidental entry (3.5 km northeast of Coolgardie; Zone 51, MGA 327140E 6576810N); d) apparently inverted concrete seal in a collapsed underground working, now  $5 \times 5$  m, and 2–5 m deep (8 km south of Coolgardie; Zone 51, MGA 322709E 6566601N)

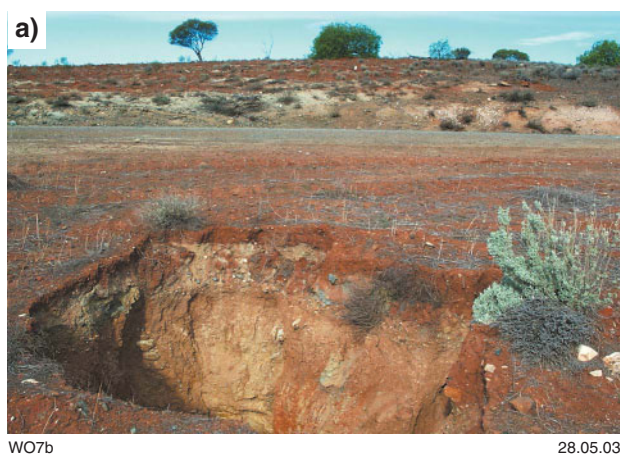
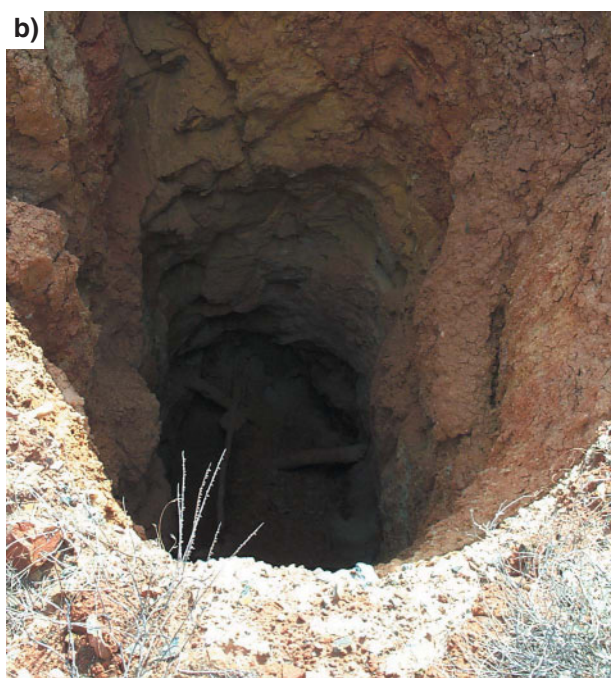
**Figure 68.** a) Subsidence of an abandoned working (4 × 3 m, 5–10 m deep) adjacent to the road as shown in Figure 67 (8 km south of Coolgardie; Zone 51, MGA 322782E 6566561N); b) downhole view of the subsidence shown in (a)

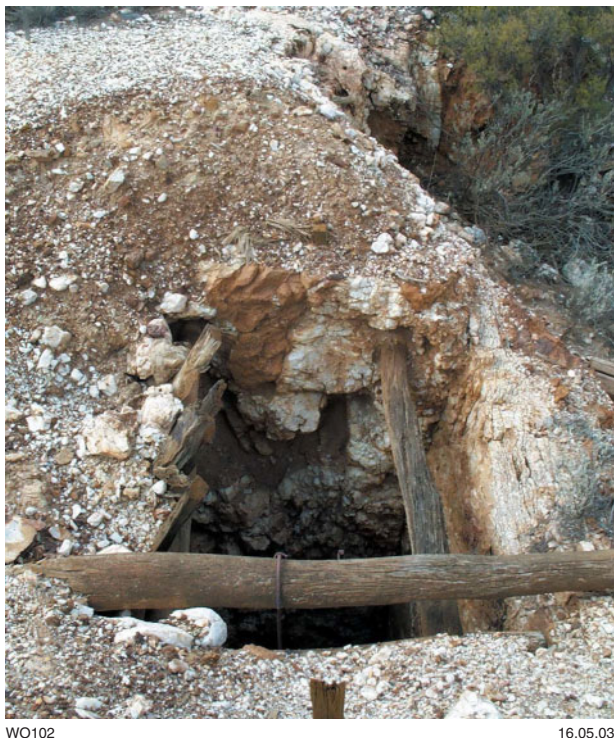
**Figure 70. Shaft (2 × 1.5 m, 10–20 m deep) on a sheared contact (290° strike and 80°N dip) of a highly fractured and folded quartz vein (2 km northeast of Coolgardie; Zone 51, MGA 326060E 6575260N)**
