BULLETIN 126

THE MECKERING AND
CALINGIRI EARTHQUAKES
OCTOBER 1968 AND
MARCH 1970

by
F. R. GORDON and J. D. LEWIS

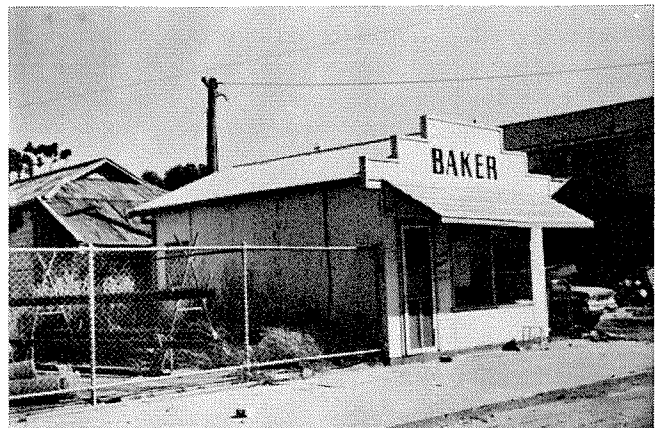
B

5. Damage to buildings in Meckering:

- (a) Wooden house in Johnson St, distorted but intact.
- (b) The baker's shop, of asbestos, on the east side of the Railway Hotel.
- (c) House in Dreyer St. The concrete walls are intact but the concrete-block gable, and the granite masonry at the rear, have collapsed.

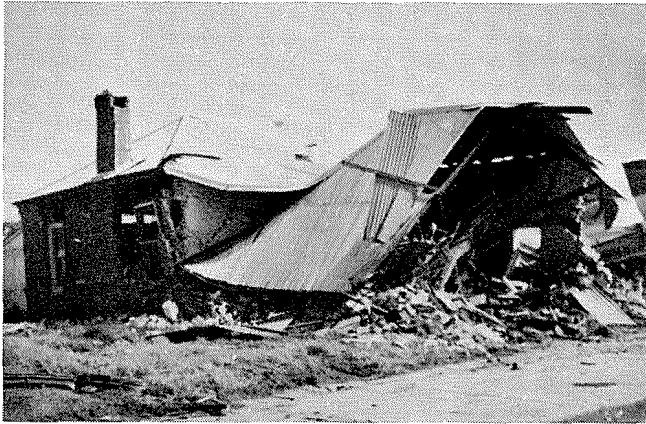
A

6. Damage to brick houses in Meckering:
- (a) Older type of double-brick house in Dreyer St.
 - (b) Modern double-brick house, Dreyer St.
 - (c) Modern brick house. Note the diagonal fractures in the brickwork and the anticlockwise rotation of the upper parts of the pillars (Photo: B.M.R.).

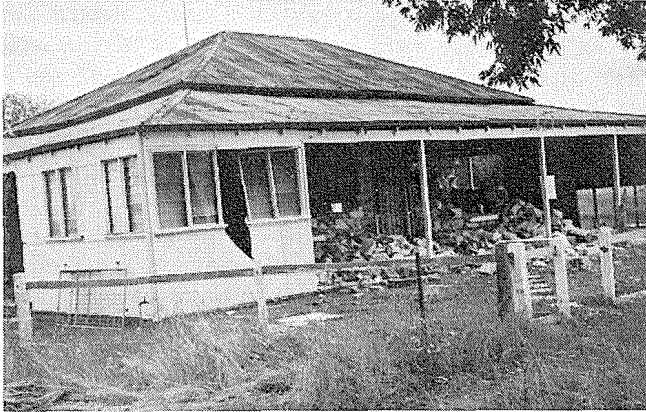
Combinations of various types of block with brick or concrete proved unsound because of the differing periods of vibration of the materials. However, several houses of unit masonry had wooden or asbestos lean-tos built on, and these survived while the main building collapsed (Fig. 7a).

A notable feature was the integrity of galvanised iron roofs, as in many cases the walls had collapsed, leaving the roof intact on top of a pile of rubble or on the internal partition walls (Fig. 7a, c). The iron roof appeared to possess a stressed skin action of considerable strength (Lay, 1968). Tiles, particularly ridge tiles, were dislodged in most instances, and there was definite evidence that the inertial weight of a tiled roof contributed substantially to structural damage by forcing the walls of houses apart.

7. Damage to mud-brick houses in Meckering:

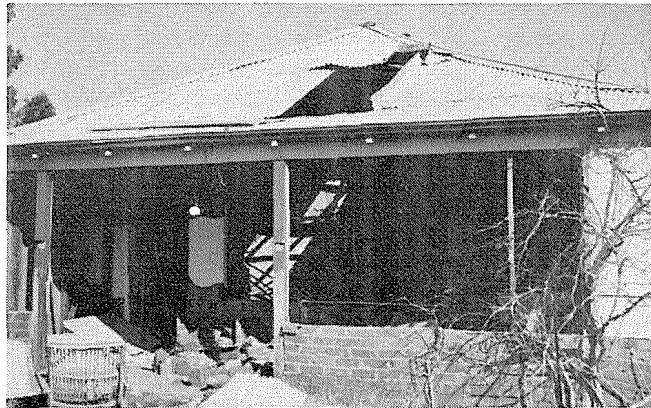
B

Brick and block chimneys were an obvious earthquake hazard because of the manner in which they broke off at roof level (Fig. 7b). Several wooden or asbestos houses otherwise intact were damaged by falling chimneys.

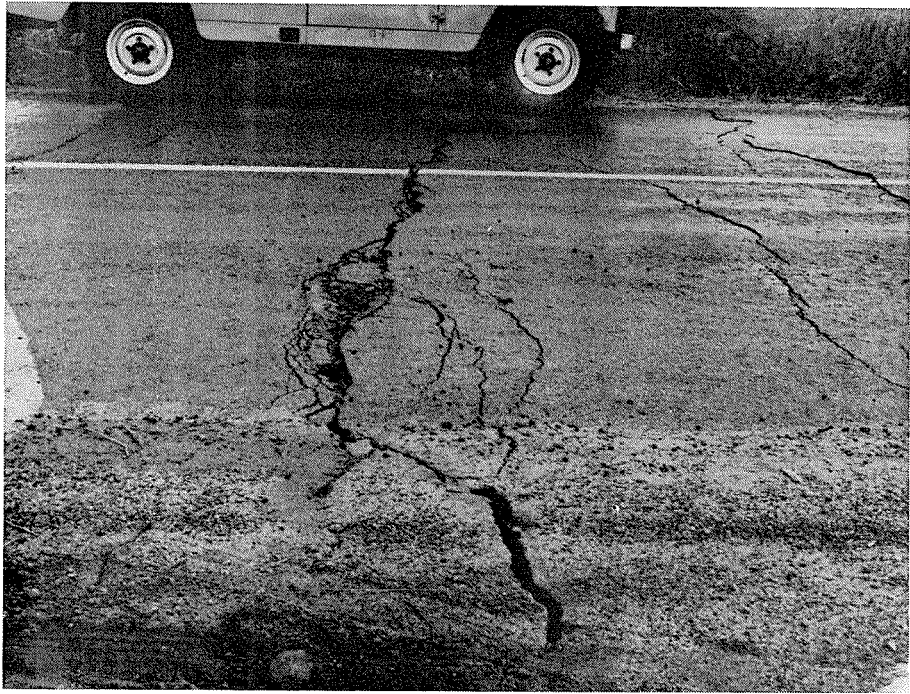
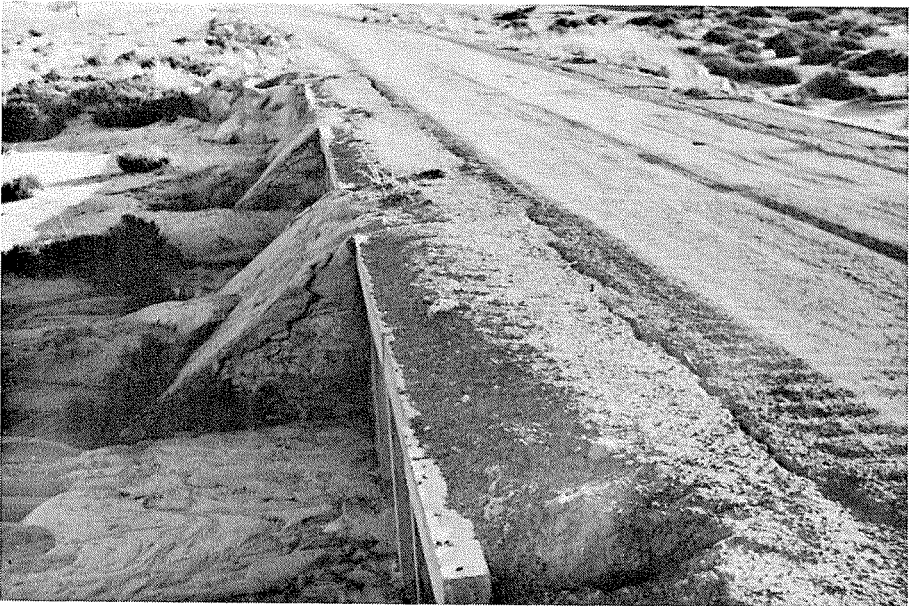
13. Road damage:

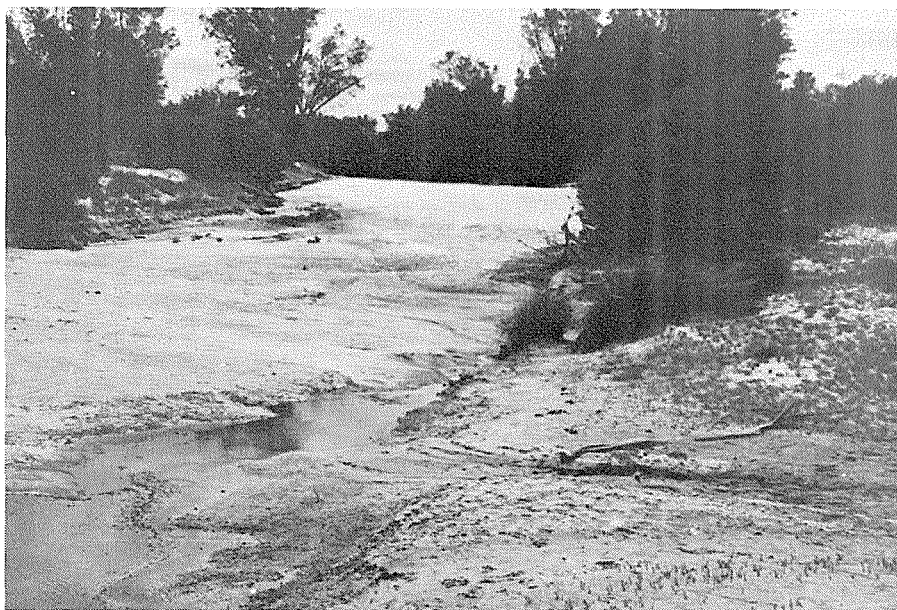
The general parallelism of the fault scarp and the river course meant that the channel was not intercepted by the fault until the river commenced a southwesterly course, about 10 km southwest of Meckering (Fig. 14). The river bed was disrupted by an uplift of about 1.5 m, but because of the parallelism of scarp and channel the grade of the river was not substantially reduced in the section between the Great Eastern Highway and the fault. In

14. The Meckering Fault scarp as it crosses the Mortlock River, 10 km southwest of Meckering.

the vicinity of Meckering, the uplift of the eastern block was not as great as at the scarp, and the grade of the river was flattened from approximately 0.91 m/km to 0.76 m/km (Green, 1969). The tilting of the upraised block had the effect of raising potential flood levels in Meckering by 12 cm.

Near the Mortlock River, the soil changed from sandy to a red-brown loam overlying weathered rock, and the thrust scarp, 1.5 m high, had a steep front face and prominent longitudinal tension fractures. For 200 m this well-defined scarp ran parallel to, and 60 m west of, the Mortlock River, but it then changed direction to run due east to intersect the river. The scarp was then joined by a series of continuous tension fractures which originated from the back of the main scarp further north and ran southwards along the west bank of the river. The fault 'nicked' the main river channel at this point, but again changed course and did not cross: instead, it continued due south as a featureless sandy ridge. It was not until 300 m further south that the fault crossed the Mortlock River, uplifting its sandy bed by 1.32 m (Fig. 14).

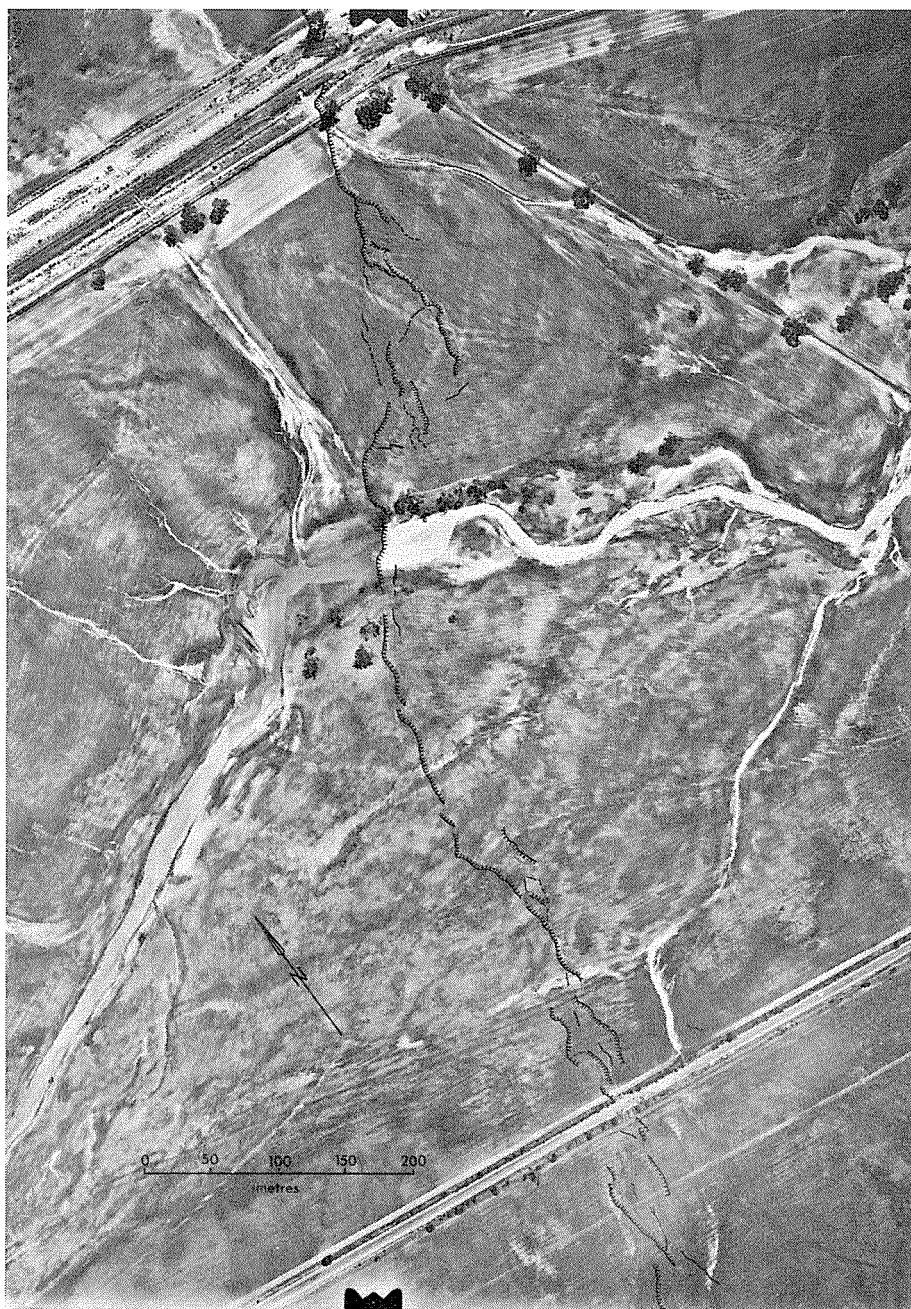
15. A small stream, west of Meckering, dammed by the Meckering Fault. The stream flows east and on the uplifted block the stream bed has dried out (air photo W.A. 1112, 5150).

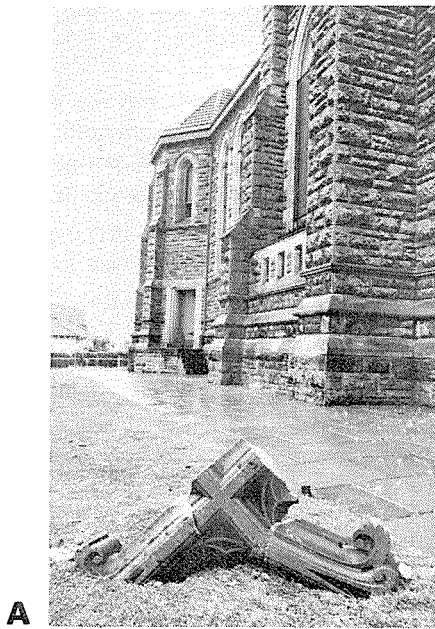
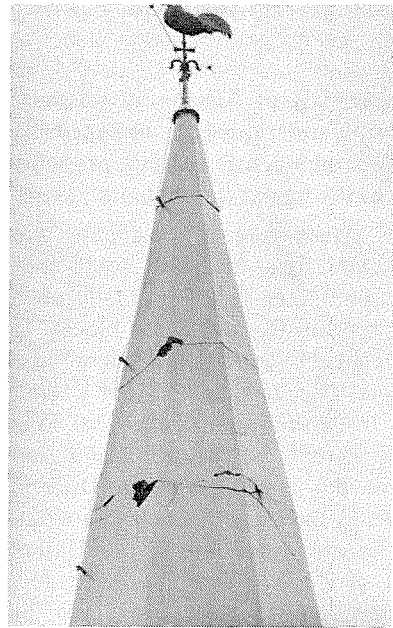
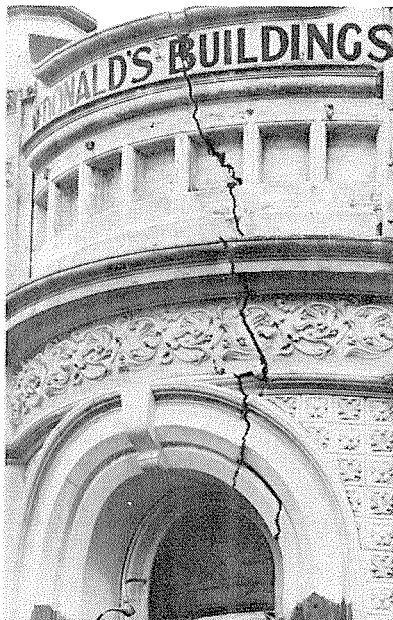
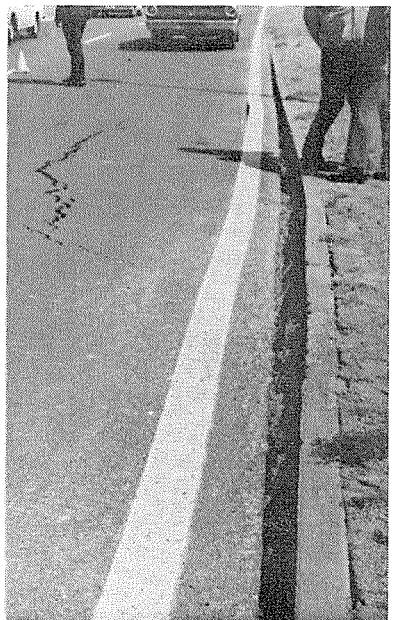
17. Earthquake damage in the Perth Metropolitan Area:

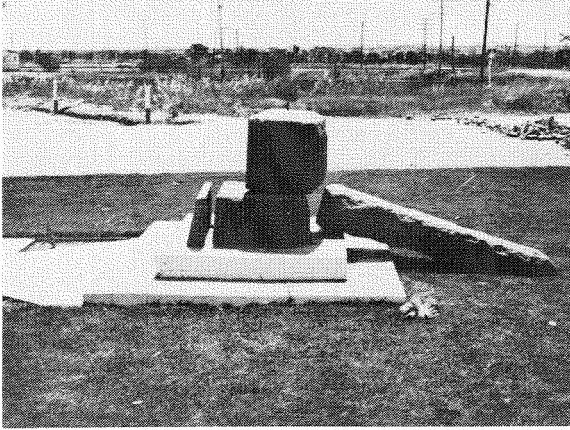
The War Memorial consisted of a tapered granite column, 1.98 m long with a 0.53×0.53 m base, sitting on two pedestal blocks and facing 235° . A 1.9 cm iron pin, 7.6 cm long, in the top pedestal block fitted into a 1.9 cm diameter hole in the centre of the column. The final disposition of the memorial is shown in Figures 22a and 23. The granite column was overturned towards 033° , and displaced a horizontal distance of 53.3 cm. The column also showed a small clockwise rotation of about 12° , and the base was displaced about 2.5 cm to the south. The top pedestal stone, with the pin, was displaced 17.8 cm towards 033° and also showed clockwise rotation of about 5° .

An examination of the pin which secured the column to its pedestal showed that it was unbent and that rust scales were intact. This indicates that the column was thrown more or less vertically from its position by the initial shock. Two small chips were missing from the northeast edge of the base of the column, but the mortar in the centre of this edge remained attached to the pedestal. Along the southwestern edge of the base of the column the rim of mortar remained intact. This indicates that the column was not rocked back and forth while riding up the pin, although chips indicate a slight initial tilting to the northeast which was insufficient to bend the pin. In its final resting place the column was slightly overhung by the displaced pedestal block, showing that the horizontal movement of the block took place after the overthrow of the column.

22. Overturned monuments in Meckering:

- (a) Meckering War Memorial.
- (b) Cullinane memorial, Meckering Cemetery, with grave No. 28 in the background.
- (c) Grave No. 28, Meckering Cemetery.

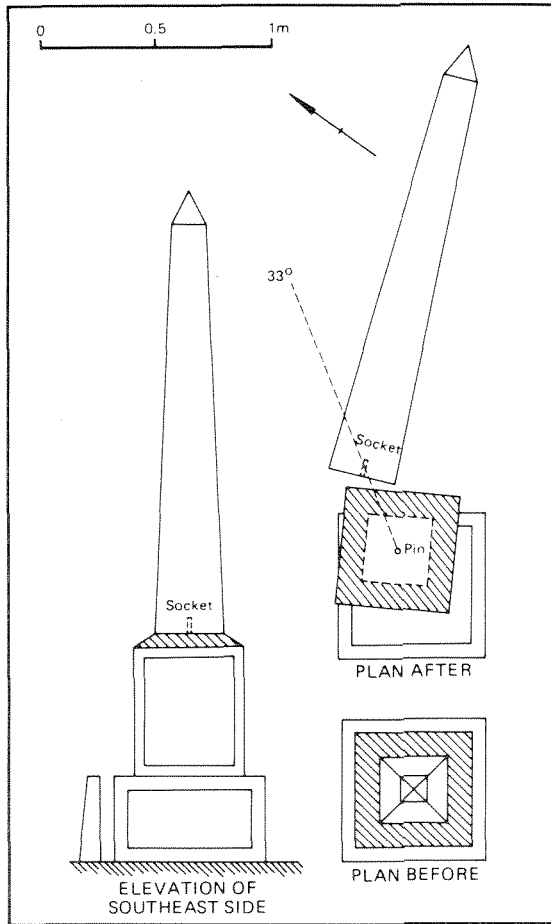
23. The Meckering War Memorial, before and after the earthquake.

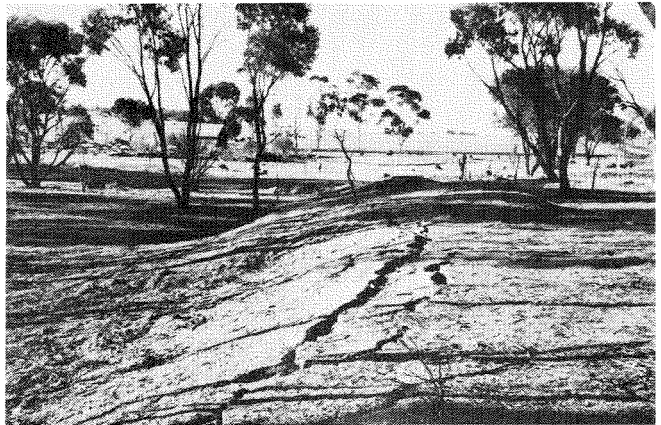
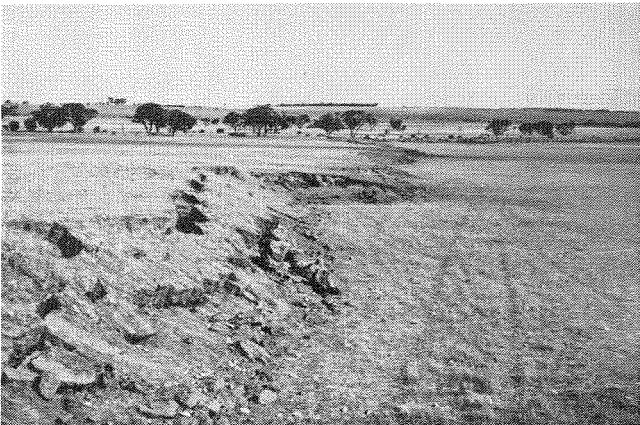
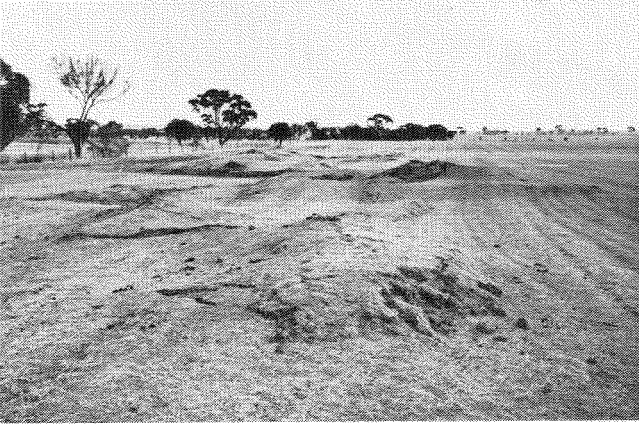
29. The Meckering Fault:

- (a) Alternating supratherusts and subtherusts in lateritic soil, 4 km north of Meckering.
- (b) The main fault scarp near the Dowerin Road-Wilson Street intersection north of Meckering. A convex scarp ridge with longitudinal tension fissures.
- (c) Rock overhanging scarp, fallen under its own weight. Note the presence of plentiful quartz pebbles. Meckering Fault, 450 m north of railway intersection.

Half a kilometre north of the railway, the zone of fracturing at the fault scarp was narrow, but the fault plane was usually hidden by the collapse of the toe of the upthrown block (Fig. 29c). However, three readings of the dip of the fault plane were possible in the 30 m section where 30 cm of soil and laterite overlaid a wine-brown ferruginised weathered rock. The dip readings were 42° , 44° and 47° , and the relative vertical displacement on the fault was 1.52 m with a similar amount of dextral strike slip. A little farther south, a dip of 48° was measured, and slickensides plunging 57° to the north were visible on the polished fault plane.

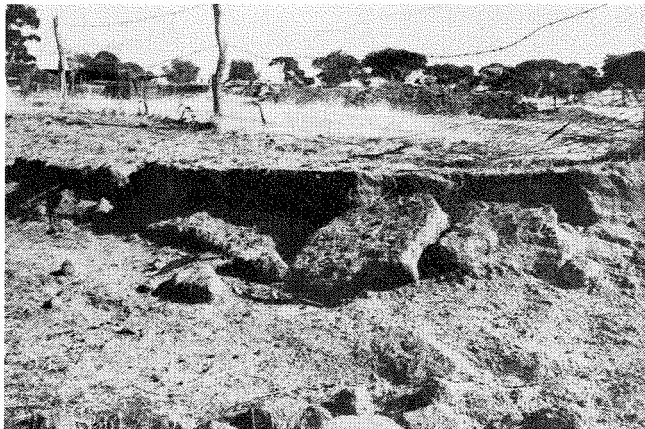
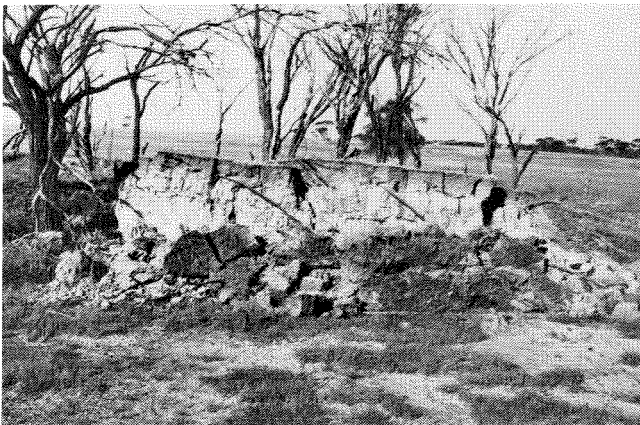
30. The Meckering Fault:

- (a) Complex pattern of ground fracturing in cohesive lateritic soil near the Dowerin Road-Wilson Street intersection. Both supratherusts and subthrusts are common.
- (b) Dermal subthrusts in laterite near the Goomalling Road-Wilson Street intersection. The main scarp is visible in the background, and the plane of the subthrust dips at 22° .
- (c) Dermal supratherust in laterite, 500 m south of Koolbunine Road.

fractures and a few fissures oblique to, and at the rear of the fault trace. As the depth to underlying weathered rock decreased, however, the scarp outline became sharper, and large blocks of laterite were uplifted by the fault (Fig. 30c).

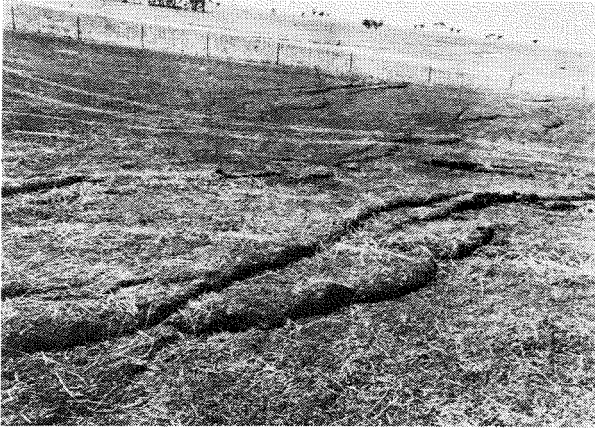
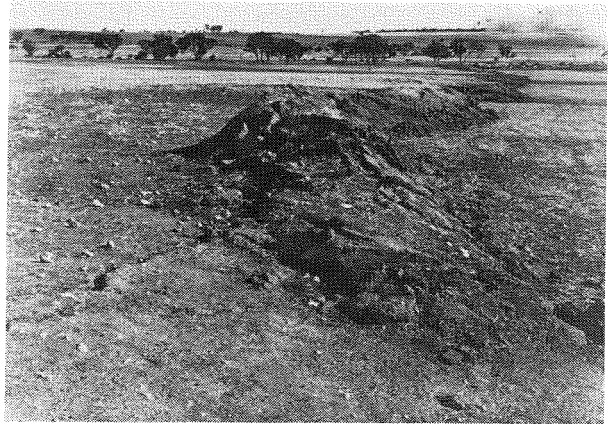
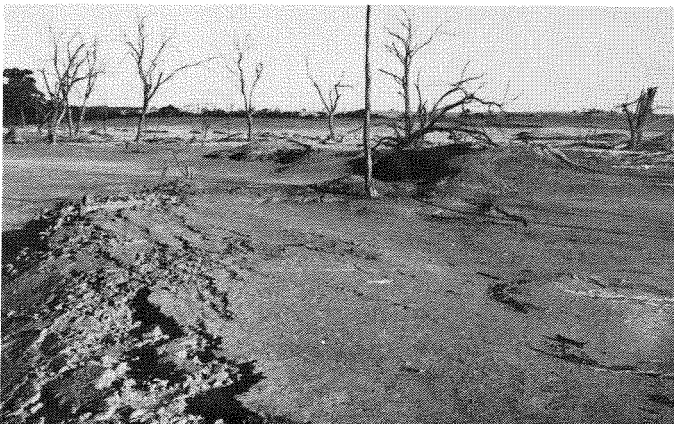
As the fault approached the Mortlock River, it developed forms typical of areas with deep soil and plastic clay. The scarp commonly developed a conspicuous underthrust, backscarp ridge with no overthrusting or fracturing of the front of the scarp. Where clay was near the surface, a strongly convex, bulbous, compressional arch type scarp was formed, and in salt flats, the fault became a zone of parallel scarp ridges (Fig. 32c).

32. The Meckering Fault:

- (a) Small lobate supratherusts slumped forward, 2.5 km west of Meckering.
- (b) Compressional arch scarp, 0.8 km north of the railway. Note the scatter of quartz fragments associated with the fault.
- (c) Sinuous pressure ridge in salt flats, 6.5 km southwest of Meckering. The ridge is parallel to and 15 m to the west of the main ridge which is seen in the centre of the photograph.

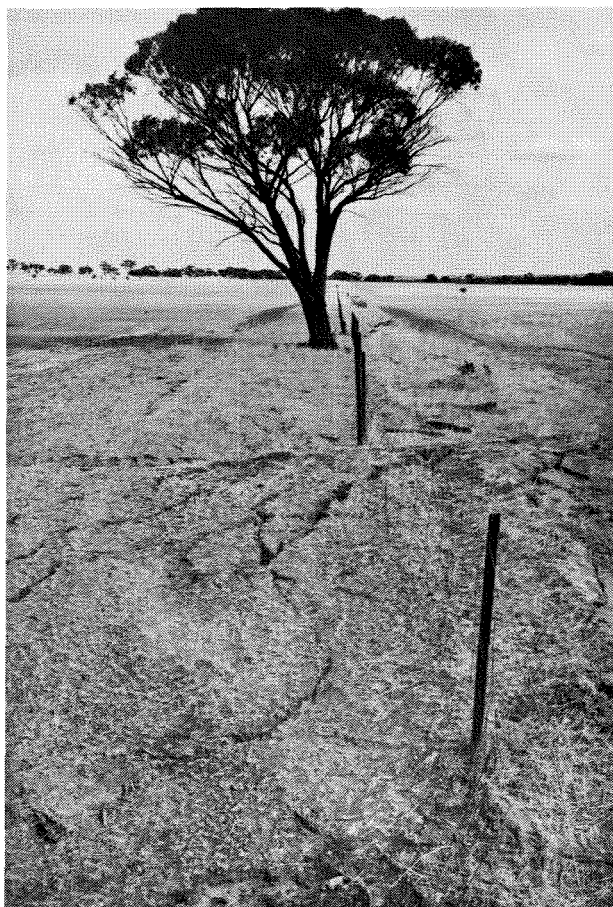
In the area where the Meckering Fault curved southward, the fault scarp bifurcated into two parallel branches about 40 m apart, and at one point the block between the two faults showed evidence of rotation. A fence crossing the traces at right angles showed a sinistral displacement of 0.38 m at the westerly fault intersection, and further sinistral displacement of 0.46 m at the easterly break (Fig. 33). A cadastral resurvey by the Lands and Surveys Department established that there had been an overall dextral movement of 52 cm. It is evident that the block between the two fault scarps had been rotated clockwise by about 2°. Rotation was suspected at a few other points, but this was the only instance where it could be confirmed.

33. Rotation between parallel fault scarps, 700 m north of Koolbunine Road. Overall surveyed displacement was 0.52 m dextral, but the apparent displacement was sinistral.

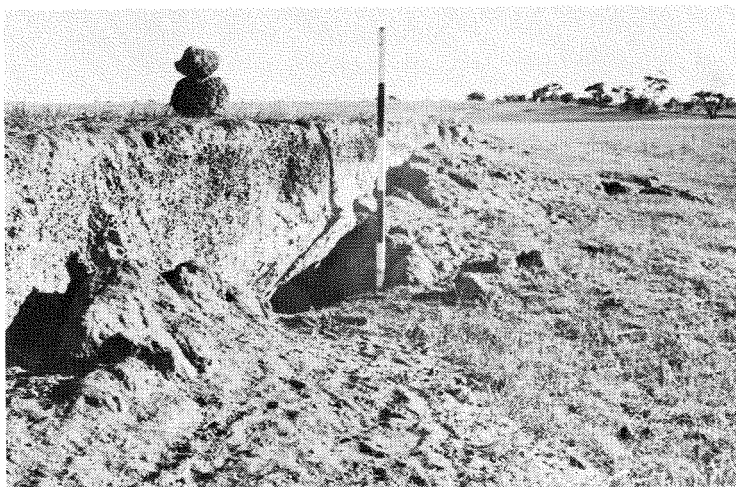
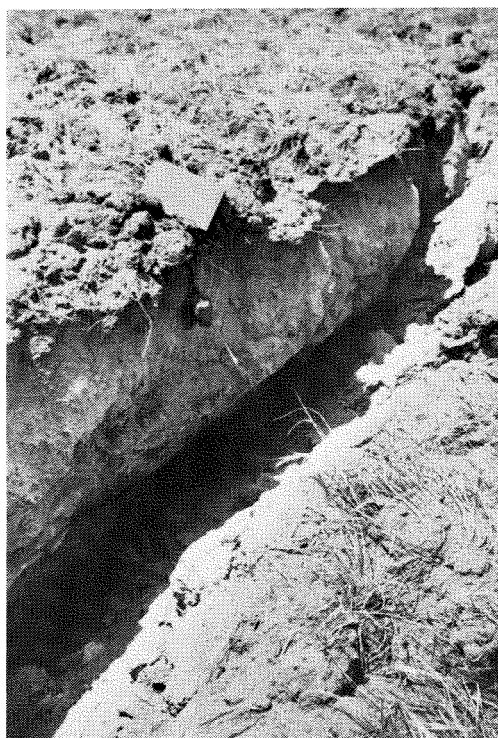
37. The Meckering Fault plane:

The scarp of the Meckering Fault did not cut through a solid outcrop of fresh rock at any point, although it traversed areas of scattered exposure. However, the soil and weathered rock profile was of minimal thickness in several areas, and the fault plane was well exposed in moderately weathered rock in at least 23 locations (Fig. 37b). At each exposure, brecciation, shearing, and signs of previous movement were visible. It was rather surprising that so many fault-plane exposures were visible, because crustal shortening tended to roll up surplus ground at the scarp front and obscure structural details. Where exposed, the fault plane was often well defined, but the large overhang formed by the thrusting was sometimes unstable, and tended to break and collapse as a rock fall under its own weight (Fig. 37a). In some locations, a tension crack appeared to the east of the fault, and the overhanging wedge of rock and soil tilted, thus decreasing the apparent dip of the fault plane.

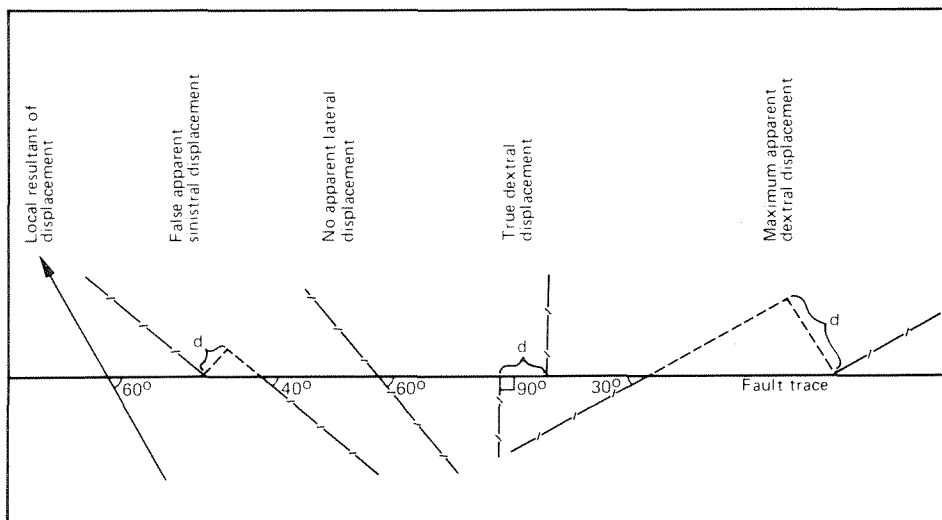
GSWA 17469

The displacements surveyed by the Lands and Surveys Department provided a framework within which measurements made by less accurate procedures could be made with some confidence. Relative horizontal movement can be obtained at many places along the fault scarp by measuring the displacement of fence lines and pipelines, and vertical throw can be measured by hand instruments, after taking into consideration any extra compressional bulge. While the throw of the fault can be measured with reasonable confidence, the lateral displacement of a fence or pipeline will depend on the angle at which it cuts the fault. A fence at right angles to the fault will be displaced laterally by the absolute amount of slip, and in the same sense, either dextral or sinistral, but at other angles both the amount and sense of the slip may be changed. A fence which crosses the fault parallel to the local resultant of movement will not be laterally displaced at all, but if it crosses in the obtuse angle between the resultant and the strike of the fault then the apparent displacement will be in the correct sense and will increase until it is at a maximum when the fence is perpendicular to the resultant. Conversely, if the fence crosses the fault in the acute angle between the resultant and the strike, the sense of apparent displacement will be reversed and will increase to a maximum when the fence is nearly parallel to the fault. These various situations are illustrated in Figure 38.

38. The effect of angle of interception on the apparent displacement of fence lines crossing a dextral thrust fault.

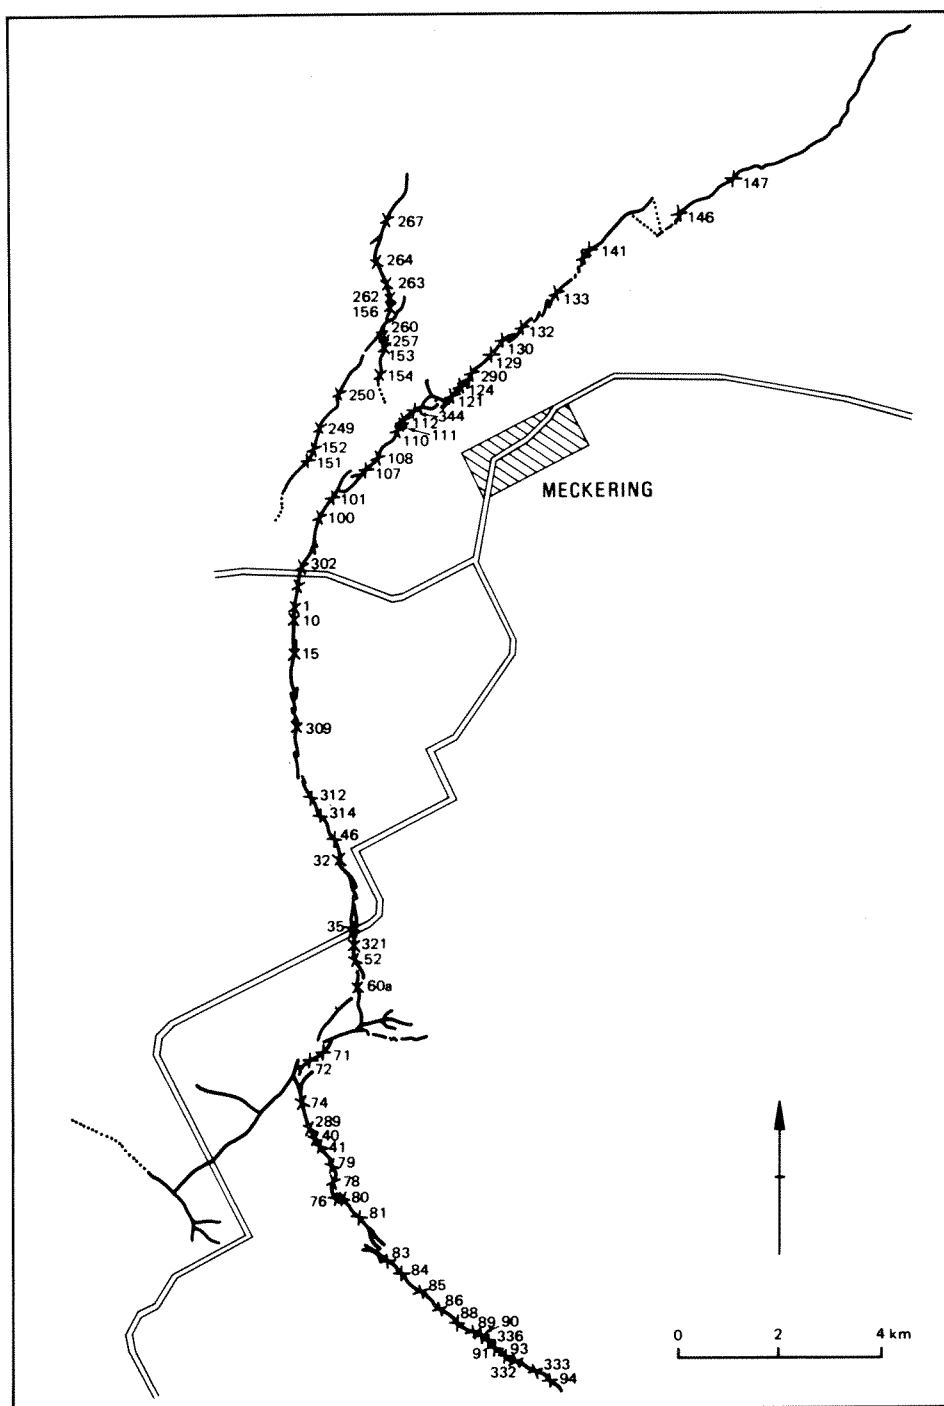
GSWA 17470

39. Observation points for fence line displacements on the Meckering Fault.

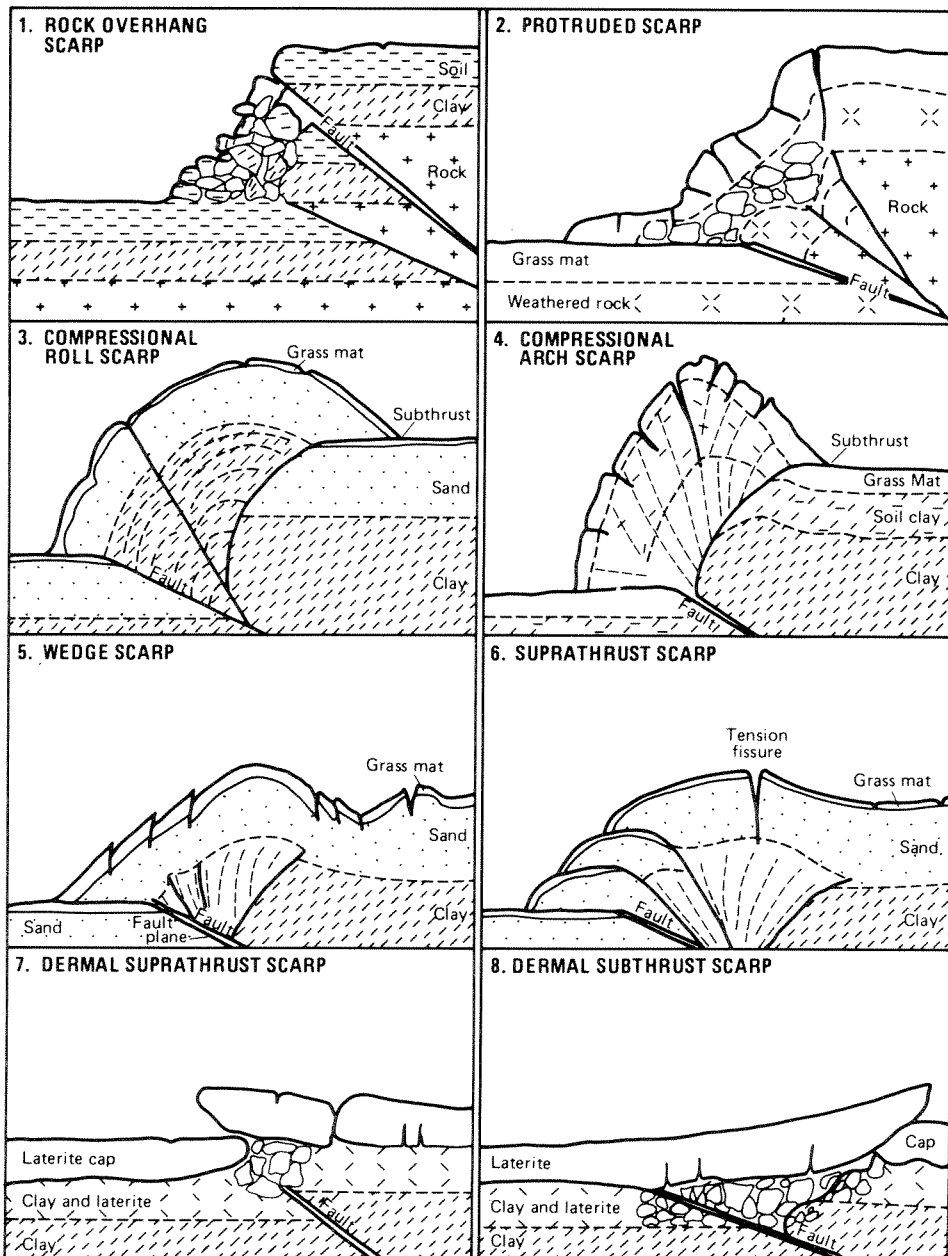
GSWA 17471

The Meckering Fault produced a variety of simple structures at the scarp which were capable of being studied and classified. The clarity of the forms produced was directly related to the shallow nature of the soil and the nearness to the surface of firm rock. The form of the scarp was also controlled by the local trend of the scarp front and by the principal stress directions, and variations in these resulted in a large diversity of form. This variety can be reduced to at least eight distinct types of thrust scarp, which are illustrated in Figure 41.

41. Thrust scarp morphology and classification.

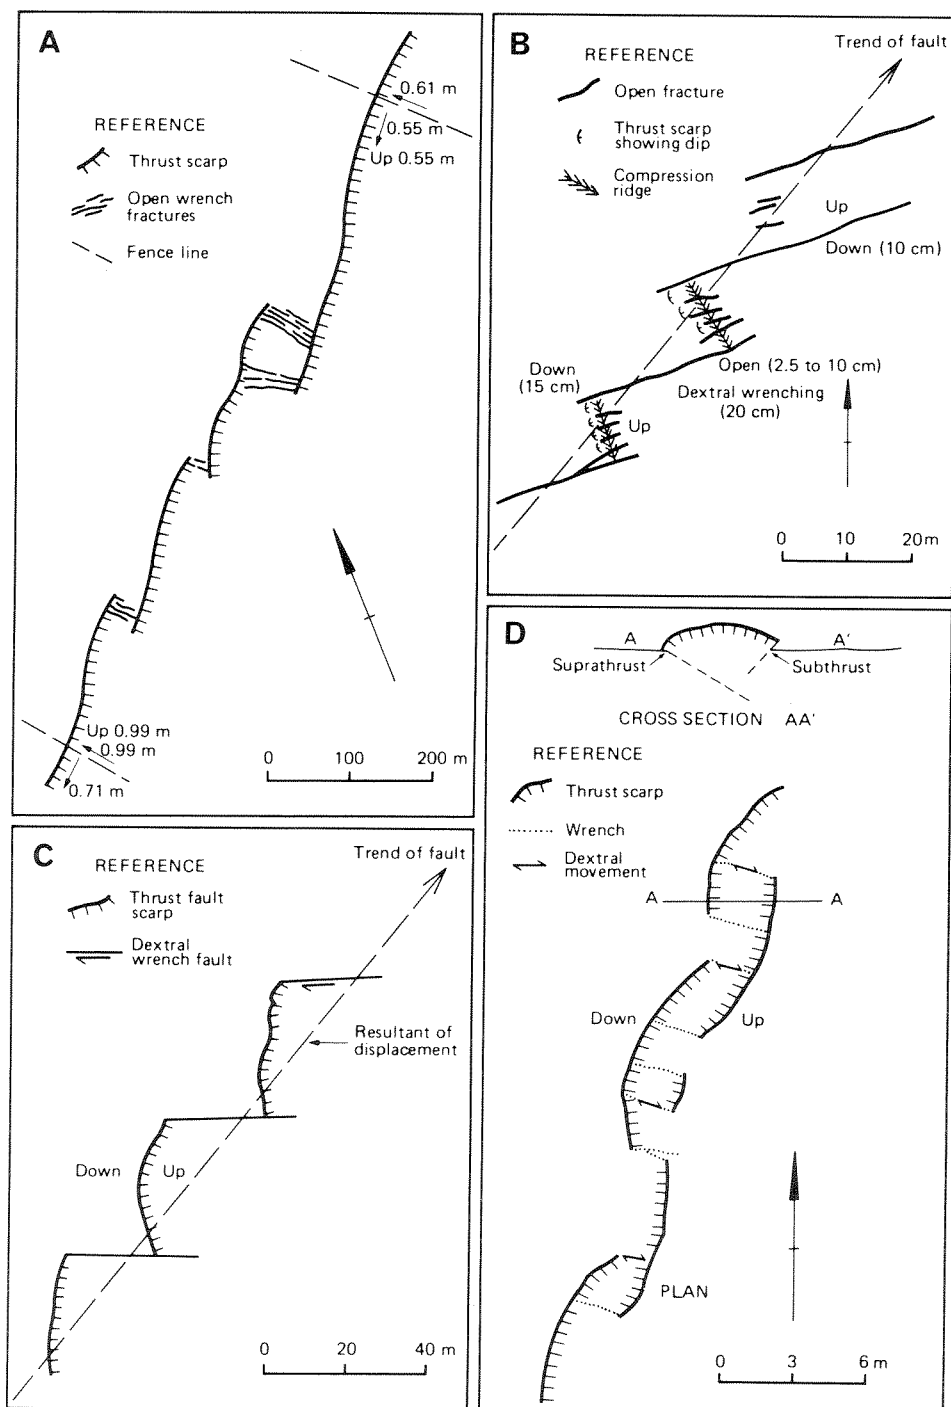
GSWA 17472

In all the primary faults of the area, *en echelon* faulting was common. Usually the individual fault scarps were at about 30° to the trend of the scarp front and rotated anti-clockwise from it, but the angle could be as little as 10° in some areas. The length of the individual faults making up the pattern ranged from a few metres to several hundred metres, and in the larger examples, the faults were often connected by tension fractures and wrenches at right angles to the trend of the fault (Fig. 42a). At the northern end of the Meckering Fault and the southern end of the Chordal Fault, where the rotation was clockwise, there was often a raised compressional ridge or 'mole track', up to 1 m high. On the Chordal Fault tension openings, trending at 30° obliquely to the ridge, divided it into narrow rectangular blocks which at either end of the fault were thrust out beyond the zone of dislocation (Fig. 42b).

42. Typical fault patterns:
- En echelon* faulting on the Meckering Fault.
 - En echelon* faulting at the southern end of the Chordal Fault.
 - Alternative thrust and wrench faulting.
 - Alternate supratrust and subthrust faulting.

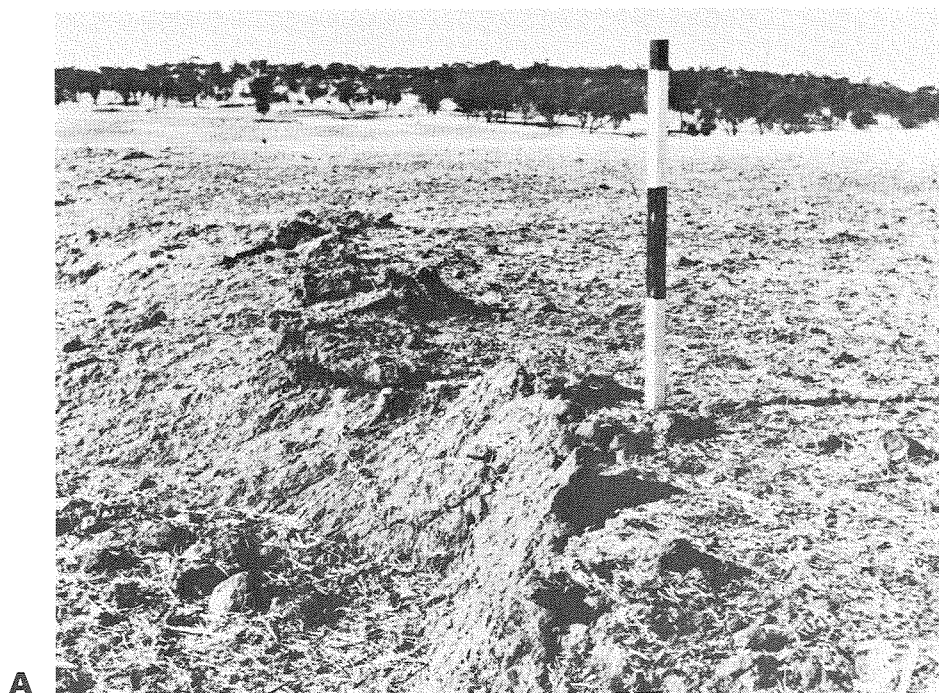
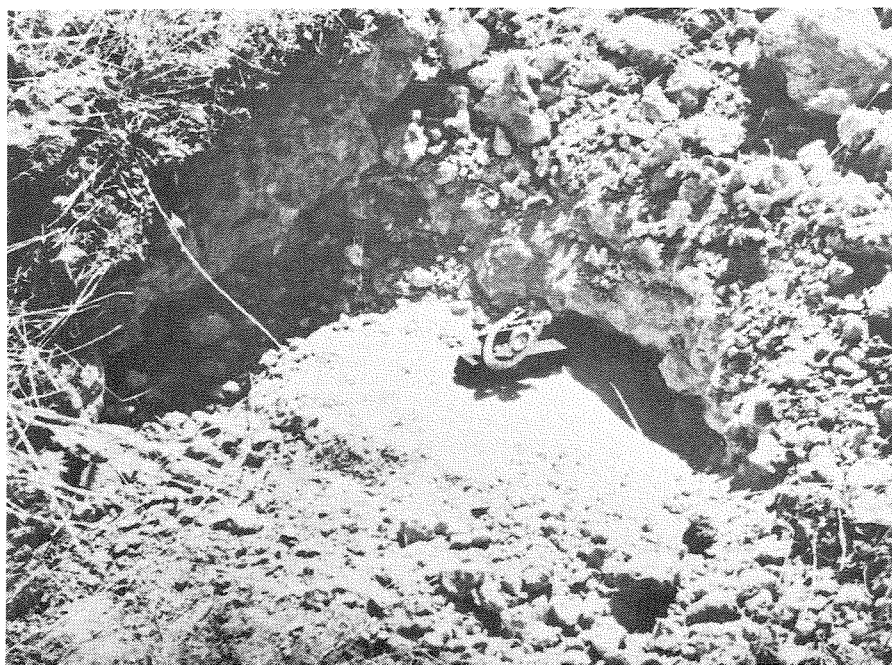
Nowhere was the fault plane of the Splinter Fault exposed naturally, but at three localities where weathered rock was present near the surface it was exposed by digging (Fig. 43b). The measured dips varied from 25° to 32° and averaged 27° eastwards. On the Meckering Fault, 1.6 km to the east, the fault plane dips easterly at angles of between 35° and 52° , with an average dip of 42° . It is possible, therefore, that the two faults may merge at a depth of about 1.6 km, at a position about 2 km to the east of the scarp of the Meckering Fault.

The maximum displacements were shown in the central portion of the fault (Fig. 43a) where it was estimated that there was a maximum crustal shortening of 61 cm, a dextral movement of 30 cm and a vertical displacement of about 33 cm. The total net slip, calculated from these figures was therefore 74 cm and the fault dipped at 28° . The

43. (a) The Splinter Fault at its point of maximum uplift of 33cm.
 (b) Excavation of the Splinter Fault plane in moderately weathered rock. The fault dipped at 30° to the east.

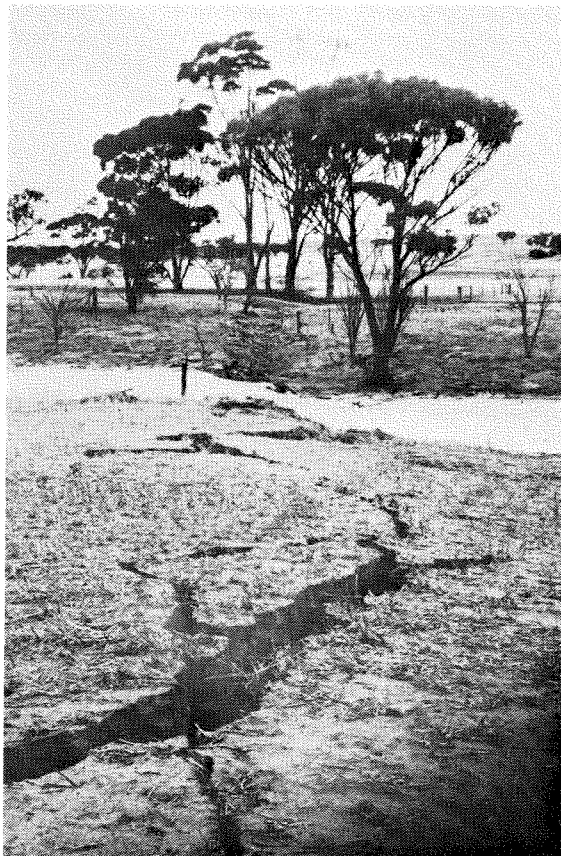
48. The Burges Fault as it crosses Reynolds Brook.

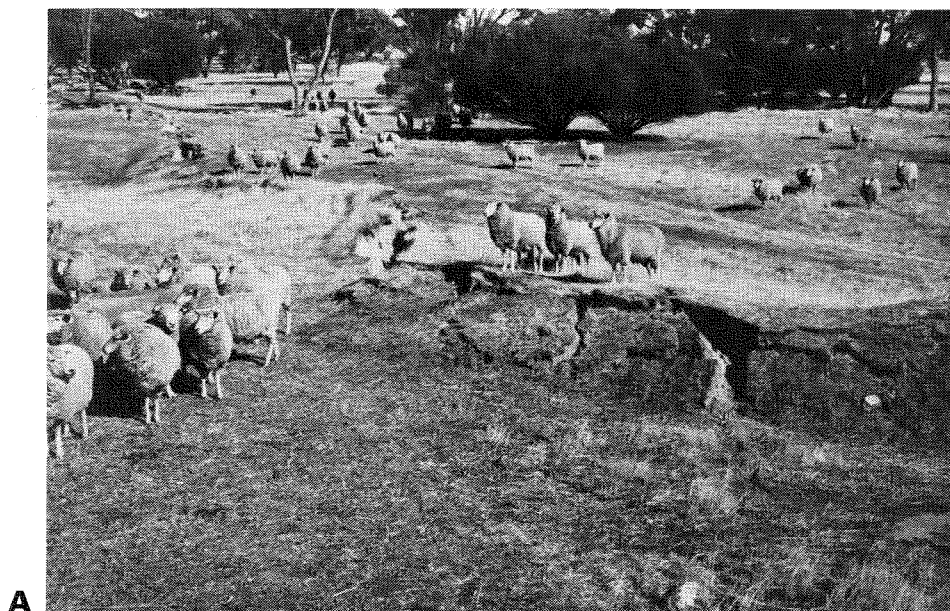
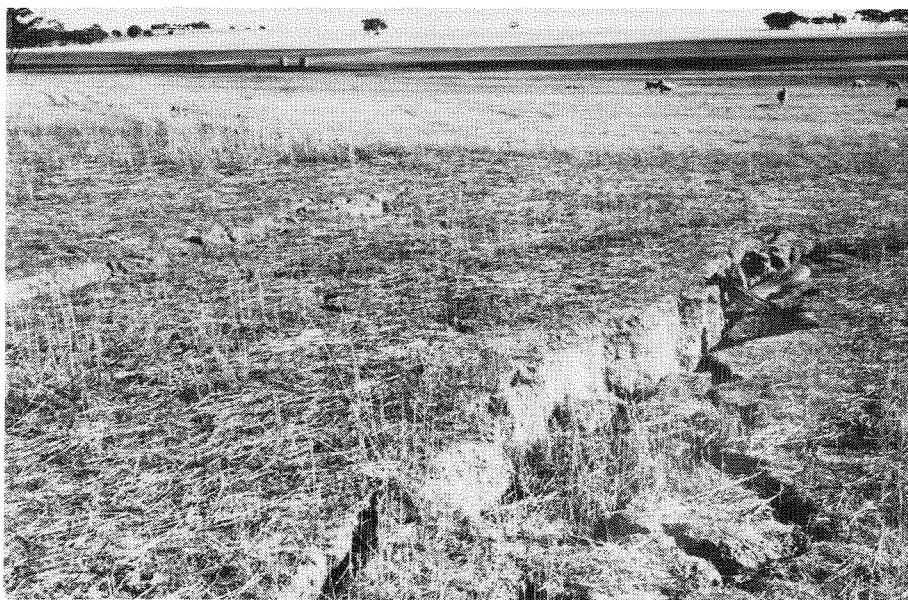
49. The Anterior Fault:

The Anterior Fault (Plate 3) was the name given to a minor branch fault which cuts across the angle between the northern section of the Meckering Fault and the southwest trending Burges Fault. It was a dextral thrust fault with a maximum strike-slip in the order of 30 cm and a vertical displacement of about 40 cm. The fault commenced at the front of the Meckering Fault scarp, 500 m north of its termination against the Burges Fault, and trended 225° for about 1 km until it reached Reynolds Brook. Throughout its length, it displayed alternate thrust and wrench fault scarps, each about 20 m long; supratrust and subthrust scarps were common (Fig. 49).

(b) Close-up of a wrench section with dextral displacement of 15 cm, throw of 40 cm to the northwest and the fracture open 12 cm.

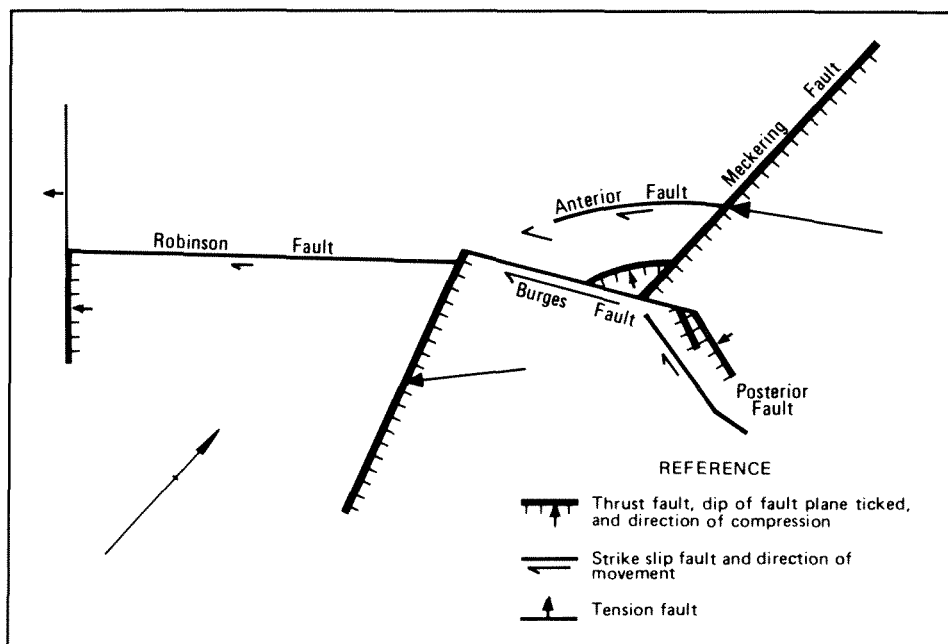
GSWA 17473

53. Schematic block movement in the Burges Fault Complex.

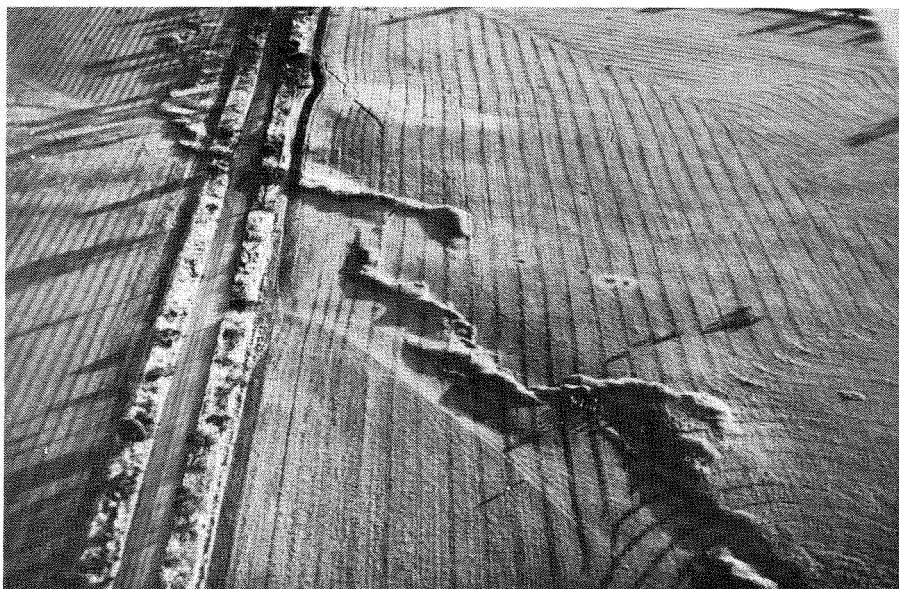
54. *En echelon* section of the Meckering Fault in the vicinity of Wilson Street. (Photo: B.M.R.)

From the north, the main fault scarp trended 215° until it was displaced 323 m to the northwest, at right angles to its trend, before resuming a southwesterly direction of 225° . Between the two parallel scarps there were two dominantly tensional and strike-slip features, a Frontal branch fault, with a trend of 295° and an Intermediate branch fault with a trend of 257° .
