BULLETIN 126

THE MECKERING AND
CALINGIRI EARTHQUAKES
OCTOBER 1968 AND
MARCH 1970

by
F. R. GORDON and J. D. LEWIS

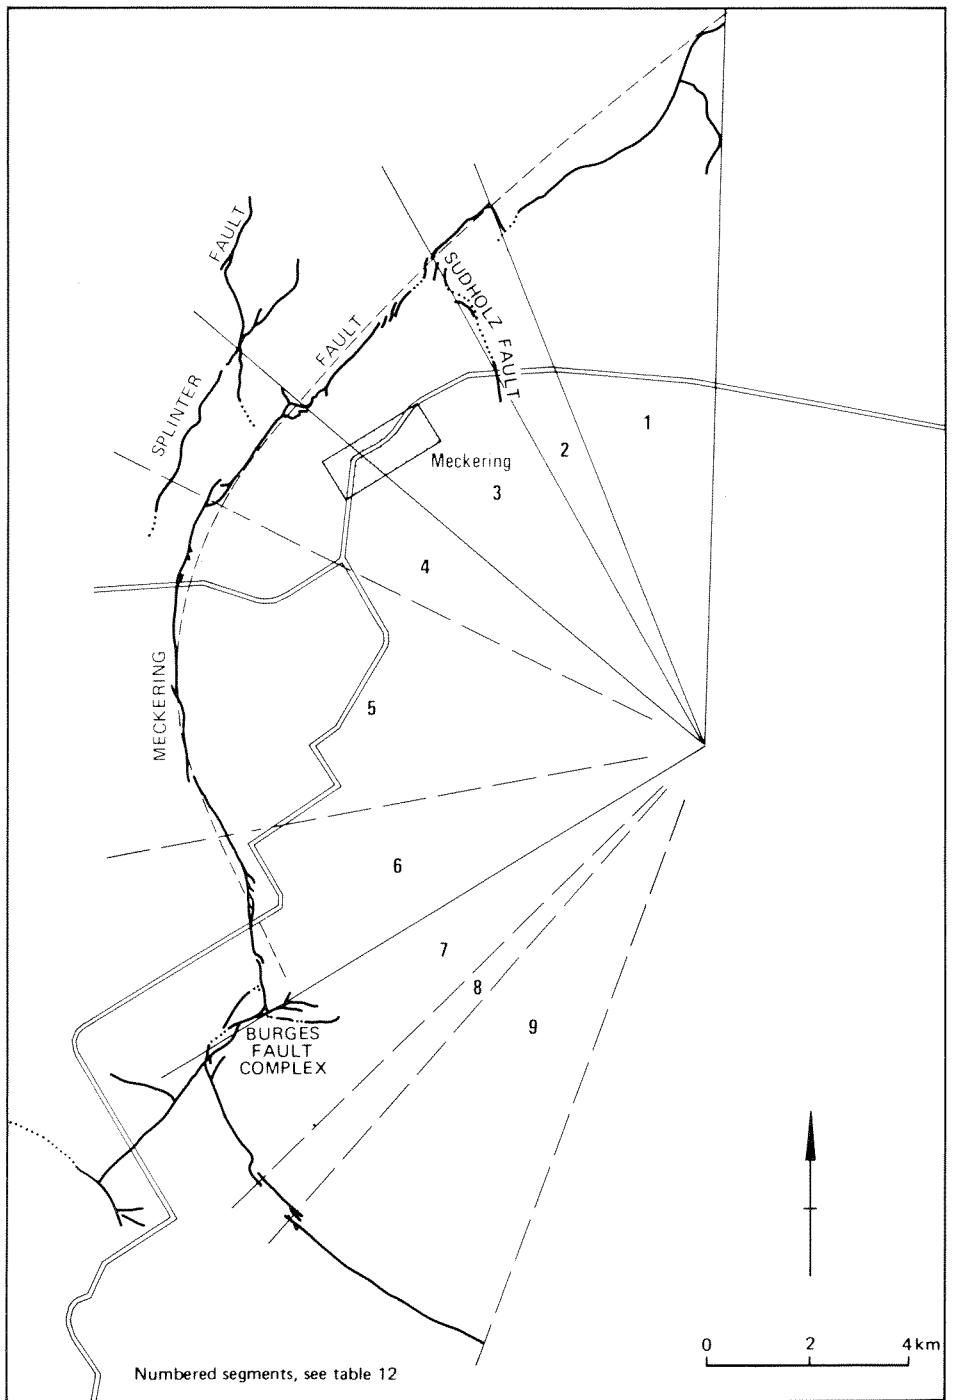
GSWA 17497

South of the Burges Fault, the radius immediately increases by 2.5 km and continues to increase throughout the southern section of the fault. If the Burges Fault is 'removed', the resultant trace of the Meckering Fault would appear to be parabolic. However, the best fit that could be obtained was for the northern section of the fault, and this conformed well to an exponential curve of the form $Y = ae^{bx}$ (Fig. 56).

56. Radial features of the Meckering Fault.

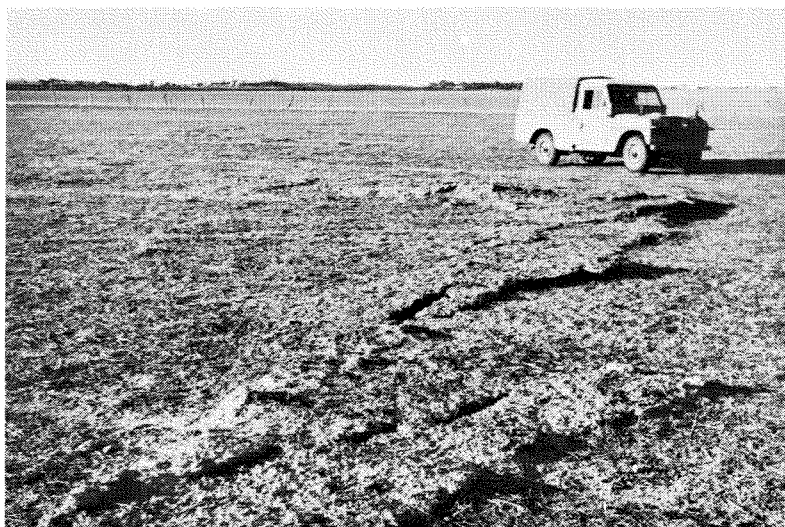
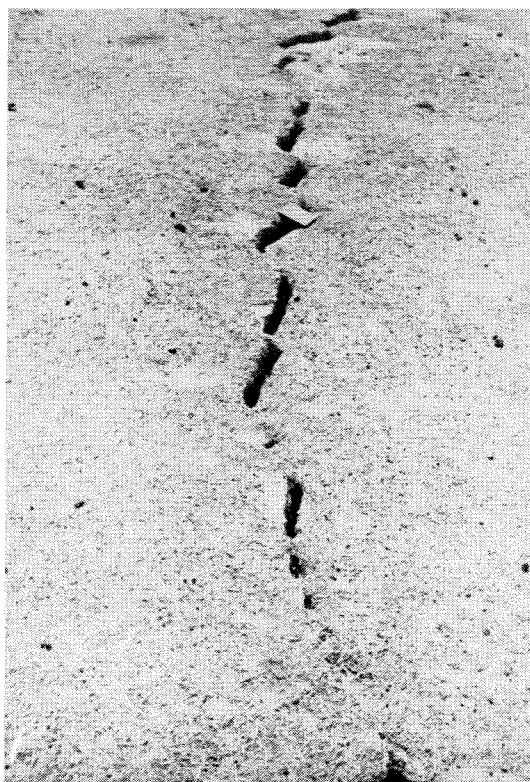
57. The Chordal Fault:

A fault having a small dextral and normal displacement was traced for over 13 km from a point near the Meckering Fault, 9 km south-southwest of the township, to where it disappeared in salt flats 4 km northeast of Meckering. It trended, with few deviations, 030°, and thus formed an almost complete chord across the arc of the main fault trace. The fault was named the Chordal Fault from its superficial geometric relationship to the Meckering Fault.

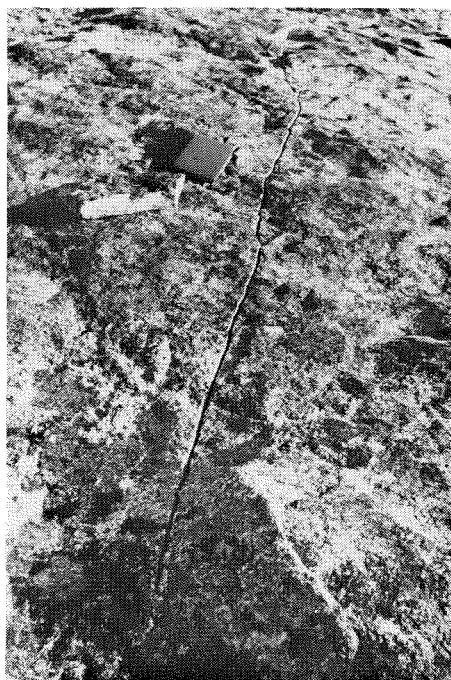
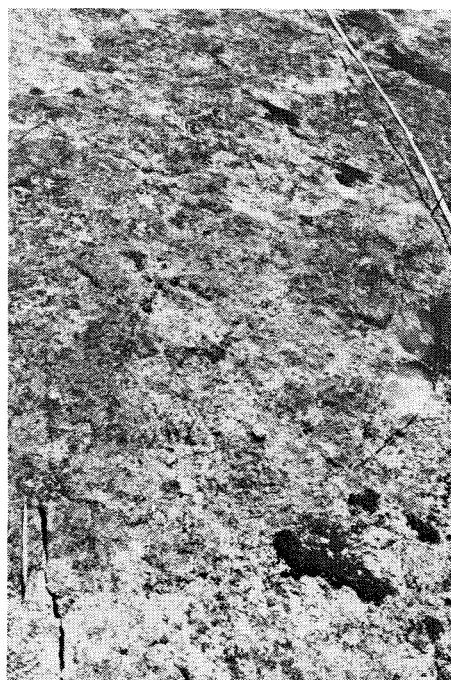
61. The Koolbunine Fault:

The fault was located 0.8 km northeast of the Meckering Fault on Koolbunine Road, and trended 070°, at right angles to the main scarp. There was no obvious surface connection with the main scarp, but the fracture was located in a zone of complex

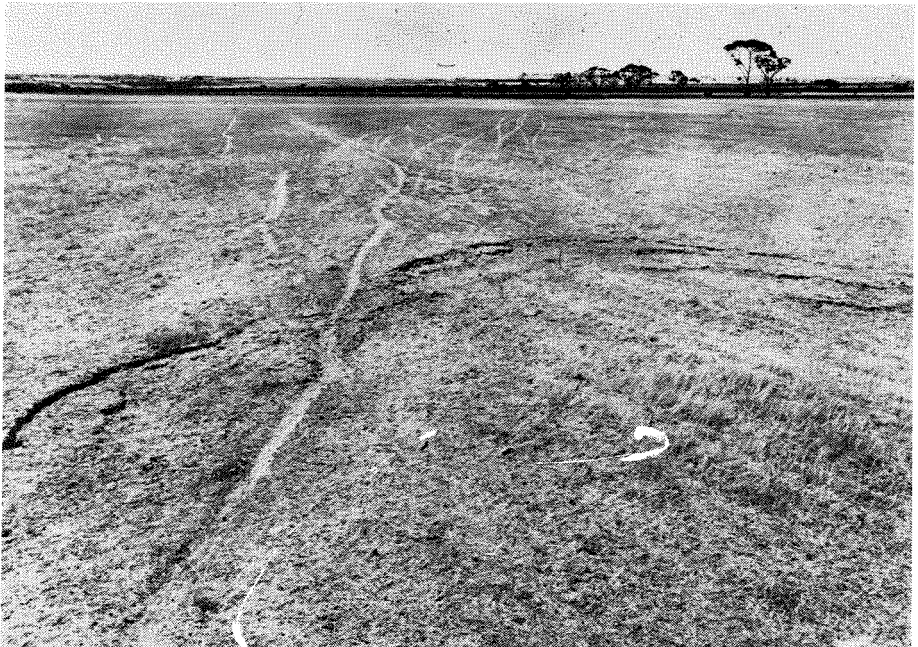
62. Part of a circular slump feature, one of six online with the Sudholz Fault, and 3 km east of Meckering.

there was a small scarp up to 15 cm high (Fig. 62). The scarp height varied around the perimeter, and was as low as 0.5 cm. Inside the circular rim of each slump, the ground was depressed as much as 60 cm, or in the case of the smallest slump only 22 cm, and there were often other minor arcuate scarps within it, sometimes in the form of small thrusts. In the cases where there was a topographic low side to the slump, small lunette sub-thrusts, concave towards the centre of the slump, were often grouped on this side.

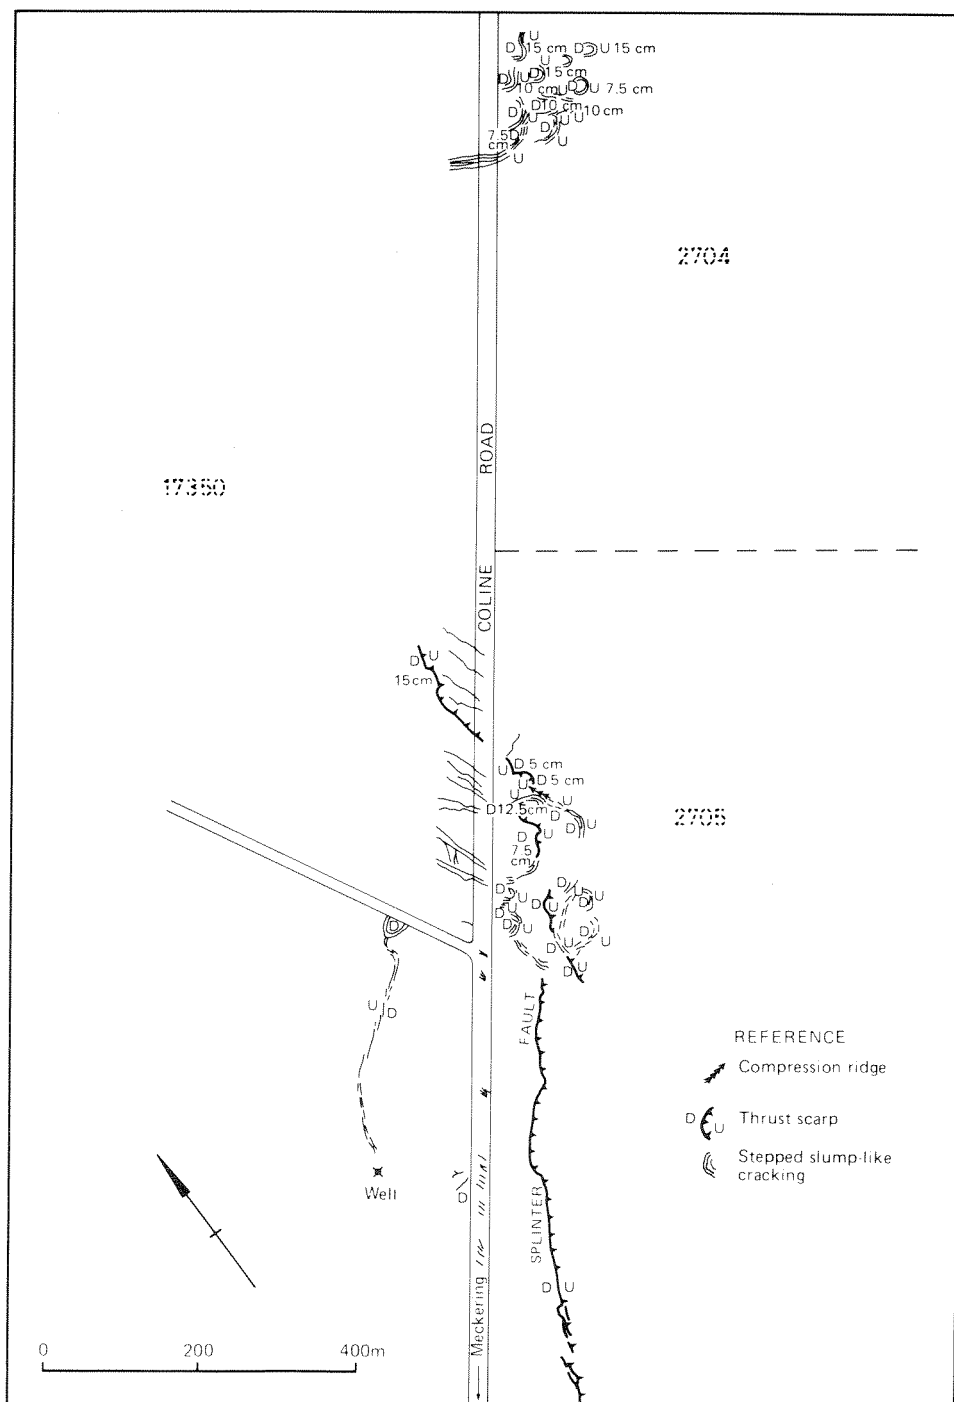
GSWA 17474

About 750 m northeast along Coline Road from the point where it was crossed by the Splinter Fault there was an isolated area of slumping in the corner of Location 2704. The slumps were in an area about 100 m by 150 m, and on line with the projected trend of the Splinter Fault. Ten separate slumps were found, all open to the west. They varied from small, almost circular slumps, 20 m in diameter, to larger arcuate slumps 100 m in diameter and subtending an angle of about 90°. The number of concentric fractures varied from 2 to 5 and the central area was depressed from 7 cm to 15 cm.

63. Slumping near Coline Road at the northern end of the Splinter Fault.

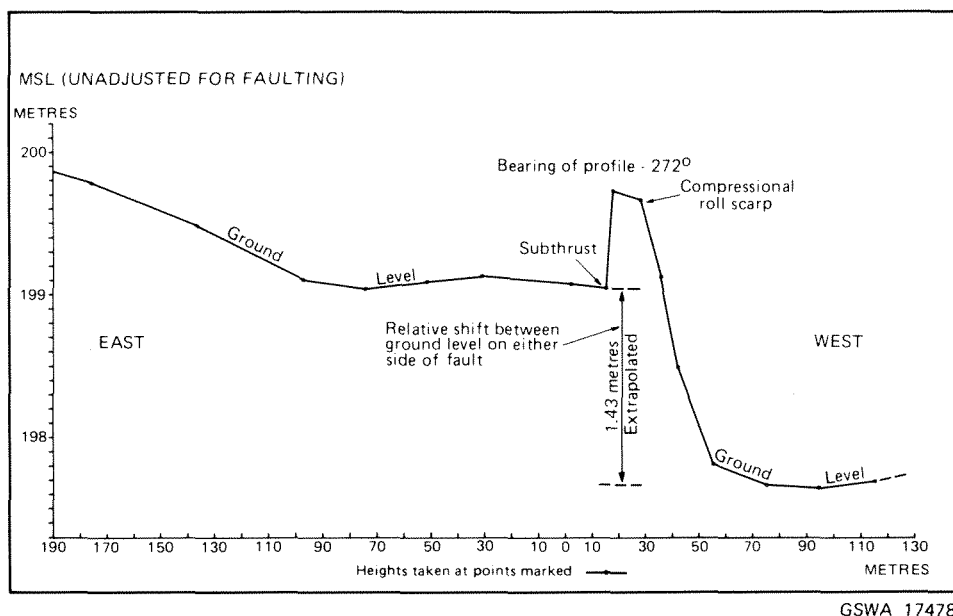
The most immediately important levelling route, on the Great Eastern Highway through Meckering, showed a simple pattern of deformation which had already been apparent in general form from the geological investigations. The changes were regular and directly related to the movement of the Meckering Fault. At the fault the eastern side had been uplifted 1.5 m and there was a slight depression of the western block. The uplift gradually decreased to the east, and for 6.5 km through the Backscarp Zone was below the pre-earthquake level. The fault profile is shown in Figure 68, and the variation in pre- and post-earthquake levels in Fig. 69.

68. Profile of the Meckering Fault on the Great Eastern Highway.

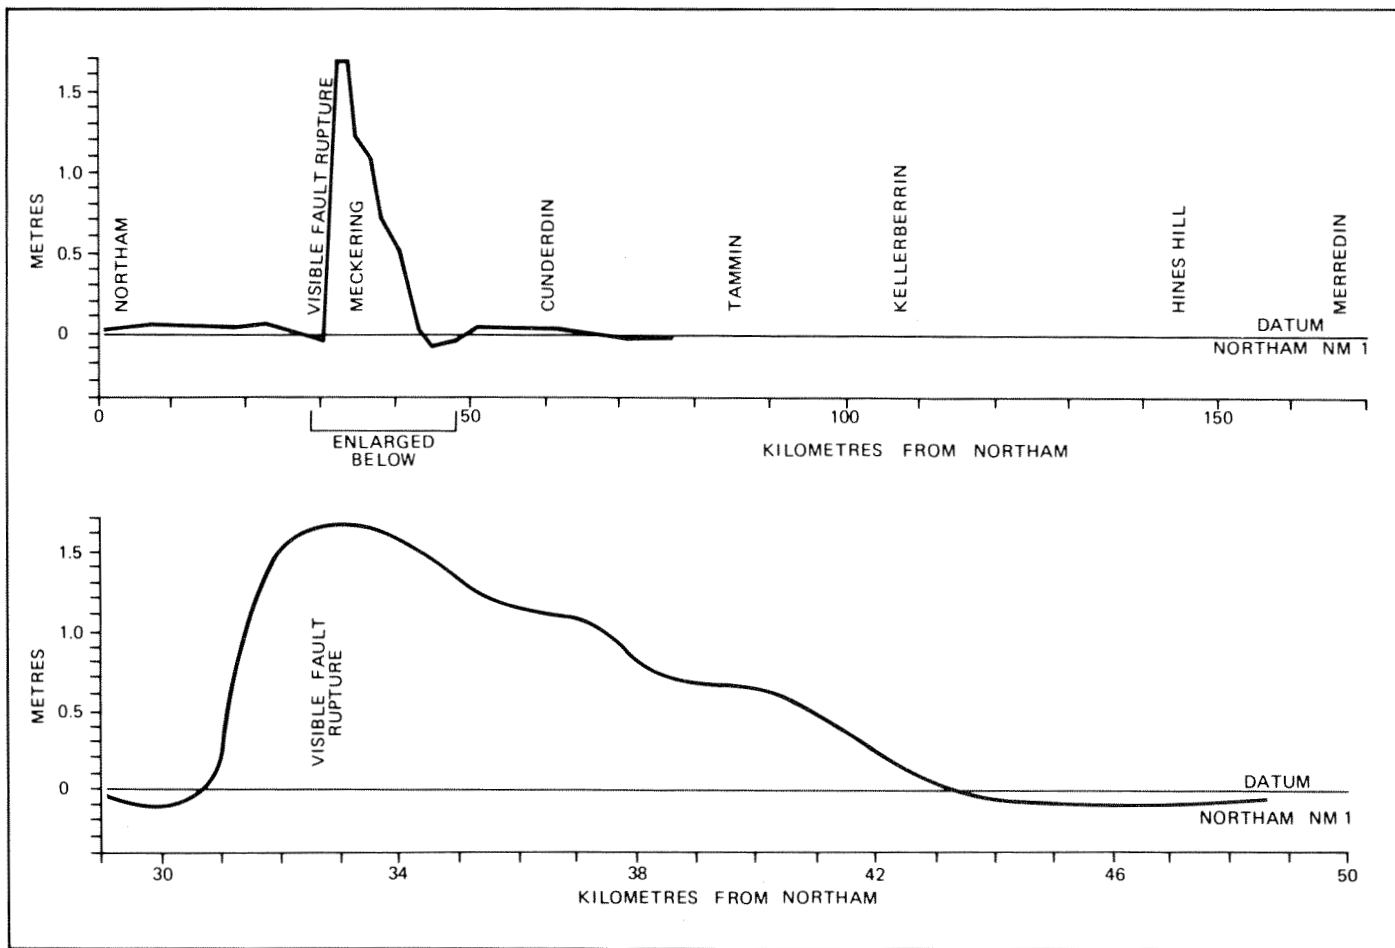
GSWA 17479

For the first 24 km eastward from Northam there was a small positive variation between the levels of August and September 1961 and the post-earthquake levels of October and November 1968. For the next 5 km, until the fault scarp was reached, the ground profile was slightly depressed. The maximum elevation of 4.6 cm was attained near the eastern end of the uplifted part of the profile, and the maximum depression was 7.6 cm, immediately in front of the fault scarp.

69. Variation between 1st order levelling, 1961, and 3rd order levelling, November, 1968, along the Great Eastern Highway.

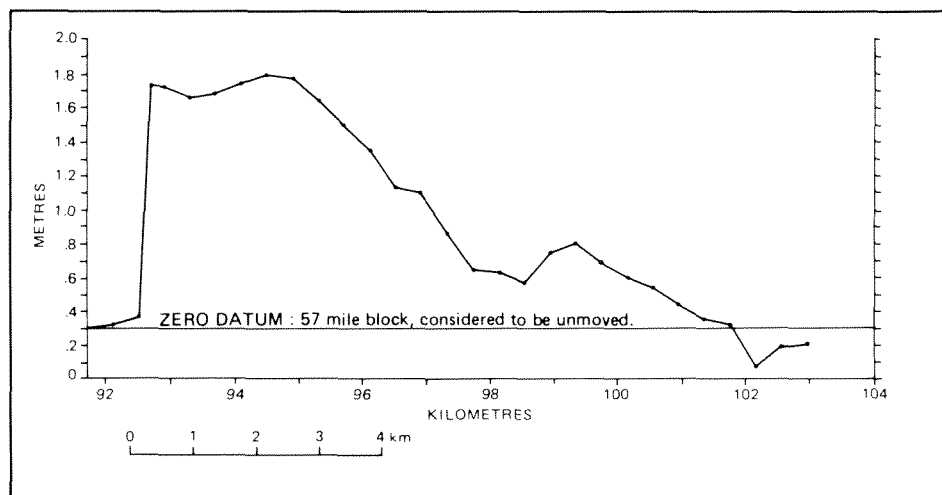
GSWA 17480

70. Variation between pre-earthquake levels and levelling of November 1968 along the Goldfields Water Supply pipeline.

The closer spaced observations on the pipeline survey enabled a better definition of the gross form of the uplifted area, but the same features were observed as in the highway levelling. The vertical uplift of 1.4 m at the scarp is followed by a slight depression to the east, and the greatest uplift of 1.5 m is reached about 1.7 km east of the fault. Within that distance are most of the tension faults that formed at the time of the earthquake. The largest tension fault was immediately east of the highest uplift point, and caused a break in the pipeline.

The uplift of the mobile block decreased in a regular manner towards the east, but with two breaks in slope. At 98.3 km the elevation remained constant over a distance of 400 m, and between 97.7 km and 99.4 km a small increase in elevation was recorded. The backslope then resumed its downward trend until it reached the Backscarp Zone at 102 km and ground levels were depressed with respect to earlier surveys.

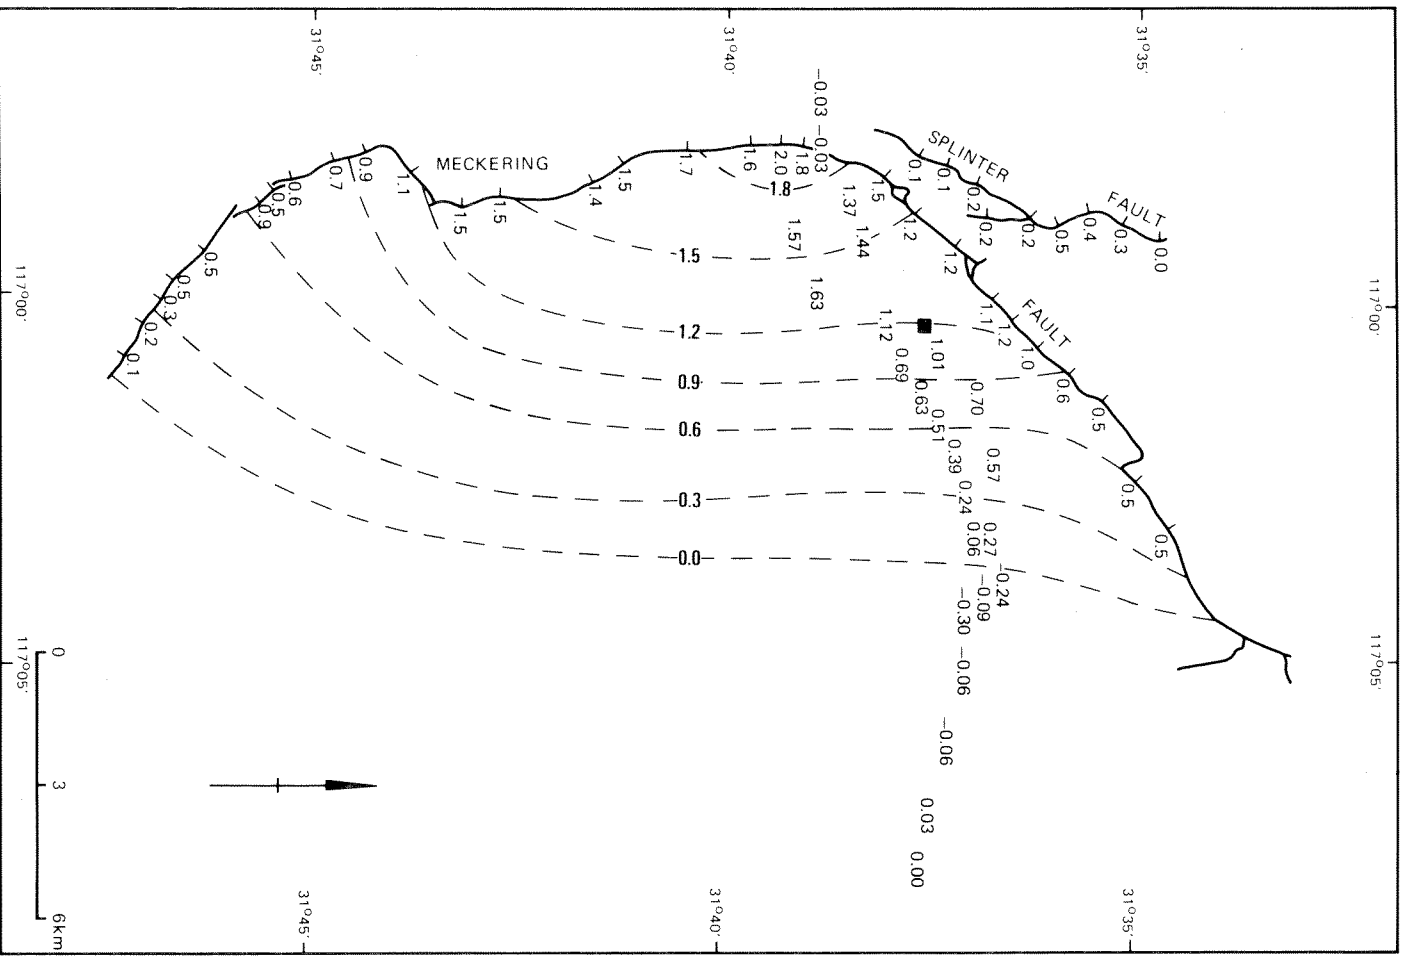
An attempt has been made in Figure 72 to contour the uplift of the mobile block associated with the Meckering Fault. Unfortunately the number of lines that were relevelled do not provide sufficient information on their own and must be supplemented with less accurately determined data. It was assumed that the uplift along the western margin of the block was given by the throw of the fault, and that minor faulting within the arc of the Meckering Fault caused insignificant changes. This was found to be true along the relevelled lines, where the western block was almost unchanged and such major features as the Chordal Fault caused no noticeable disturbance of the profile. It should be noted, however, that the considerable throw of the Splinter Fault has not been contoured or allowed for.

The contours indicate that the block enclosed within the arc of the Meckering Fault was uplifted and tilted to the east. The easterly tilt continues into the Backscarp Zone as a slight depression and the movement is finally absorbed at the eastern edge of this 6 km wide zone. The total apparent downthrow of the small faults within this zone was 60 cm, compared with a maximum measured depression of only 20 cm on the water supply pipeline. The discrepancy was probably caused by the eastward tilt of many of the small fault-bounded blocks.

72. Uplift contour map for the mobile block of the Meckering Earthquake.

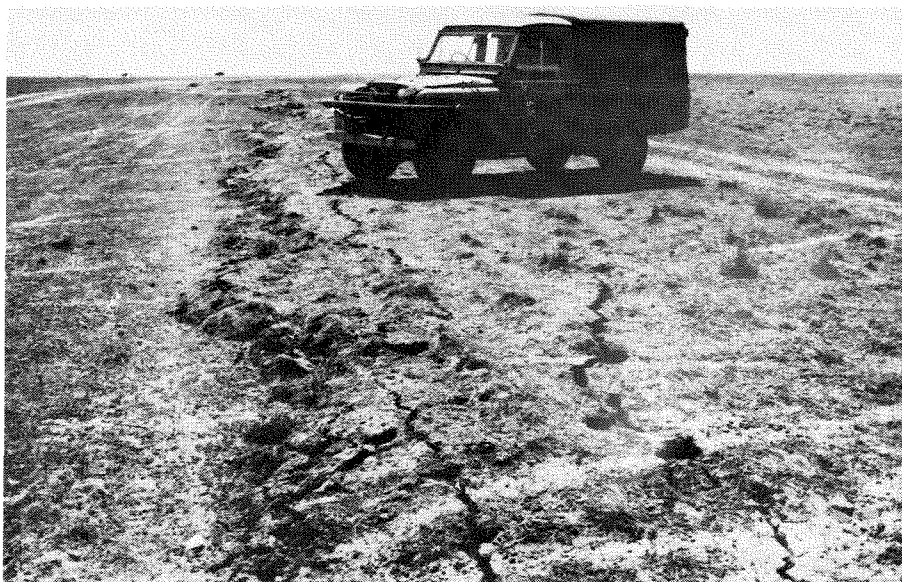
78. Central portion of the southern section of the Calingiri Fault, looking north along the 28 cm-high thrust scarp.

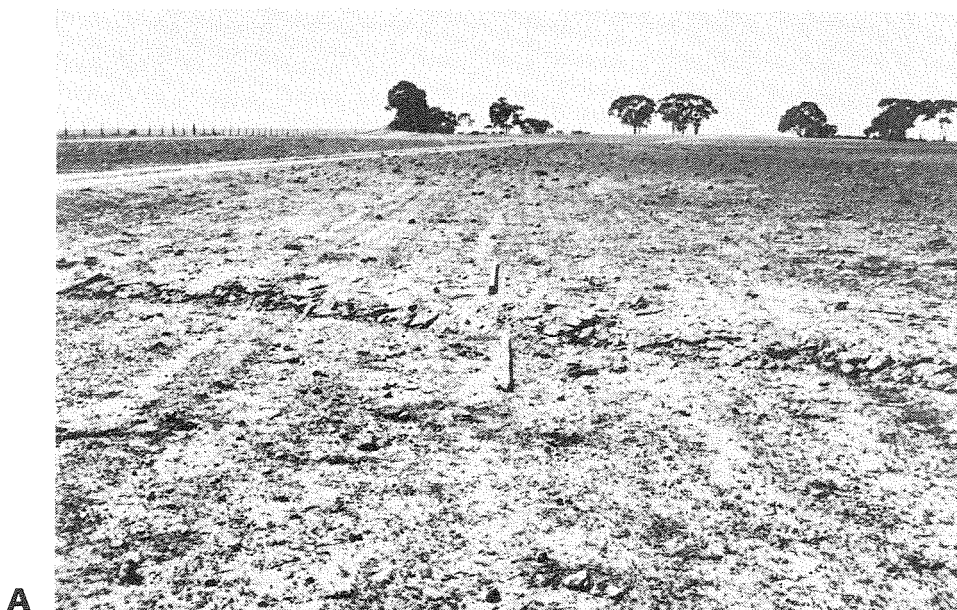
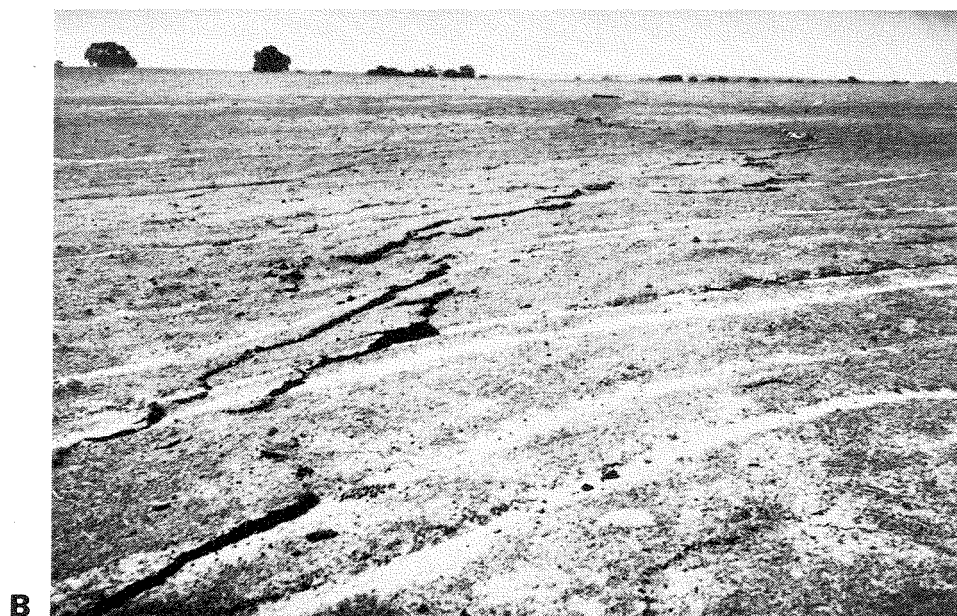
79. Calingiri Fault, southern section:
 (a) Sinistral displacement of 12 cm measured on plough furrows.
 (b) Dermal subthrusting at the northern end of the southern section.

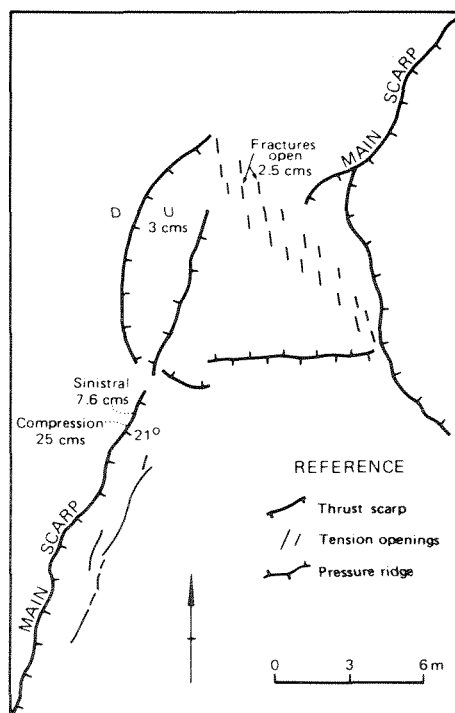
GSWA 17499

In general, the form of the thrust scarp was quite simple, a compressional roll or supratherust scarp, backed by occasional small tension cracks formed by the flattening of the fault plane in the unconsolidated soil. In parts, however, the scarp was complex, and an example is shown in Figure 80. This is a detail of the fault at the point of maximum heave. The main fault, showing a compression of 25 cm and a sinistral strike-slip of 7.6 cm died out northward in a small supratherust and subthrust scarp before a small dextral offset of 4.5 m. Between the two portions of the main fault there was an east trending pressure ridge and a northwest trending set of small, open, *en echelon* shears.

80. Complex portion of the southern section of the Calingiri Fault.

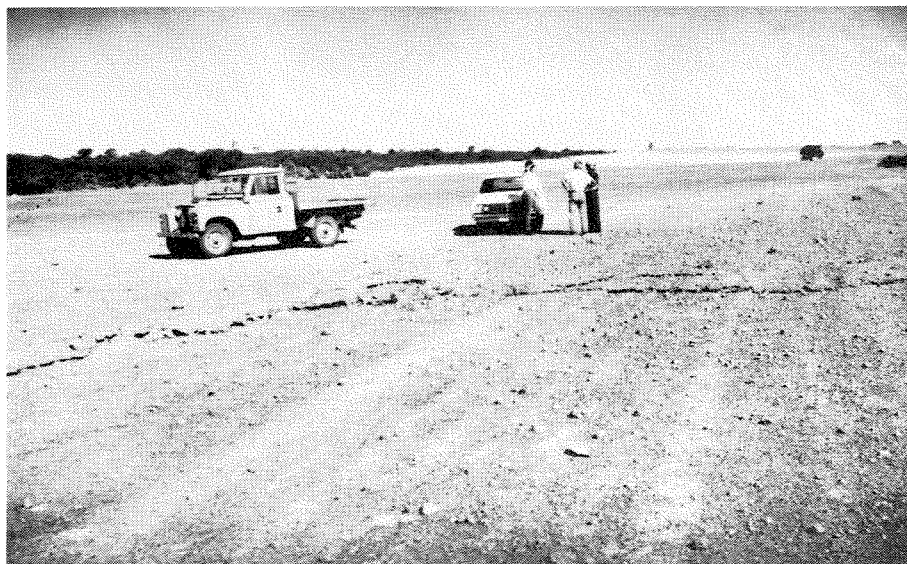
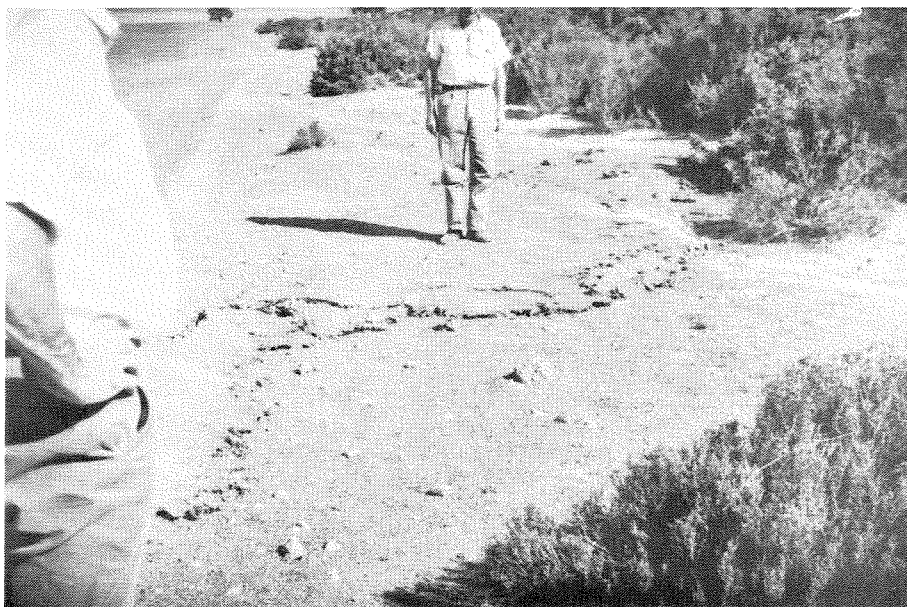
In Loc. 2245, south of the Calingiri-Goomalling road, the thrust scarp was a series of small *en echelon* thrusts with a sinistral offset. At the road, the uplift of the eastern block was only 7.6 cm. North of the road, the fault became complex, and branch and parallel scarps formed a zone 100 m wide. Strong thrust features were visible in a scrub-covered

81. Calingiri Fault, northern section:

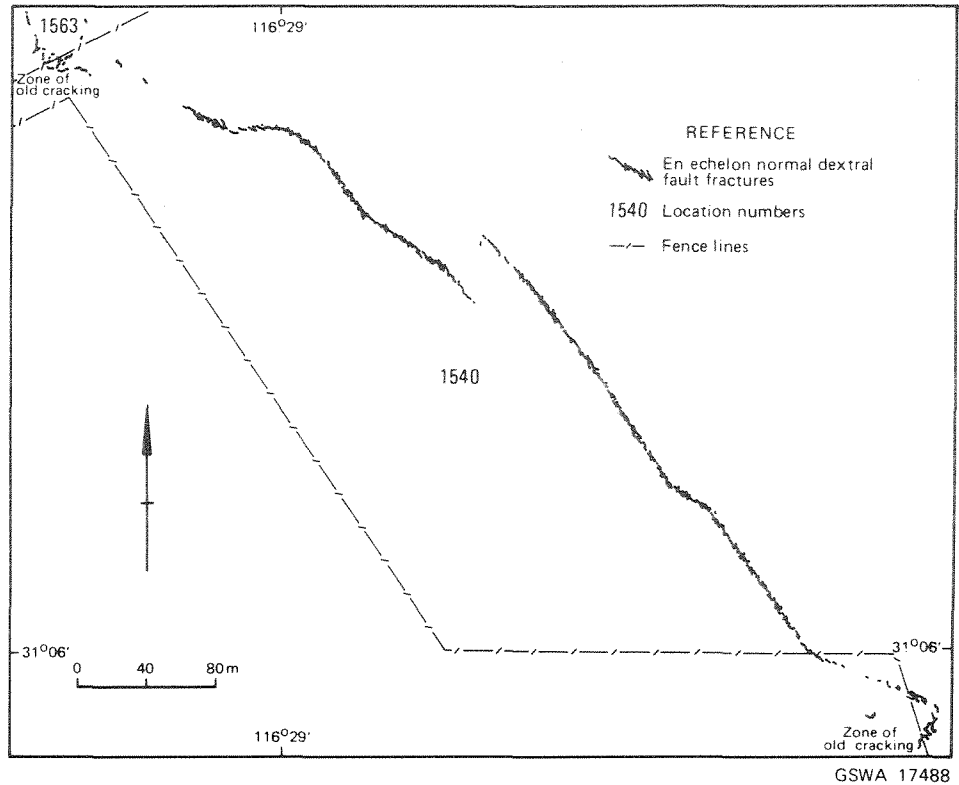
The fault trended about 125°, and its northern extremity was 680 m east of the northern end of the Calingiri Fault, which trended about 190° (Plate 5). The fractures consisted of two separate and parallel features with a sinistral offset of 26 m and an overlap of about 30 m. The total length of the fault was about 600 m (Fig. 82). The Calingiri Chordal Fault consisted almost entirely of small *en echelon* fault openings, offset left and trending about 20° east of the fault trend. At either end, the fault began as small discontinuous tension fractures, and the maximum displacements were found near the centre of each trace. The fault was principally normal in character, having its west side elevated up to 4 cm, and individual fractures open by the same amount (Fig. 83). Small dextral strike-slip movement was also noted, and reached a maximum of about 2.5 cm near the northern end.

82. The Calingiri Chordal Fault.
