GEOLOGICAL SURVEY
OF
WESTERN AUSTRALIA

REPORT 11

THE CADDOUX EARTHQUAKE,
2 JUNE 1979

By
J.D. Lewis
N.A. Daetwyler
J.A. Bunting
and J.S. Moncrieff

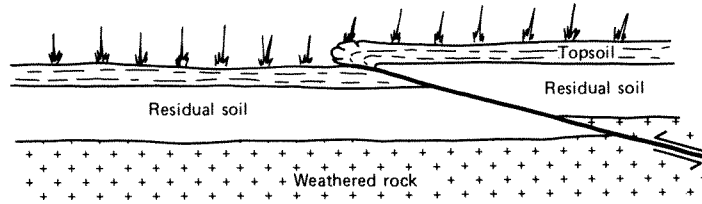
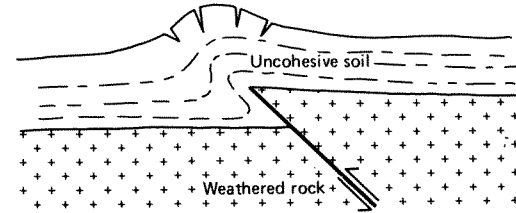
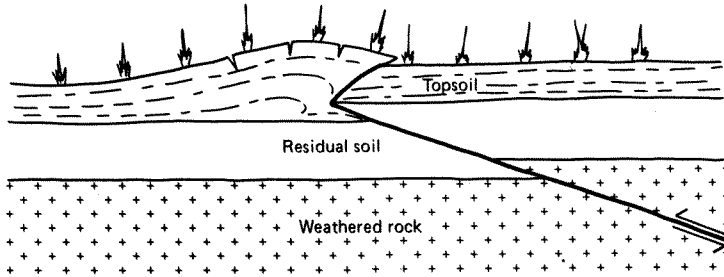
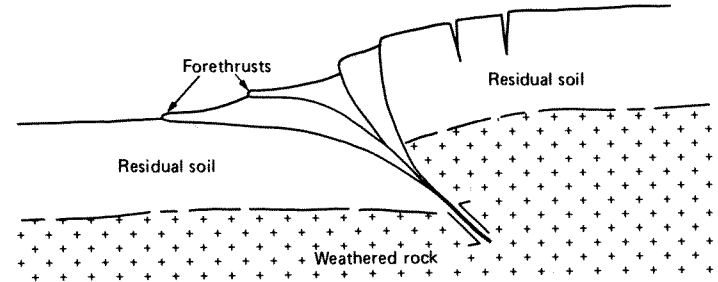
Some 270 m east of the point where the main fault scarp died out another smaller thrust scarp was developed. This scarp, trending approximately northeast, passed directly through the farmyard of the Shankland property (Fig. 11), and diminished until it disappeared in the driveway, some 160 m beyond the house. The fault scarp, 450 m long but rarely more than a few centimetres high, displayed west-over-east displacement and varied from a supratherust to a subthrust scarp (Fig. 12).

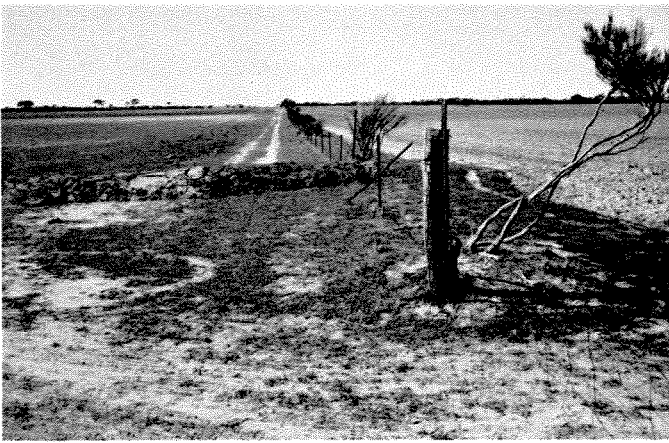
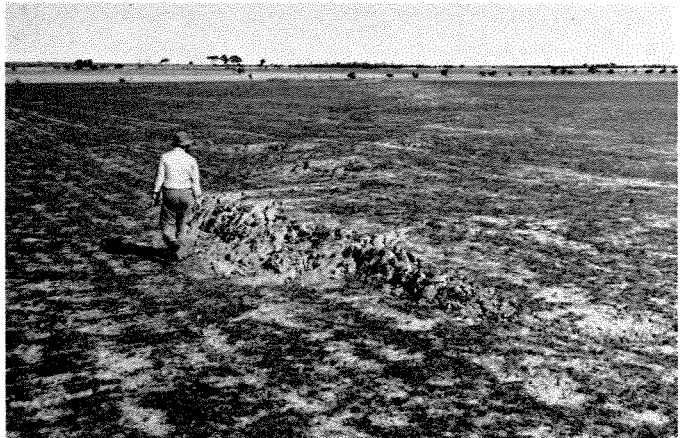
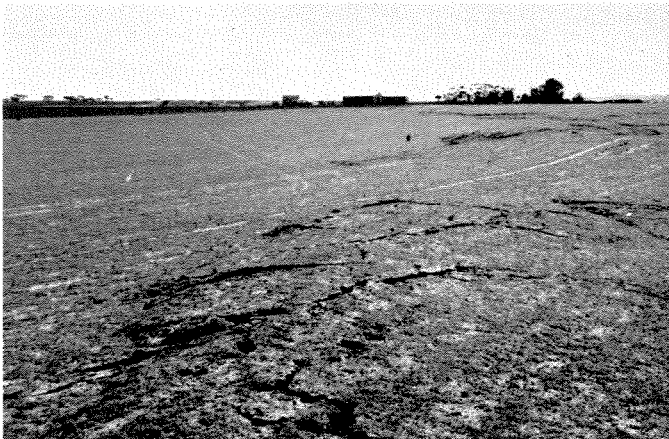
heave of 0.68 m was measured and the fault scarp, about 0.5 m high, was formed by a subthrust from the west (Fig.14a). Further north the fault trace became a series of complex meandering compressional rolls with tension gashes on the crest (Fig.14c). These rolls were in some cases quite formless, but they often included supratherust fronts and a subthrust rear. Throughout this section the crest of the fault scarp was often raised above the level of the uplifted block, thus exaggerating the apparent vertical displacement. Towards the northern end of the paddock the pattern of surface fractures became more regular, firstly with a series of *en echelon* thrust scarps joined by tension gashes and then as a zig-zag pattern of alternate thrust and wrench faults each 30-40 m long (Fig.14b). The wrench faults trended 075° , were parallel to the resultant movement of the western mobile block, and were simple strike-slip faults with a right-lateral displacement of about 0.3 m. The thrust sections trended more nearly north-south and were purely thrust faults.

Figure 14. Complex fault patterns on the Robb Fault: (a) sub-thrust rear of the fault trace 1.45 km south of the Koorda road. Note the vertical displacement of 0.5 m on the fence post and the almost total degradation of the fault trace to the south of the fence, caused by subsequent ploughing, (b) alternate thrust and wrench faults 1.25 km south of the Koorda road. Short thrust sections are joined by minor strike-slip faults trending 075° , (c) meandering compressional roll scarp, alternately sub- and supra-thrusted, to the north of 14(b) (GSWA 18744)

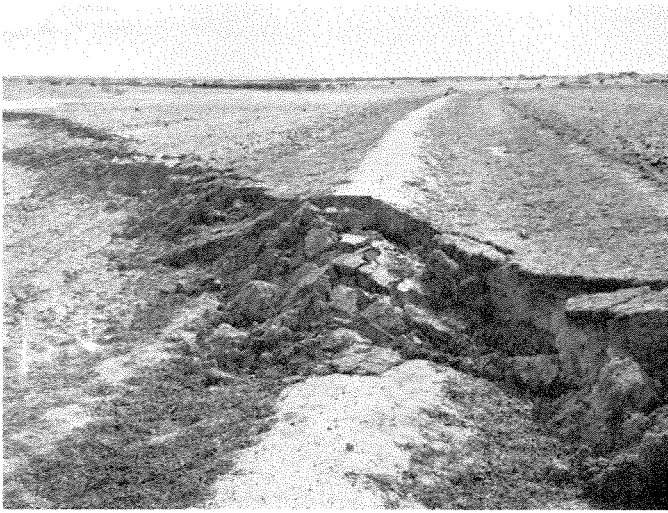
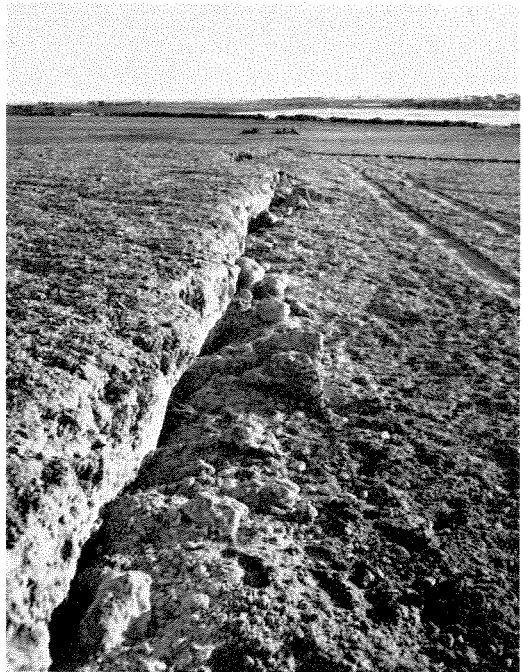
The fault was expressed at the surface in two forms. The part west of the "lone tree" was a simple scarp in clayey soil. Some collapse of the scarp had taken place, but in many places the fault-plane surface was still preserved at the time of this study. Short tensional gashes up to 2 m long, and oblique to the main fault are compatible with the left-lateral movement (Fig.18a).

Figure 18. Reverse strike-slip fault scarps: (a) the Lone Tree Fault, 400 m from its western end, showing a left-lateral displacement of the contour bank, (b) the Tank Fault, 700 m west of Kokardine tank; the fault plane is exposed in weathered granite and the southern block is upthrust 0.7 m (GSWA 18748)

The fault plane was well exposed 700 m west of the tank, where weathered granite bedrock gave rise to a single scarp 0.7 m high (Figs 18b and 23a). The plane dipped south at 80° , although this was seen to become shallower some 1.5 to 2 m beneath the surface. The exposed fault plane contained a layer, 1 mm thick, of fault gouge material (in this case sheared kaolin) with slickensides. Most slickensides plunged between 55° and 80° E. A second phase of movement was indicated by slickensides plunging 30° E which were superimposed on the earlier slickensides.

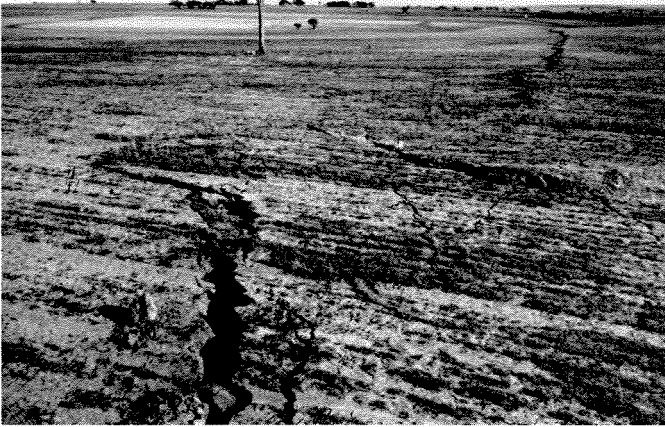
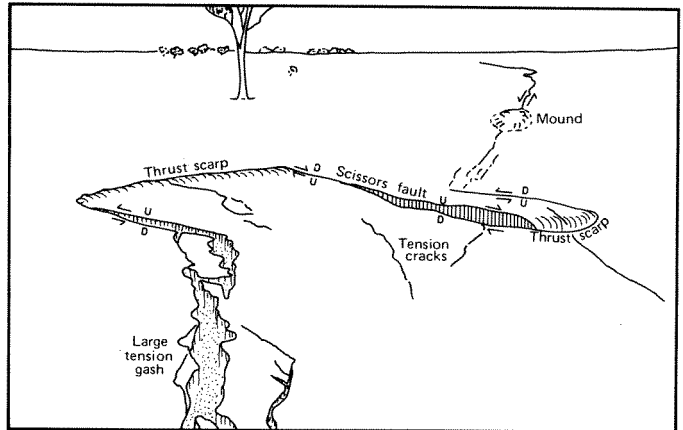
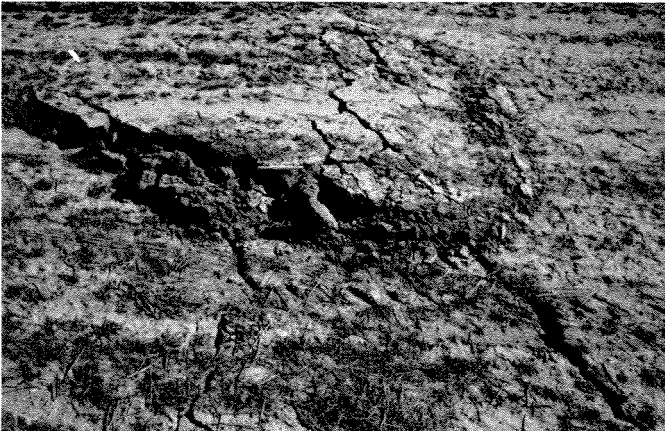
developed in several places was the presence of conjugate thrusts separated by a scissors fault (Fig.19). This was due to deformation of the soil cover between *en echelon* tensional gashes. A complex zone of thrusting and shearing, or, on a smaller scale, dome-like structures 3 to 4 metres across, were produced.

Figure 19. A complex structure on the Lone Tree Fault, 200 m west of the railway: (a) scissors fault with associated opposing thrusts (GSWA 18749), (b) diagrammatic representation of (a) (GSWA 18750), (c) detail of the northerly thrust front (GSWA 18749). The tension crack in the lower right of the photograph has been partially filled by the advancing thrust front

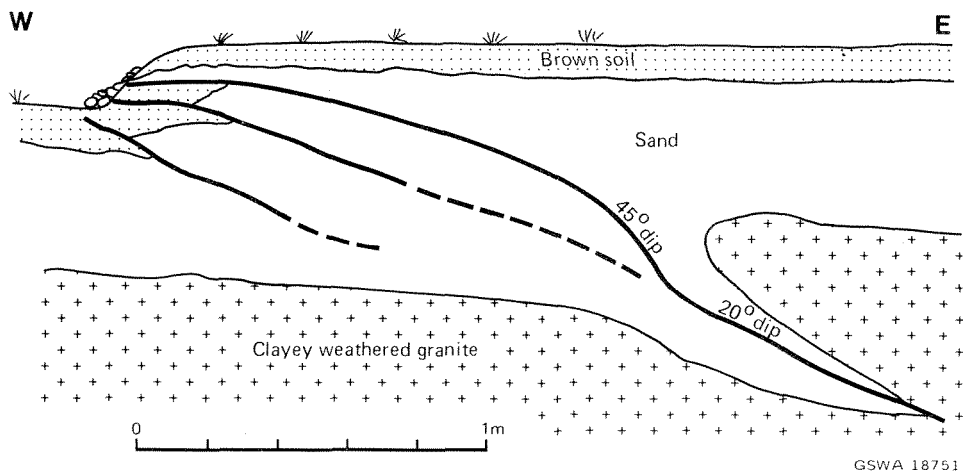
the scarp. A trench, 1 m deep, was excavated across an apparently simple thrust front 200 m north of the junction with the Lone Tree Fault. This revealed, in the soil profile, several small flat thrusts which steepened and converged at depth to a single thrust plane dipping 20° east in weathered bedrock (Fig.20).

Figure 20. North wall of a trench across the Carter Main Thrust, 200 m north of the Lone Tree Fault

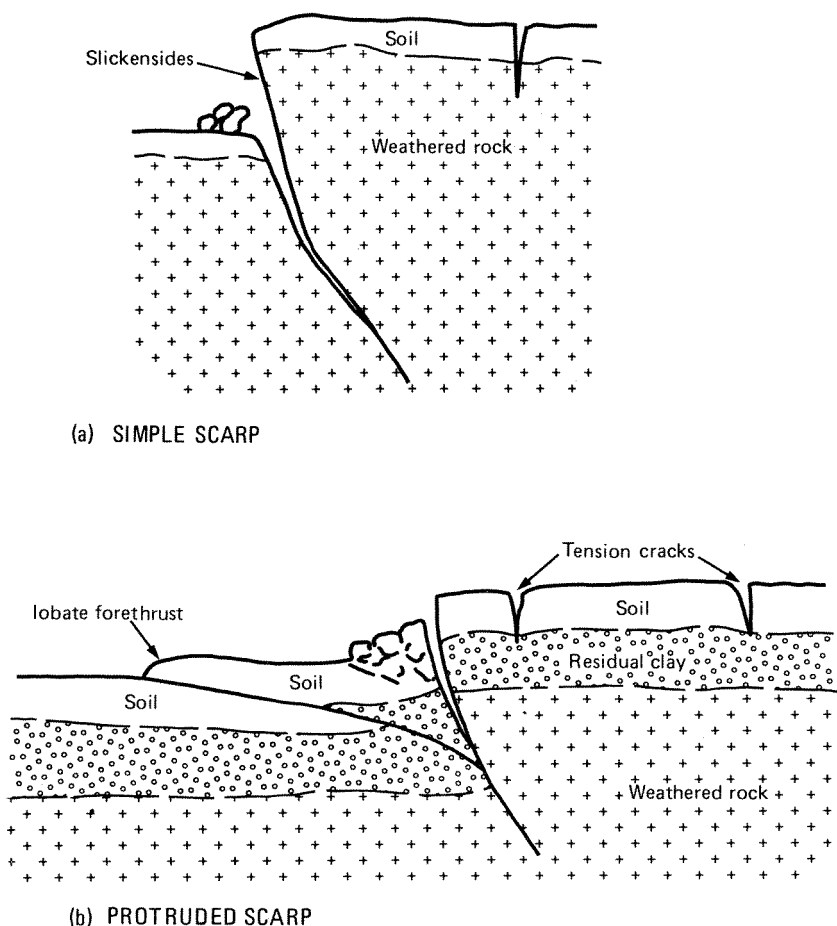
Figure 23. Scarp types on the Tank Fault

More typical than the simple scarp just described, was a complex scarp in which a steeply dipping main scarp, with some frontal collapse, formed behind a low-angle thrust (Fig. 23b). The thrust scarp, which was usually only a few centimetres high, is thought to have been a secondary feature produced by the forward heave of the steep reverse fault when it reached the unconsolidated soil horizon. In plan, the reverse fault had a secondary thrust lobe several metres in front of the main scarp.

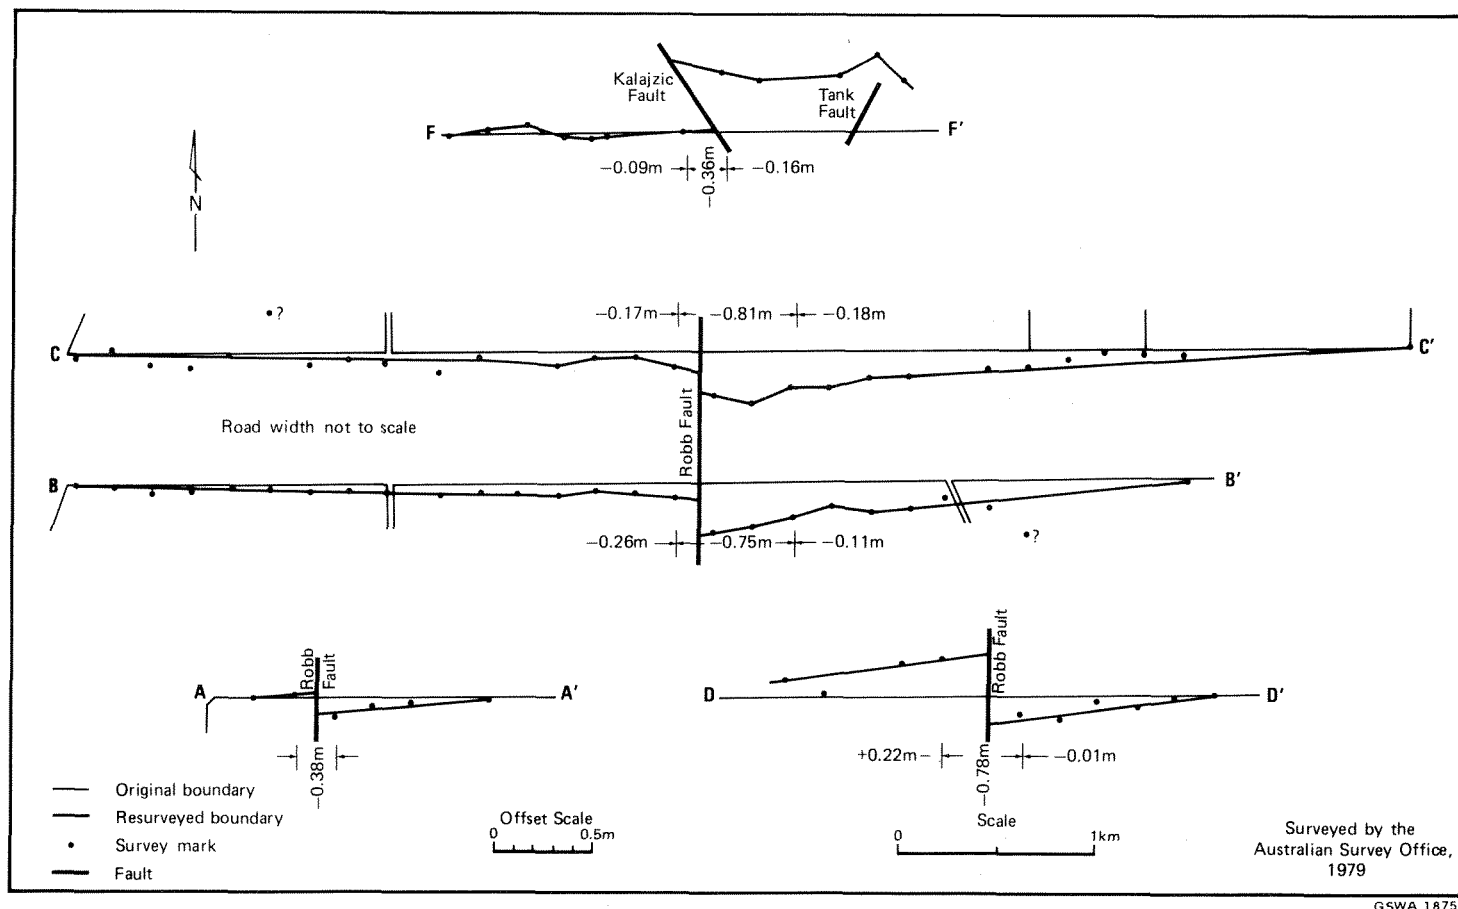
A total of five fence lines were surveyed across the Robb Fault (Figs 26 and 27), the most complete sections being along both sides of the road along the Wongan-Ballidu Shire boundary (Sections B & C) and the southern side of the Koorda road (Section E). Except for the Koorda road section (Fig. 27) all traverses showed horizontal movement at the fault scarp. The traverse along the Wongan-Ballidu Shire boundary was 6.8 km long (Fig. 26, Sections B & C) and at the fault showed a right-lateral translation of 0.20 m. A crustal shortening of about 0.8 m is also shown, mostly in the immediate vicinity of the fault, but including 0.3 m over a distance of 400 m to the east of the scarp. Away from the scarp small increases or decreases of survey length are mainly ascribed to survey errors, but occasional systematic changes on both sides of the road, and both east and west of the fault, probably indicate localized tension or compression. Excluding the fault zone the traverse showed an overall shortening of 0.36 m; including the fault zone the compression was 1.14 m.

The survey confirms the right-lateral strike-slip character of the Robb Fault, and allowing that the fault plane dips west, the simple picture of ground movement is that the mobile west block moved north relative to the east block. However, the survey also shows an apparent southward movement of both blocks, the west block by about 0.05 m and the east block by about 0.25 m, and that a small angle has developed between the two sections. Moreover, there is some curvature in the line, apparently drag induced, particularly on the north side of the road. These features could be explained by regional compressive forces causing buckling in the survey line followed by fracturing which rotated the east block anticlockwise, dragging the west block with it. But, remembering that the regional tilt recorded by levelling on the water supply pipeline was unlikely to be an instantaneous effect of the earthquake,

Figure 26. East-west cadastral surveys of location boundaries across the fault-affected area. The offset of the new survey line is exaggerated x 1000 (for locations see Fig. 25).

it appears more likely that both the buckling near the fault trace and the southward distortion of the survey line accumulated over a period of years, and that the earthquake released this strain and allowed the western half to nearly recover its former position.

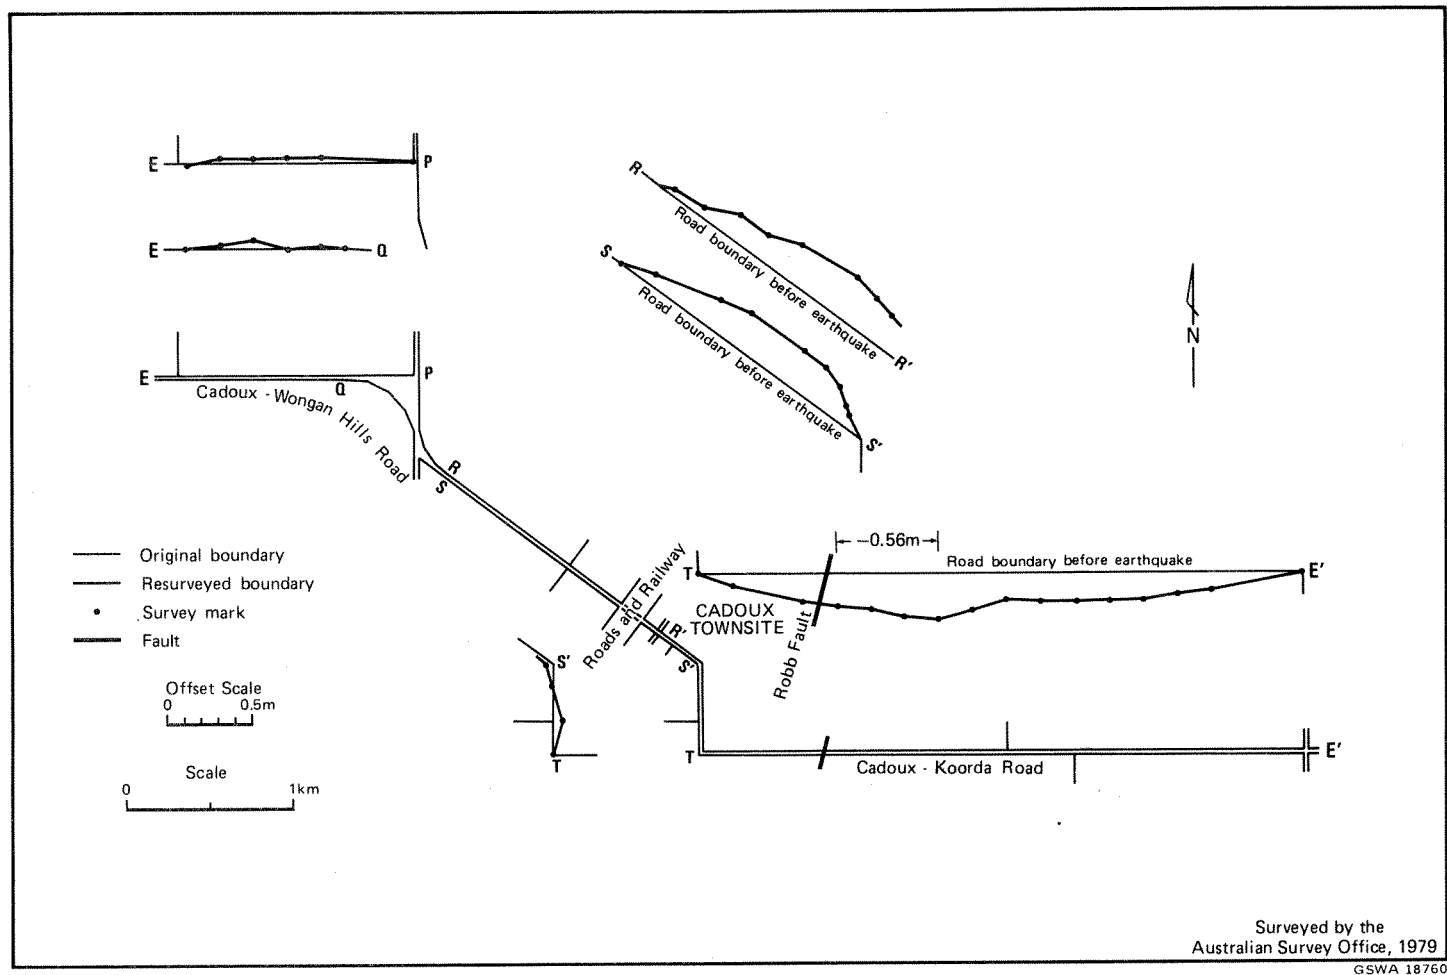
The angular displacement of survey lines is well seen on the southern side of the Koorda road (Fig. 27). On the northern side of the road a small right-lateral displacement was seen but this was not apparent on the south side. The resurvey confirms that although a shortening of 0.56 m took place there was no lateral displacement. Instead there is a southward distortion of the survey line with a maximum displacement of about 0.4 m east of the fault. From Plate 2 it will be seen that at the Koorda road the main trace of the Robb Fault disappears and is replaced by a right-lateral strike-slip fault trending about 070° .

Figure 27 also shows a ground distortion within the Cadoux townsite area. On the ground this was evidenced by several small fractures in the road surface near the school and by very minor fractures to the northwest of the grain silo. The Department of Lands and Surveys attempted to resurvey property boundaries within the townsite but many markers were not recoverable. The four major corner markers of the townsite, however, showed excellent agreement with the survey of 1929 and it would appear that the distortion noted within the townsite was very localized. Beyond the townsite towards Wongan Hills there appeared to be no further distortion.

Figure 27. Resurvey of the Wongan Hills-Koorda road through Cadoux. The offset of the new survey line is exaggerated x 1000 (for location see Fig. 25)

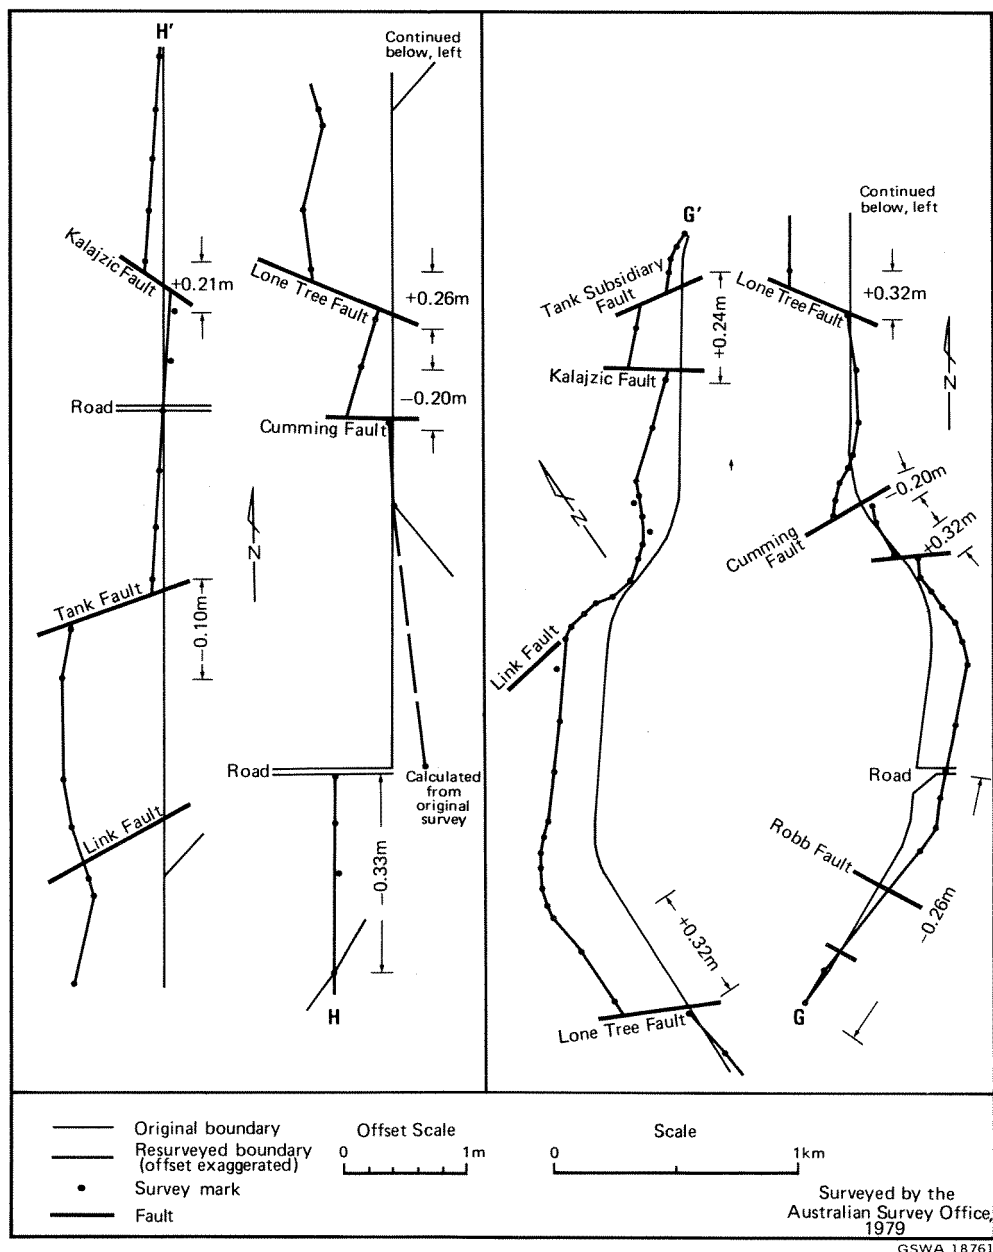
North from Cadoux the resurvey of the eastern boundary of the road and rail reserve (Fig. 28, Section G) intersects most of the fractures of the conjugate faults which form the northern half of the Cadoux Fault system. The section extends from the northern boundary of Cadoux townsite to a little north of Kokardine water tank, a distance of 6.2 km, which overall had suffered no change in length. Within the section, however, the line had been compressed, extended, and offset by a number of faults.

Figure 28. Resurvey of boundaries within the conjugate fault system north of Cadoux. The offset of the new survey line is exaggerated x 1000 (for locations see Fig. 25)

Where the Robb Fault cuts the road it has changed from a right-lateral reverse fault trending 020° to a small left-lateral reverse fault trending 295° . An extension of 0.28 m was surveyed south of the fault and a compression of 0.47 m north of the fault. It would appear that most of the northward right-lateral movement of the Robb Fault has been absorbed in this area. No left-lateral step is seen at this point, as the direction of the survey line coincided with the resultant displacement. The direction is 033° , the same resultant as calculated a little to the east (Table 3, point 6).

The Cumming Fault is seen to have an apparent left-lateral displacement of 0.29 m, much greater than was observed in the field. However, when allowance is made for the angle at which the survey line crosses the fault, and a shortening of 0.20 m in the same area, the displacement reduces to 0.19 m. The survey, together with an observed throw of 0.2 m enables the displacement of the fault to be calculated and the resultant is a displacement of 0.32 m towards 033° on a fault plane dipping 50° to the south. This result is not easily reconciled with the displacements of the conjugate faults to the north or the Robb Fault to the south and emphasizes the distinctive character of the Cumming Fault.

The survey west of the road and rail reserve (Fig.28, Section H) shows many of the features described above except that the westward displacement of the fence between the Lone Tree Fault and the Tank Fault is up to 0.83 m. The Link Fault is again shown to be a minor feature, causing only a slight local decrease in the westward movement of the fault block. The termination of the Robb Fault and several small faults south of the Cumming Fault, all of which intersected the survey line, appear to have had little effect west of the railway.

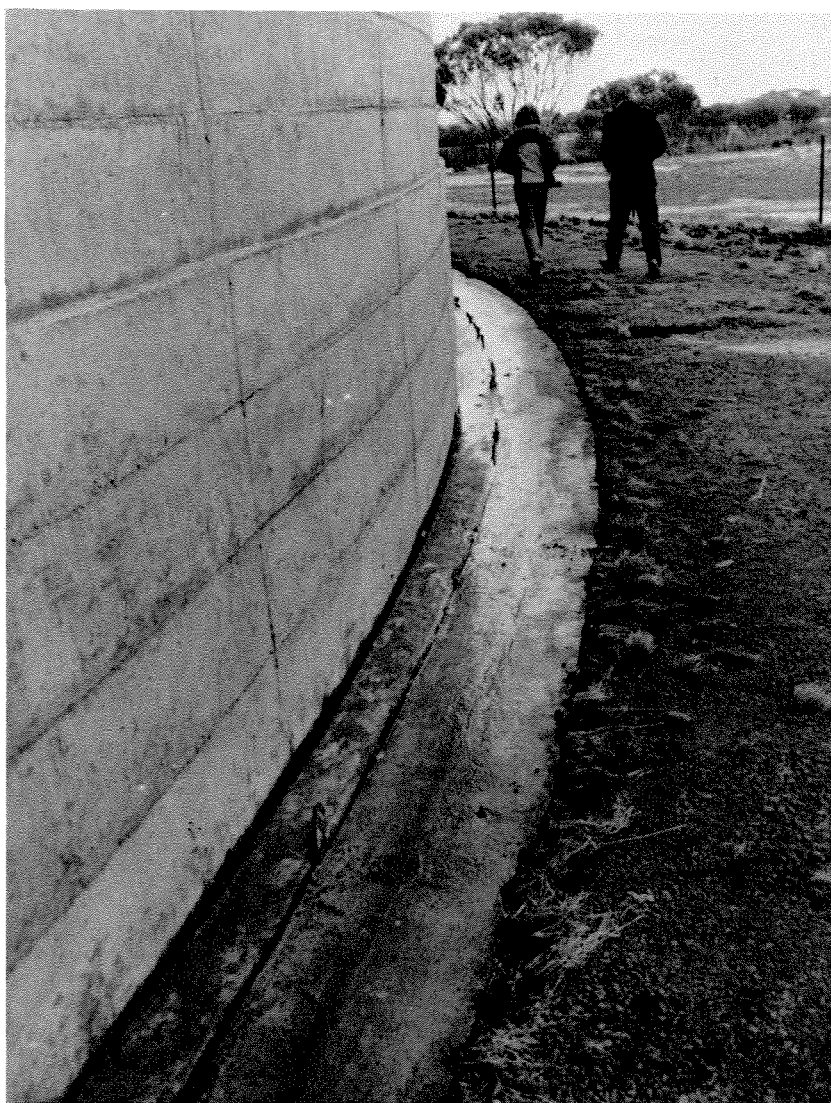
A Public Works Department (PWD) water tank of 9 000 m³ capacity at Kokardine, some 6 km north of Cadoux, was severely damaged (Daetwyler, 1979). The tank consists of a circular reinforced concrete wall resting on a reinforced concrete base. To allow for differential thermal movement of the wall, the butt joint between wall and base was sealed by a rubber water stop. The tank failed due to lateral movement of the wall as a whole, which sheared the water stop. (Fig.35). The total movement was 0.42 m in a direction of 348°.

↑
water
seal

↑
original position of tank

Figure 35. Damage to the Kokardine water tank: note the ruptured neoprene rubber water seal (photo : W.A. Newspapers) (GSA 18768)

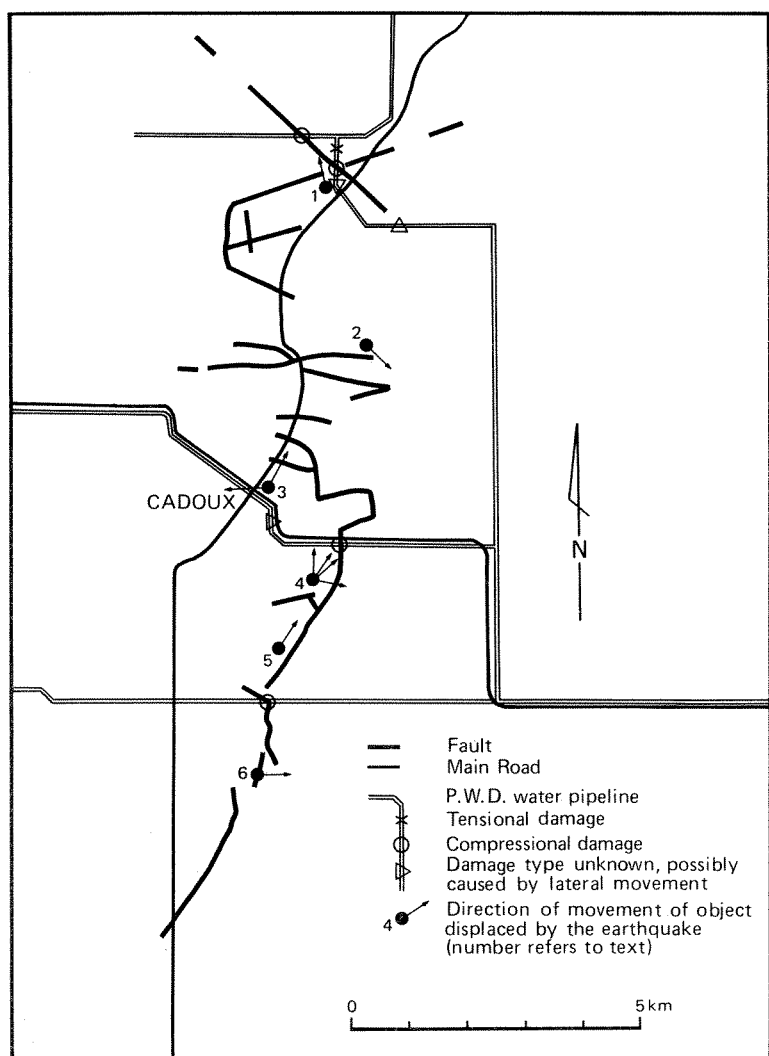
Earthquake-induced pipeline damage has been reported by the PWD (Gugich, 1979). Damage included cracking and displacement of the reinforced concrete supports, and dislocation of the pipe itself, resulting in warping and telescoping under compression, and separation of the pipe at welded joints under tension. The location of these damaged areas is shown on Figure 36.

Figure 36. Location of damage to water pipelines, and of objects displaced by the earthquake

Pipeline damage occurred at three other locations south and east of Cadoux (Fig. 36). Two of these involved a buried main running parallel to the Koorda road; the more easterly was a compressive break, associated with the Robb Fault, but the more westerly break was not seen to be directly related to any specific fault.

Within the conjugate faults north of Cadoux only two structures were displaced. The PWD tank at Kokardine (point 1, Fig. 36) was displaced 0.42 m in the direction of 348° ; this shows no correlation with the displacement of the faults in the area, which was approximately east-west. The preservation, in part, of the original water seal (Fig. 35) may indicate a vertical component in the shaking. Damage to a grain silo on the Cumming property (point 2, Fig. 36; and Fig. 43) may also indicate vertical motion. The concrete slab on which the silo stands was badly damaged and there was a lateral displacement of the silo of 0.15 m to the southeast. The movement on the nearby Cumming Fault was predominantly northwards.

On the upthrust block to the west of the Robb Fault a fairly consistent displacement direction to the northeast is apparent, with a few structures moving northwards and westward. In Cadoux township (point 3, Fig. 36) the Telecom exchange showed a displacement of 0.77 m in the direction of 027° , and a transportable house moved about 0.06 m westward on its supports. In the Robb farmyard, south of Cadoux, (point 4, Fig. 36) the base of a wheat silo moved in the direction of 001° , while the tower itself collapsed in the direction of 047° (Fig. 44). Nearby, a truck rolled 0.8 m backwards, in the direction 002° , while its load was lifted out of the tray and displaced 0.2 m westwards. A fuel bowser some 100 m southeast of the silo was found to have

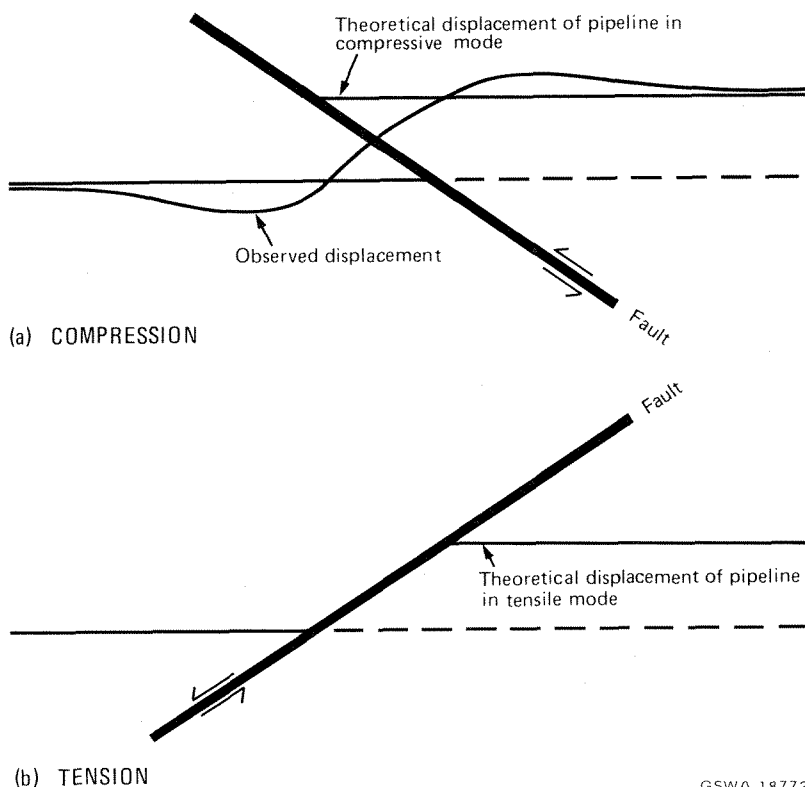
Figure 38. Damage to water pipeline where it crosses the Kalajzic Fault: the pipeline has failed through left-lateral movement and compression (see Fig. 39a) (GSWA 18771)

Figure 39. Differing modes of failure for a pipeline crossing a left-lateral strike-slip fault

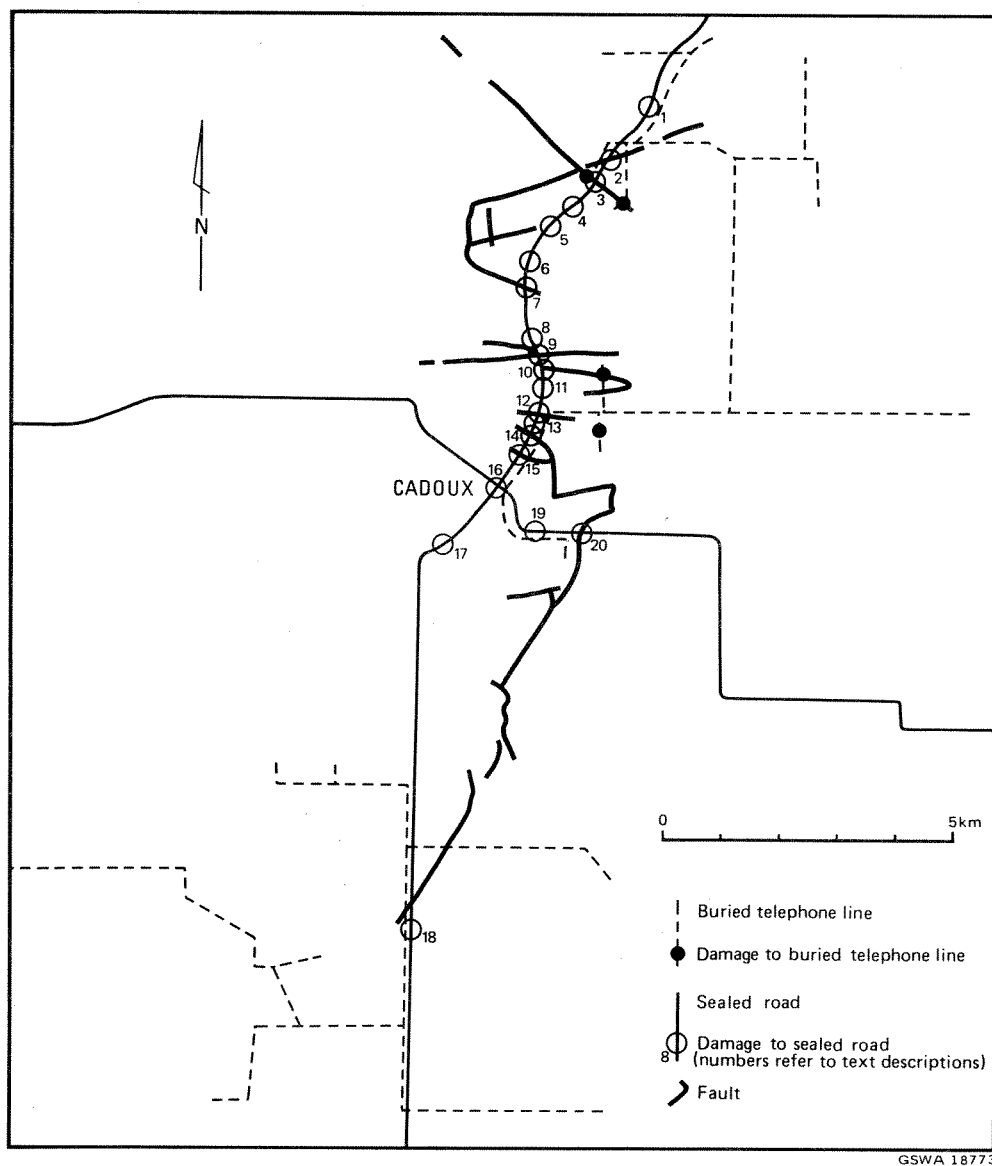
All breaks in the buried cables occurred north of Cadoux, and can be related to individual strike-slip faults. A number of faults intersected cables but did not damage them (Fig. 40). Two cable breaks were caused by the Kalajzic Fault, confirming it as the most destructive feature of the earthquake. A break in the cable serving the Cumming house appears to have been caused by the most northerly of the minor faults between the Robb and Cumming Faults. A fourth cable break occurred on the line to the Hopkins house, and appears to be related to the strike-slip fault which was mapped immediately west of the break. It is interesting to note that this fault failed to break a cable at a point where the fault was conspicuous, yet it broke the same cable where no surface expression of the fault was seen.

A total of 20 disruptions of the sealed road around Cadoux were recorded, ranging from major vertical steps to minor tension cracking. The locations of the disturbed sections of road are shown on Figure 40. Breaks numbered 2, 3, 5, 6, 7, 9, 10, 12, 14, 15 and 19 were all directly related to earthquake faulting.

Figure 40. Location of damage to roads and buried telephone cables

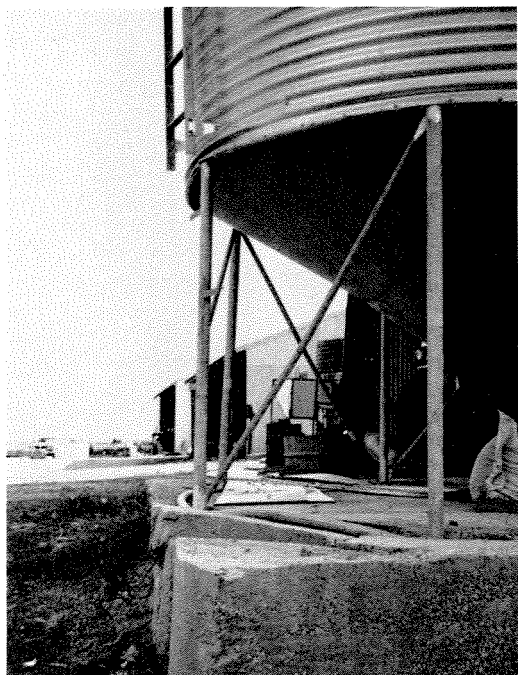
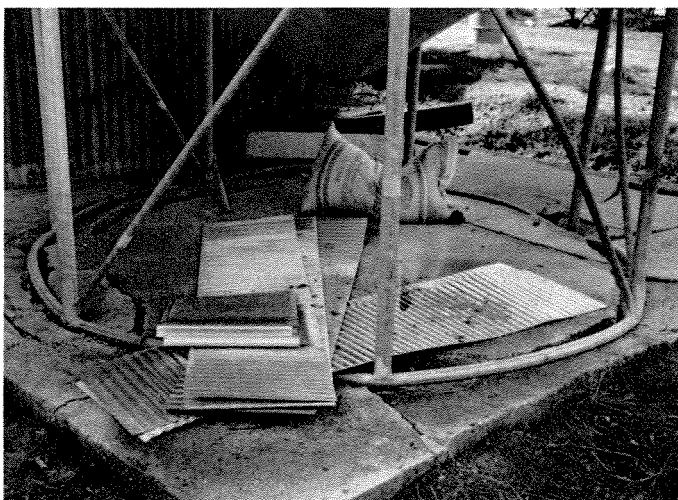
Figure 43. Damage and displacement of a wheat silo on the property of E.W. Cumming: (a) looking west, the concrete slab support has been badly damaged, (b) looking northeast, the silo has been displaced to the right of the photograph (GSWA 18776)
